RECALL CAMPAIGN BULLETIN

NTB08-024a

VOLUNTARY RECALL CAMPAIGN 2009 MURANO AIR BAG CONTROL MODULE REPROGRAM

CAMPAIGN ID #: P8201
NHTSA # 08V-066
APPLIED VEHICLE: 2009 Murano (Z51)
APPLIED VINs: JN8AZ18U(*)9W 000101 – 008983
 JN8AZ18W(*)9W 100101 – 119273

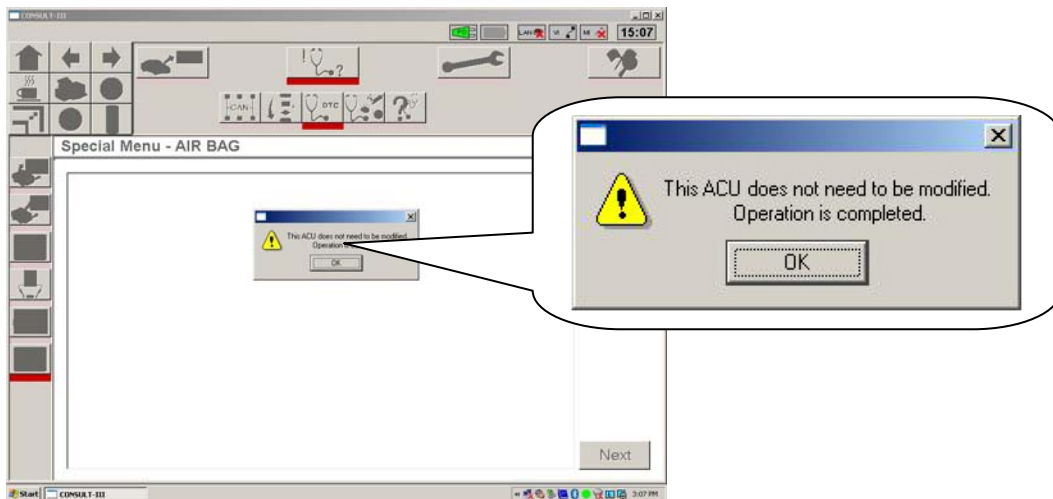
NOTE: If the error message shown in Figure 7 is displayed, the campaign has already been completed on this vehicle.

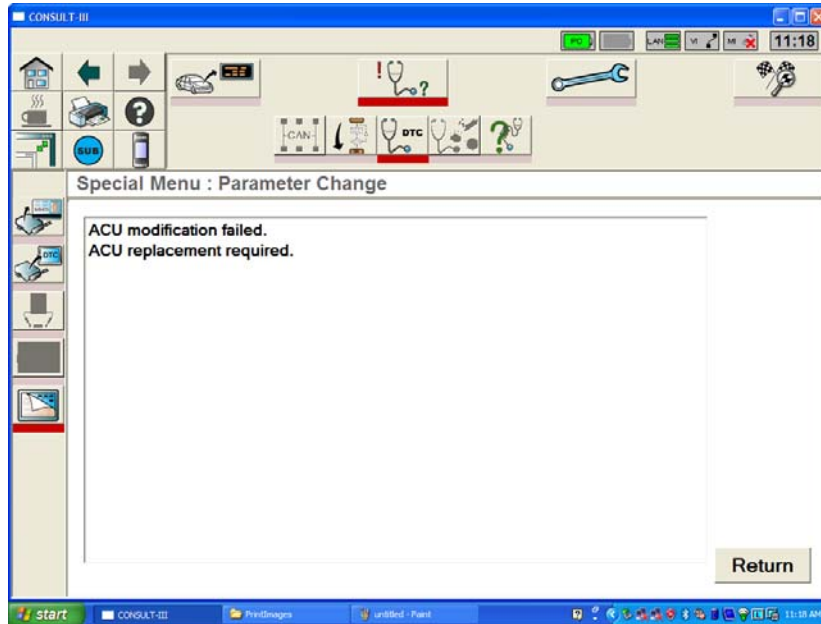
- If the message in Figure A is displayed, the ACU (Air Bag Control Unit) is damaged and must be replaced.

Replace the ACU.

Do not reprogram the new ACU.

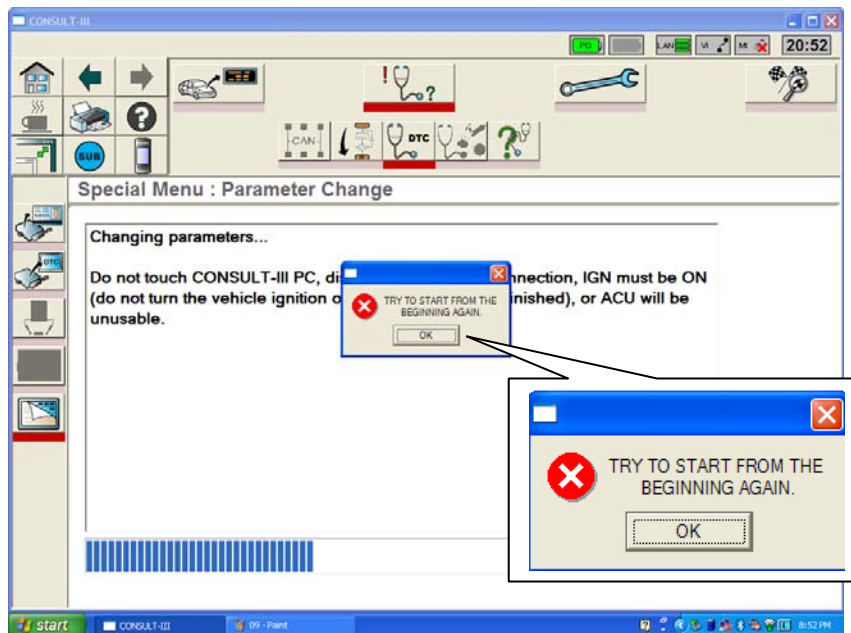
- If the message in Figure B is displayed select **OK**, then go back to step 1 on page 2 and perform the procedure again.

Follow each step in the procedure exactly.
