**RE: RECALL CAMPAIGN – CONTINENTAL GT & CONTINENTAL FLYING SPUR –  
PASSENGER AIRBAG TRIMMED COVER, REPLACEMENT PART (3W1858452F) –  
INCORRECT TETHER LENGTH – RE08/01**

**Passenger Air Bag – Parts Replacement Trimmed Cover -  
Tether length incorrect – RE08/01**

08-02-08-01

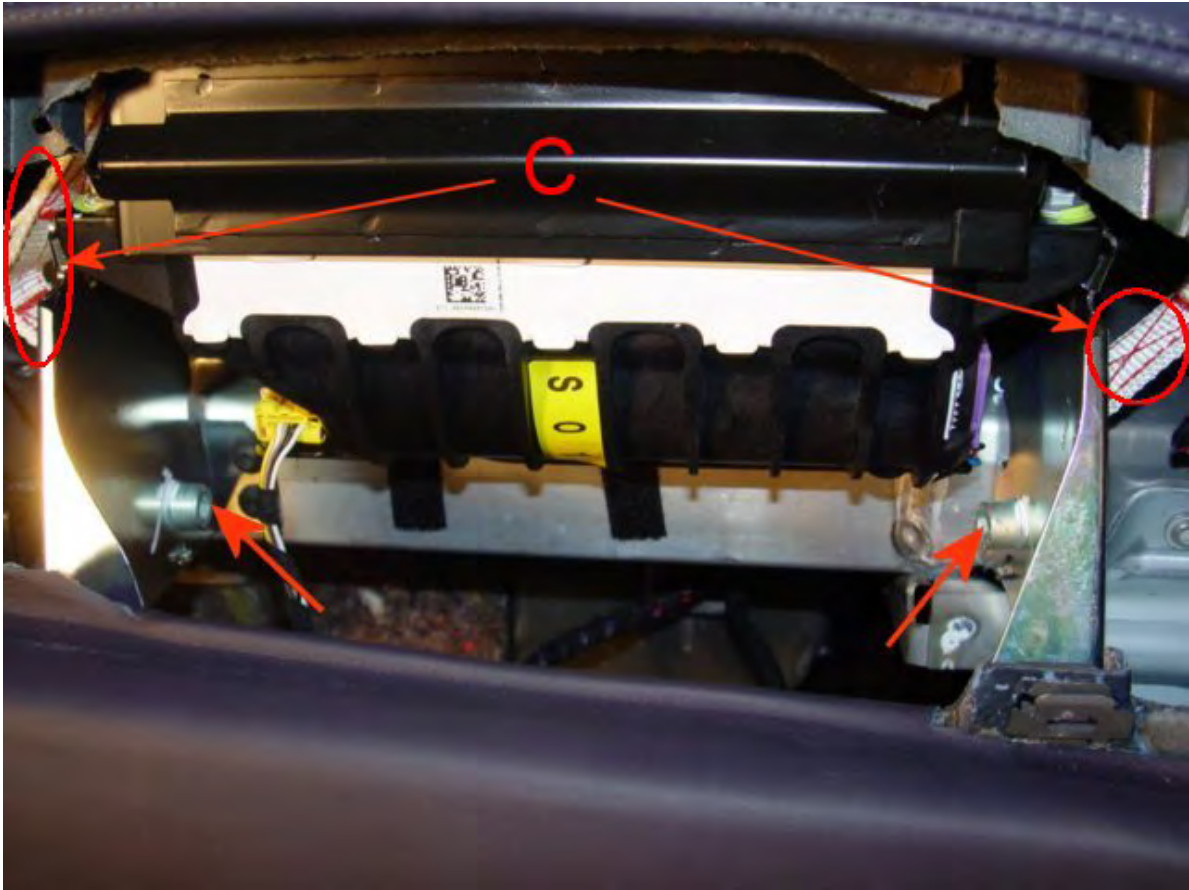
Figure 3

**Note:** It has been determined that vehicles on the attached VIN list will be fitted with the incorrect tethers. These tethers use red stitching on the webbing (see item C Figure 3). If any other colour stitching is seen on these vehicles, contact the TSC via Hotline Channel. The colour of the stitching is not indicative of incorrect parts on vehicles outside of this Bulletin.

- Partially remove the assembly until the glove box link harness can be disconnected before finally removing from the vehicle
3. Remove the two M10 fasteners securing the trimmed cover tethers to the instrument panel (see Figure 3)

10. Secure the two tethers to the instrument panel torque tighten M10 bolts to 15Nm (see Figure 3)
11. Reconnect the glove box link harness before locating the glove box assembly into the instrument panel and securing with six screws (see Figure 2)

| <p><b>Caution:</b> Ensure the M10 tether retaining bolts are torque tightened before fitting the veneer panel, operation 10 (see Figure 3)</p> |
