Subject: Safety Recall- 08V-080
Wheel nuts

Campaign number 08V-080

2007 Tundra Wheel Nut Replacement Procedure

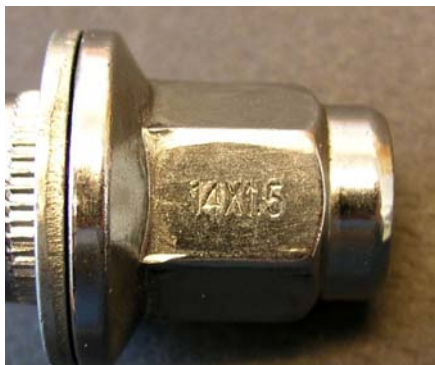
When the vehicle was processed, an alloy tire/wheel was installed as an upgrade. The upgrade included 4 alloy wheels with attaching wheel nuts. It has been determined that the wheel nuts can crack and break if the wheels are not installed carefully or if the wheel nuts are not carefully torqued. This condition may occur at time of wheel installation, tire rotation or service.

Figure 1 Identifying wheel nuts requiring replacement

You are requested to replace all of the non locking wheel nuts on the vehicle (4 per wheel, total 16 wheel nuts per vehicle).

1. Raise the wheels off the ground.
2. Remove the 4 non-locking wheel nuts from wheels.

NOTE: Locking wheel nuts are not to be replaced.

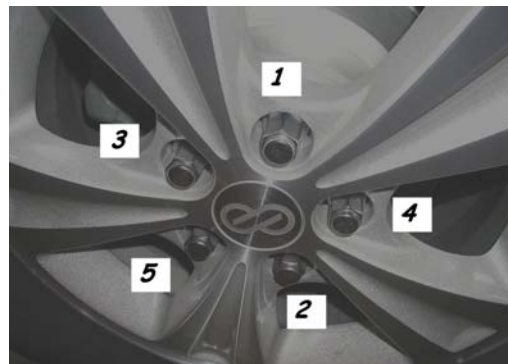
Figure 2. Torque wheel nuts in the order shown.

3. Save removed wheel nuts for parts return.
4. With wheel firmly positioned against hub, install new wheel nuts finger tight on the wheel studs.
5. Torque each wheel nut a little at a time until a torque of 97 ft. lb is reached. Use the tightening sequence shown in Figure 2.
