**Re: Defect Information Report – Supplemental Report No. 2
08V-088, FL-524, Braun Wheelchair Lift**

Subject: RECALL 08V-088 – Braun Wheelchair Lifts/Threshold Warning

Service Bulletin 34273

Instructions for Braun Corporation "Public and Private Use" Dual Parallel Arm Lift Threshold Sensitivity Evaluation and NHTSA Compliance Applicable for NL, NCL and NVL Series Lifts

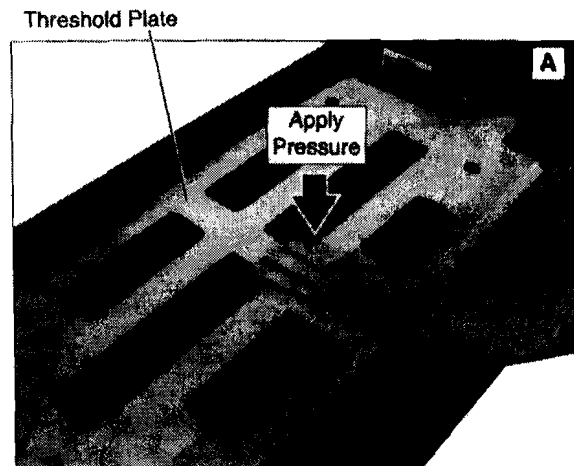
1. Turn Lift Power switch ON. Deploy the lift platform fully to the ground.
2. Apply hand pressure on the center of the threshold plate as shown in Photo A. The visual and/or audible threshold warning* should be activated when you push down.

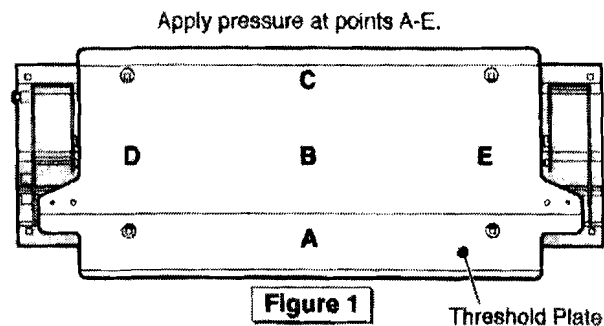
Repeat the sensitivity test procedure at positions A-E shown in Figure 1.

If the threshold alarm is not activated at all positions, perform the retrofit procedures detailed on pages 2 and 3 of this bulletin. Repeat the sensitivity test procedures following the retrofit. If the lift still does not meet the requirement, contact a Braun Corporation Product Support representative at 1-800-THE LIFT*.

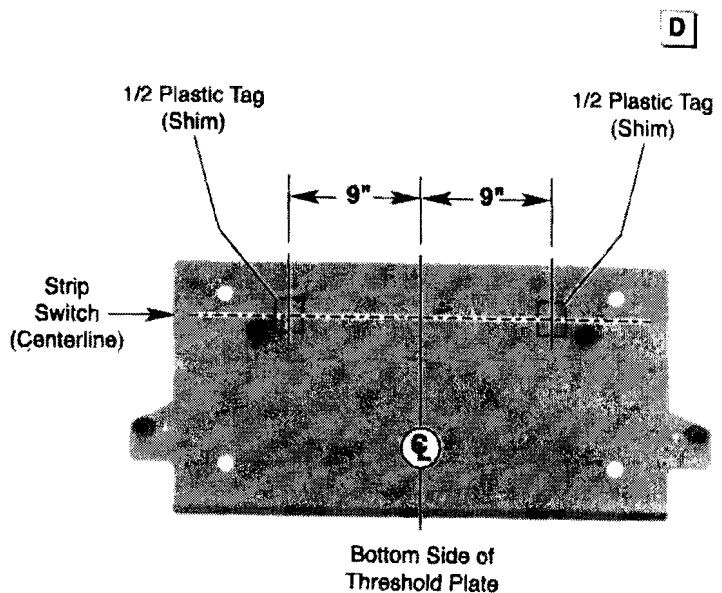
Turn threshold plate over. See Photo D. The strip switches typically leave an impression (mark) on the yellow plate from use. Use the impression of the inboard strip switch as a centerline for shim positioning (or measure to establish position).

Position each shim 9" from the center of the threshold plate (see Photo D). Align the tags with the strip switch centerline. Clean the surface as detailed below and affix the adhesive-backed tag to the plate (**press firmly**).

Note: Clean the surface with isopropyl alcohol before affixing the tag. Use a clean cloth or paper towels. Do not use oily shop rags. Wipe surface free of residue with dry portion of cleaning cloth.

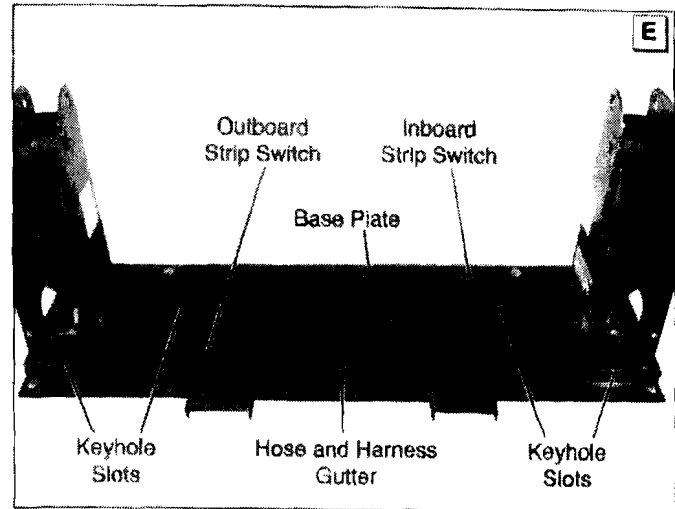
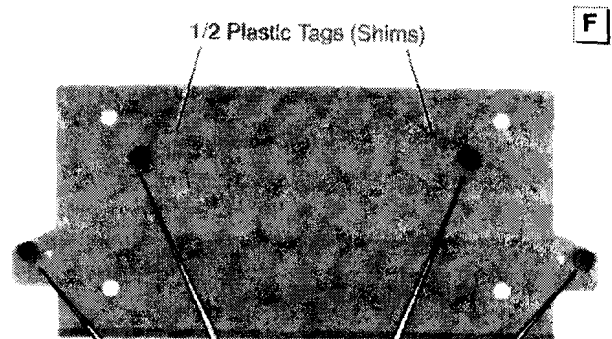
Keeper Standoffs
(Engagement Studs)

Ensure all hoses and wiring harnesses routed through the base plate gutter are positioned fully in the gutter and not located anywhere they could potentially interfere with activation of the tape switches. See Photo E.

4. Reposition the threshold plate (with shim). Align the keeper standoffs (studs) on the bottom of the threshold plate with the base plate keyhole slots. See Photos E, F and G. Insert studs and **carefully** slide the plate inward (engage slots fully).

Note: Spraying a light mist of glass cleaner (or other) to the strip switches will aid in the plate sliding easier into position. See Photos E, F and G.

Ensure all four keeper standoffs engage the base plate keyhole slots.
