# SERVICE BULLETIN

M-1217

## 2005-07 POLICE MODEL ABS BRAKE LINE RECALL

08V-090

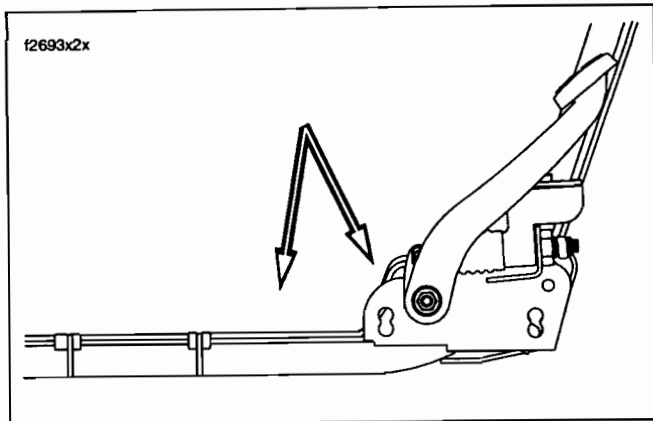
Figure 1. Brake Lines 40632-05/06 to Clutch Cable

3. See Figure 1 and Table 1. Inspect three brake lines (Part No. 40632-05/06) leading from the brake manifold and rear master cylinder to the ABS module. Pay careful attention to the following areas:
  - a. Brake line to clutch cable inboard and/or rear of rear master cylinder/brake pedal frame weldment.
  - b. Brake line hoses to adjacent hoses inboard of ABS module.
4. See Figure 2 and Table 1. Inspect the brake line (Part No. 40610-05) leading from the ABS module to the rear caliper. Pay careful attention to the following areas:
  - a. Brake hose to edge of saddlebag cut out.
  - b. Brake hose to adjacent 40632-05/06 hoses.

5. Take appropriate action based on both visual observation and feel of any wear marks.
