American Honda Motor Co., Inc. Acura Automobile Division Service Bulletin

April 22, 2008

Applies To: 2004–06 TL – ALL

Safety Recall: 2004–08 TL Power Steering Feed Hose Leak

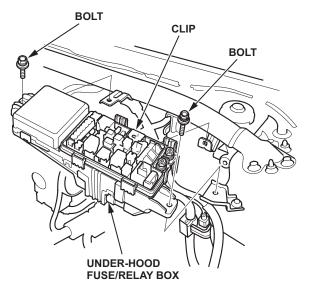
- Drain the P/S fluid: NOTE: Take care not to spill any fluid. Wipe off any spilled fluid immediately.
 - Refer to page 17-13 of the 07–08 TL Service Manual, or
 - Online, enter keywords STEERING FLUID, and select Power Steering Fluid Check/ Replacement from the list.
- 3. Check the condition of the drained fluid:
 - If the fluid is contaminated, dark, or discolored, discard it; do not reuse it.
 - If the fluid is clear with no contamination, save it in a covered container. It will be reused in step 45.
- 4. Reinstall the return hose on the P/S reservoir. If the hose clamp on the return hose is damaged, replace it.
- 5. Remove the two bolts from the under-hood fuse/ relay box, then detach the fuse/relay box from the strut brace bracket.

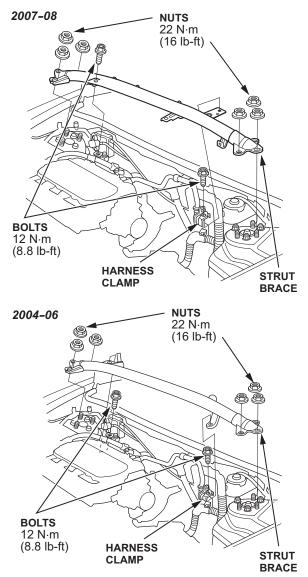
THROTTLE CABLE BRACKET STRUT BRACE

6. Remove the two bolts from the throttle cable bracket, then detach the clip from the strut brace.

- 7. Remove the strut brace:
 - Remove the harness clamp.
 - Remove the two bolts.
 - · Remove the six nuts.

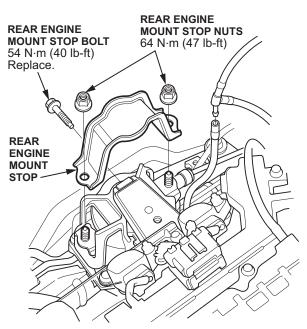
17. Remove the rear engine mount stop (two nuts), then remove the rear engine mount stop bolt. The stop bolt *will not* be reused.

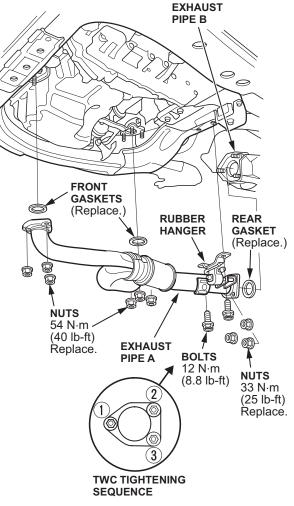
2007–08 TL is shown. Earlier models are similar.

- 20. Raise the vehicle on a lift, and make sure it's securely supported.
- 21. Remove exhaust pipe A:
 - Remove the rubber exhaust hanger from the subframe.
 - Remove exhaust pipe A (nine self-locking nuts). The nuts *will not* be reused.
 - Support exhaust pipe B with a stand.

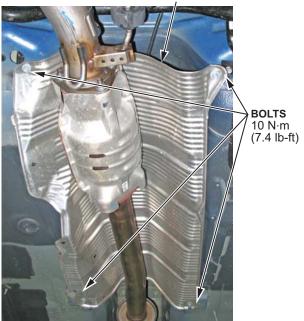
EXHAUST HEAT SHIELD

22. Remove the exhaust heat shield.

- 39. Reinstall the exhaust heat shield, and torque its bolts to 22 N·m (16 lb-ft).
- 40. Reattach exhaust pipe A using new gaskets and self-locking nuts. Use the torque specs on page 5.

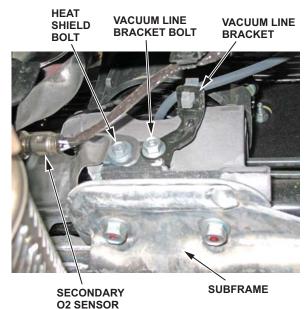
24. Remove the vacuum line bracket from the rear engine mount (one bolt).

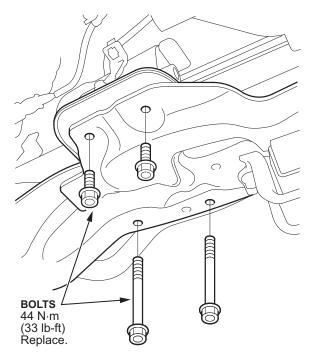
27. Remove the four rear engine mount bracket bolts from the subframe. The bolts *will not* be reused.

- 37. Torque the four new rear engine mount bracket bolts to 44 N·m (33 lb-ft).
- 38. 2004–06 M/T models only: Torque the two new rear engine damper bolts to **38 N·m (28 lb-ft)**

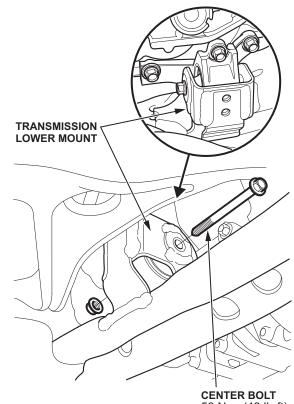
CENTER BOLT 59 N·m (43 lb-ft)

29. 2007-08 models only: Remove the center bolt from the transmission lower mount:

- 35. Lower the transmission jack, and remove the block of wood.
- 36. 2004–06 models only: Install four new transmission front/rear lower mount nuts. Torque the nuts to 44 N·m (33 lb-ft). 2007–08 models only: Reinstall the transmission lower mount center bolt, and torque it to 59 N·m (43 lb-ft).

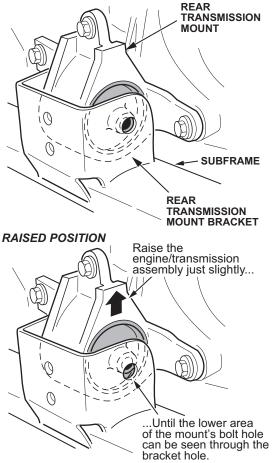
ORIGINAL POSITION

- To minimize the stress damage on the other engine/transmission mounts, do not lift the assembly too much.
- On 2007–08 models, the maximum allowable lift is reached when you see the lower part of the mount's bolt hole through the bracket hole (see below).
