SAFETY RECALL BULLETIN

SUBJECT: FLOOR HARNESS SAFETY RECALL		No: SR-08-002
		DATE: March, 2008
		MODEL: 2007 - 08 Outlander
CIRCULATE TO:	<input type="checkbox"/> GENERAL MANAGER	<input checked="" type="checkbox"/> PARTS MANAGER
<input checked="" type="checkbox"/> SERVICE ADVISOR	<input checked="" type="checkbox"/> SERVICE MANAGER	<input checked="" type="checkbox"/> TECHNICIAN
	<input checked="" type="checkbox"/> WARRANTY PROCESSOR	<input checked="" type="checkbox"/> SALES MANAGER

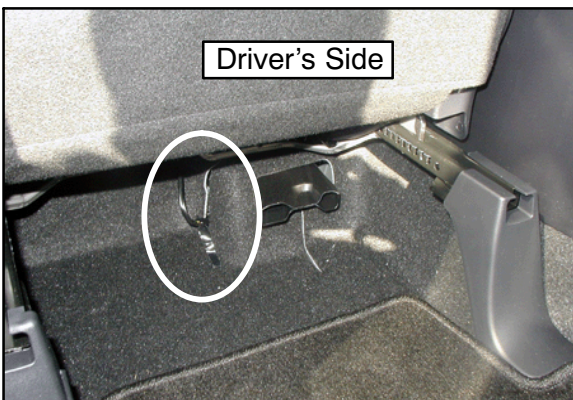
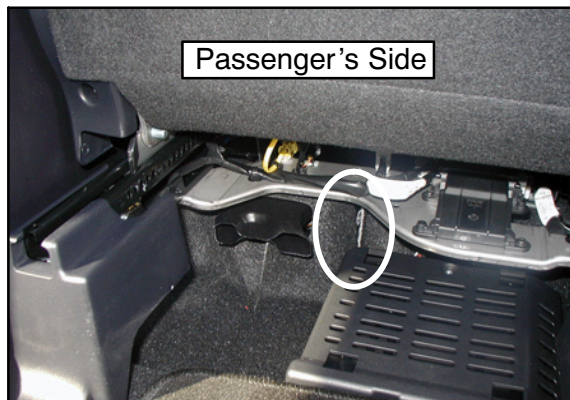
3. Reach through the carpet cutouts as illustrated and locate the loose connectors. There are two connectors for the driver's side (D25, 2 pin, power seat & D26, 4 pin, seat heater) and one connector for the passenger's side (D-33, 4 pin, seat heater).

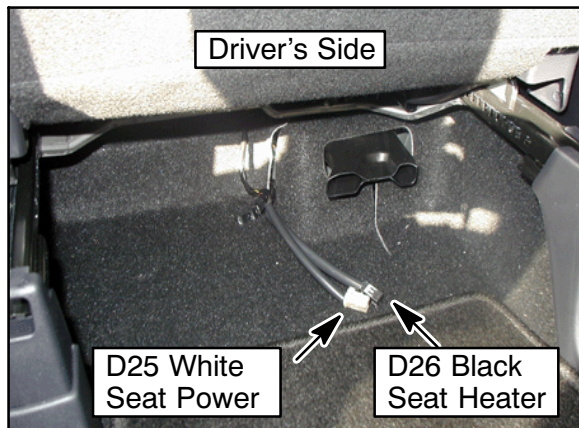
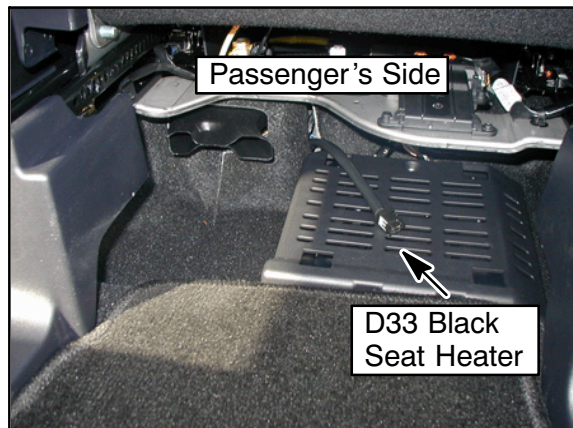
4. Pull the connectors out from under the carpet.

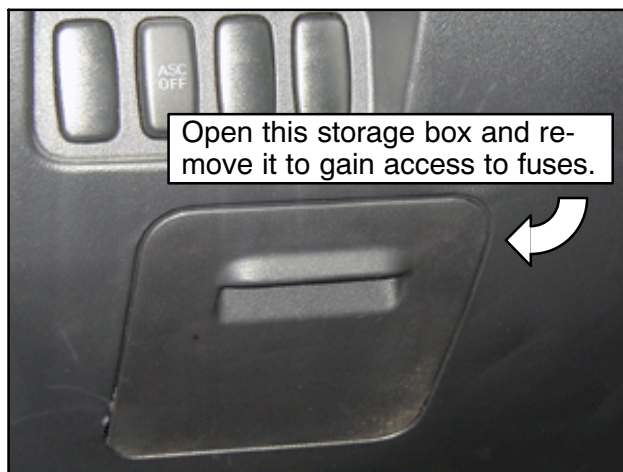
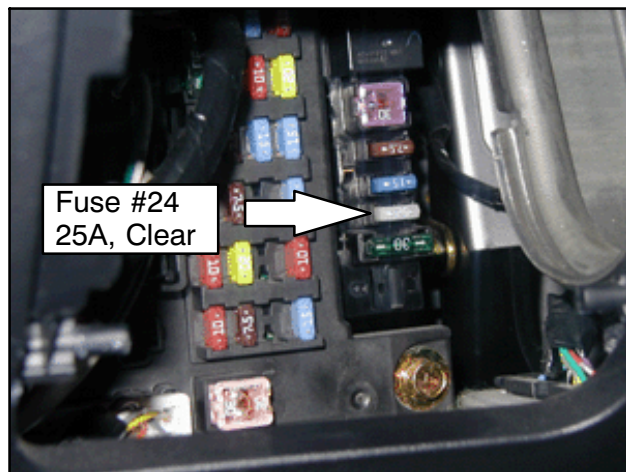
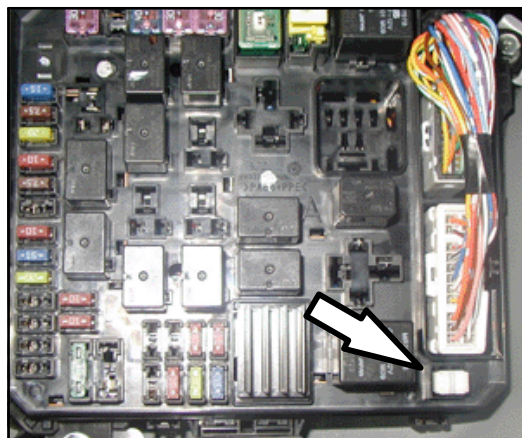
NOTE: If you find a melted connector, remove multi-purpose fuse #24 for the power seat, located in the fuse panel behind the storage box on the driver's side lower dashboard. Retain the fuse for reinstallation when repairs are completed. Cut the melted connector from the harness and wrap the loose ends of the wires separately with electrical tape, and then tape the power seat and seat heater harnesses together before proceeding. Inspect if the removed fuse has blown. If it has, replace it.

If you do not remove fuse #24 as indicated when cutting a melted connector from the harness, your cutters may create a short circuit and the fuse may blow.
