Service Information Bulletin

Advanced Notice of Recall 08V-111

Subject: Technical campaign, Wheel-bearing check

Model: G 650 Xcountry, G 650 Xchallenge (K15)

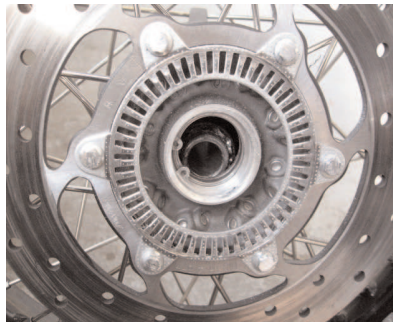
Fig 1: Left rear wheel-bearing guide

Details: Some G 650 Xcountry and G 650 Xchallenge motorcycles left the factory with the wrong circlip (Figure 2) installed on the left-hand side of the rear wheel-bearing guide (Figure 1). The result can be that this circlip rubs against the spacing bushing. The particles of metal removed by friction can penetrate the wheel bearing and cause failure. There is also the possibility of incorrect sensor signals causing the ABS to malfunction. If this happens the ABS warning light comes on, alerting the rider to the situation. Even under these circumstances, the brakes remain fully available to slow the motorcycle.

Aftersales Solution: Please check your entire stock of motorcycles in the range of VINs affected, starting with a Vehicle History Check, and make sure that every motorcycle is fitted with the correct circlip.

If you find that the wrong circlip is installed, the spacing bushing, both wheel bearings, the circlip and both shaft sealing rings have to be replaced.

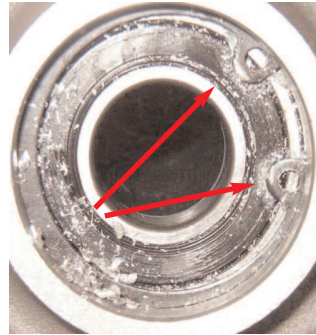
Fig 2: Wrong circlip

The distinguishing feature between the two circlips is the shape of the lugs for the eyes that engage the tips of the circlip pliers. The correct circlip is distinguished by the inward-facing flats on these lugs (see Figure 3); whereas the wrong circlip has rounded lugs (see Figure 2).
