RE: NHTSA Campaign No. 08V-126

**Re: NHTSA Safety Recall, Program- Campaign number 08V - 126 - Alternator B+ cable retention  
Van Hool Coaches type C2045**

## SB1210A

| <b>SUBJECT</b> | : <b>Alternator B+ cable retention</b> |

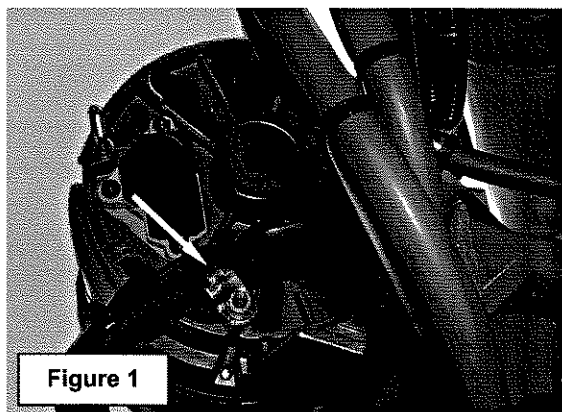
1. It has been determined that on the above-mentioned units a possible defect may exist, which relates to motor vehicle safety.  
As a result of vibration the B+ alternator cable retention may fail through breakage of the B+ ring terminal. The positive battery cable detaching from the rear of the alternator could result in a loss of battery charging capability or cause a short-circuit and even start a fire.
2. To address these issues in production, a P-clamp is now fitted below the black PVC terminal cover in order to improve cable retention and ensure the service life of the terminal (Figure 1). This modification has been introduced on both the upper most and lower most mounted alternators as from Commuter Coach # 47448.

3. Owners and operators of affected field units should have the retention of the alternator B+ terminals checked without delay.

If the check reveals signs of ring terminals cracking then immediate remedial action should be taken and the terminals should be replaced by new ones.

**CAUTION:** In all cases it is necessary to improve the B+ cable retention and fit P-clamps as described in this Bulletin.

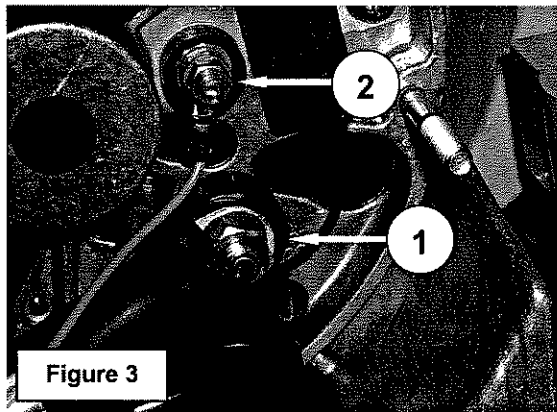
Pull back the B+ ring terminal protective cover.  
Check the terminal for possible damage.  
If the terminal shows any signs of cracking, it should be replaced first.

Undo the nut securing the terminal (1, Figure 3).  
Undo the nut securing the D+ terminal (2, Figure 3).  
Cut cable ties as required to allow re-routing of the B+ and D+ cables.
