**Subject: WVD-14 Impreza Wagon Rear Gate Stay Stud Bolt Safety Recall**

**PRODUCT CAMPAIGN BULLETIN**

**APPLICABILITY:** 2002-2003 MY Subaru Impreza Wagon  
**SUBJECT:** Rear Gate Stays

**NUMBER:** WVD-14  
**DATE:** May 2008

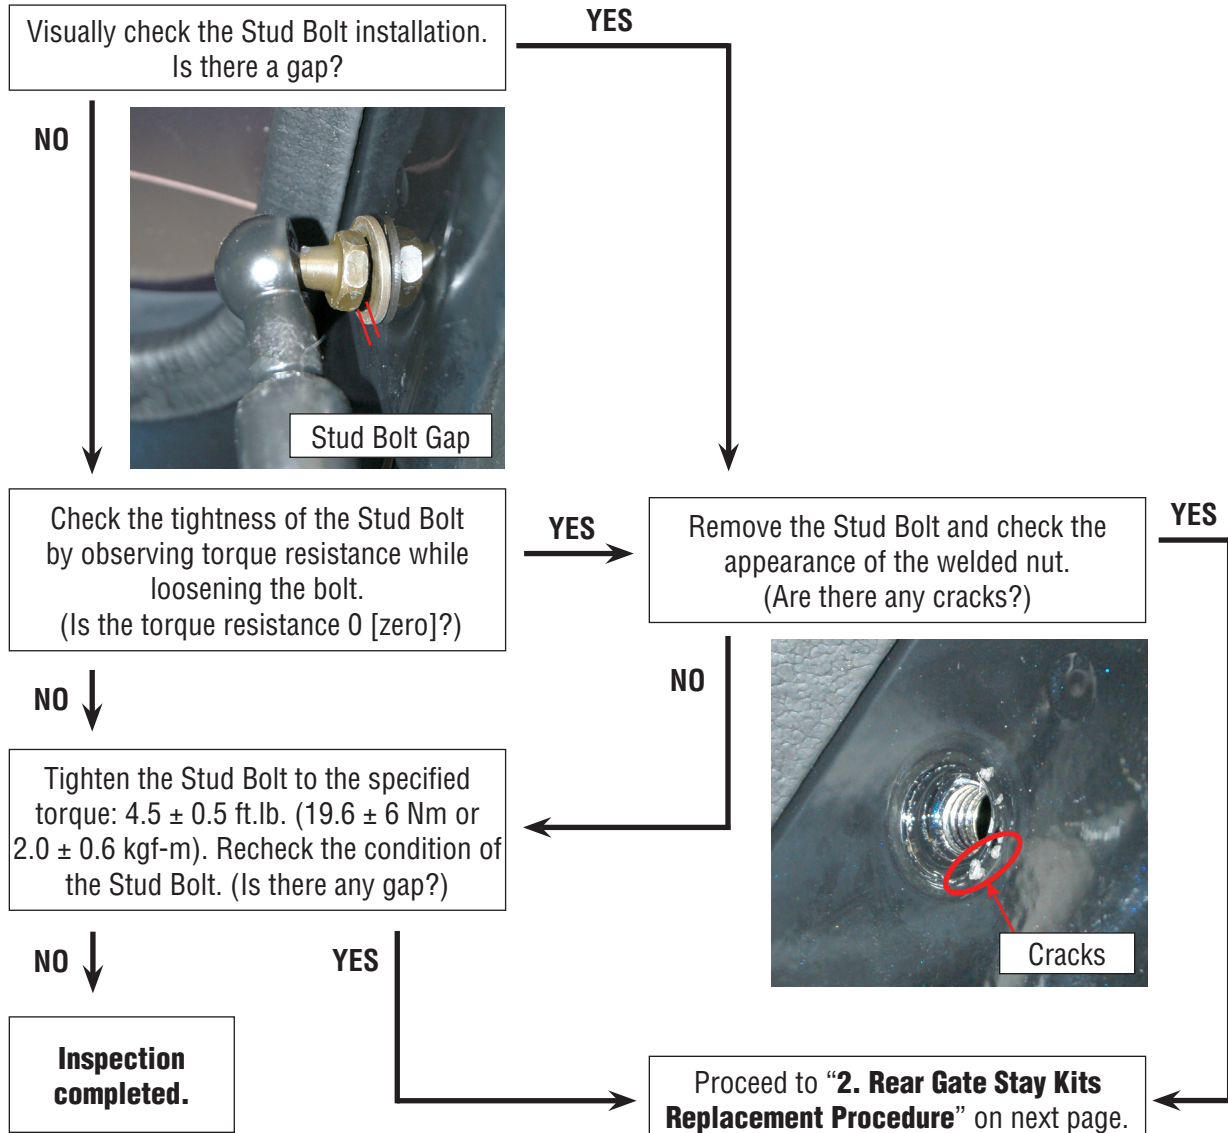
- 1) Tools required:
  - 12MM Combination Wrench
- 2) Inspection procedure:

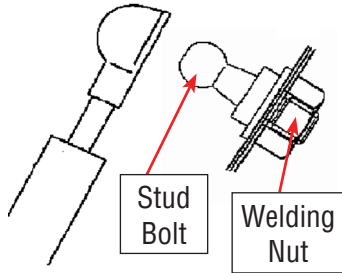
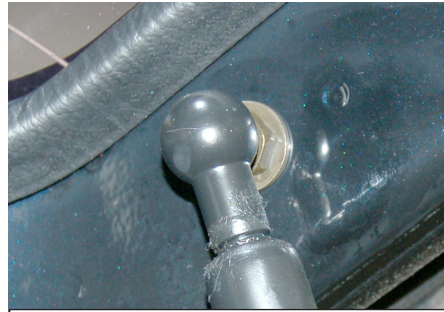
Note: Never disassemble the rear gate stay or separate the stud bolt from the stay.

Specified tightening torque of Stud Bolt:  $4.5 \pm 0.5$  ft.lb. ( $19.6 \pm 6$  Nm or  $2.0 \pm 0.6$  kgf-m).
