Rev 1, March 2018

Safety Recall H07

Tire Pressure Monitoring System Electrical Connectors

2007-2008 (JS) Dodge Avenger and Chrysler Sebring

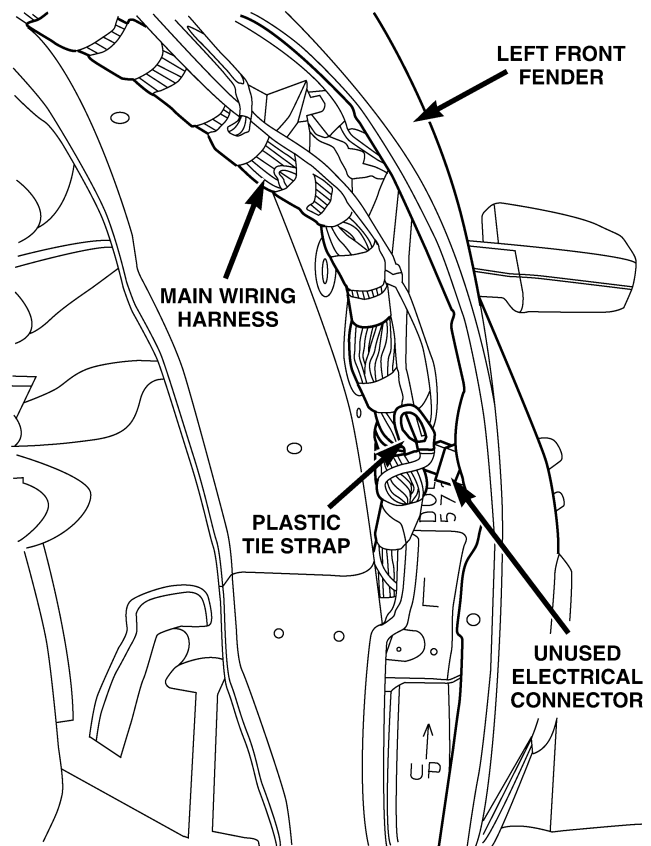
Figure 1

2. Partially lift the vehicle on an appropriate frame contact hoist.
3. Remove the left front wheel and tire.
4. Remove the rear section of the left front plastic inner fender splash shield.
5. Locate the unused 6-cavity tire pressure monitor electrical connector that is tie strapped to the main wiring harness (Figure 1).

6. Cut off and discard the plastic tie strap that holds the 6-cavity unused electrical connector to the main wiring harness (Figure 1).

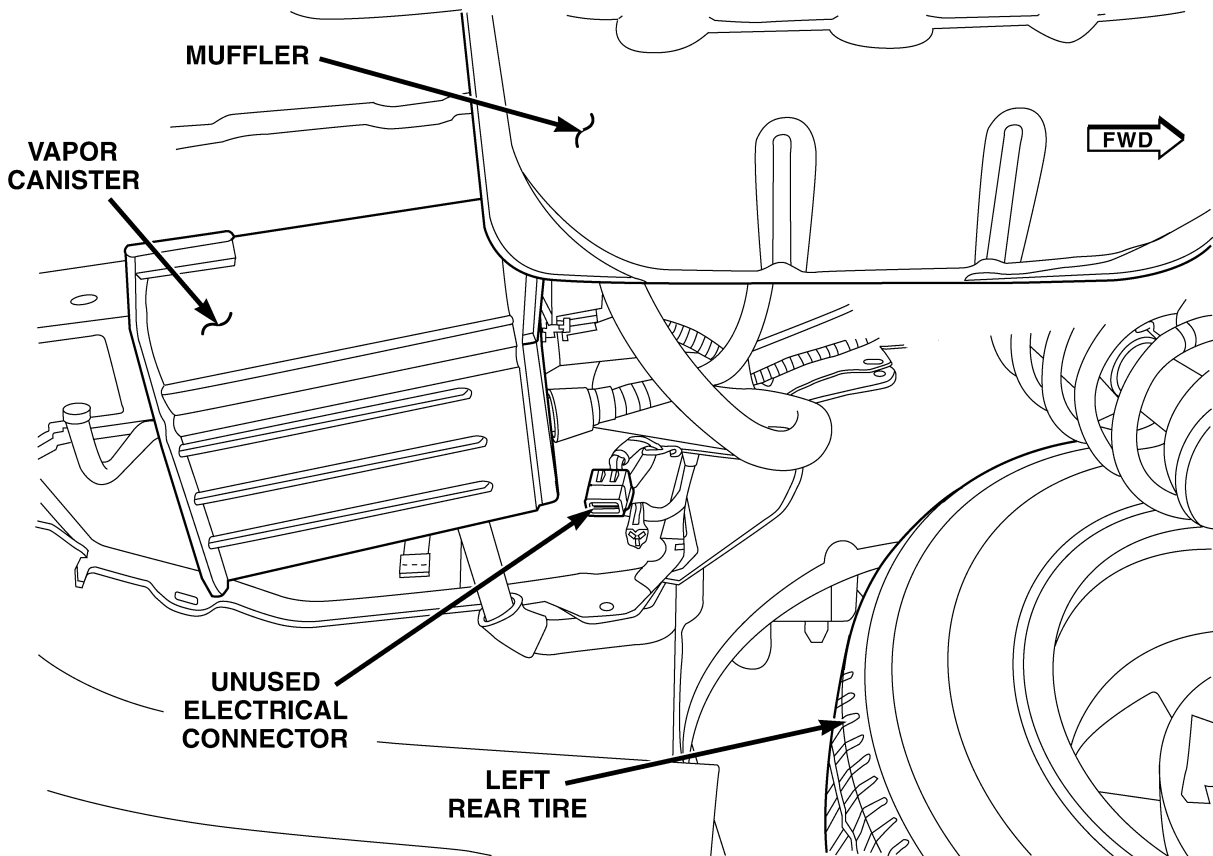
Figure 4 – Left Side Shown

12. Install the wheel and tire assembly. Tighten the lug nuts to 100 ft. lbs. (135 N·m).
13. Lift the vehicle all the way up on the hoist.
14. Inspect the left and right rear wheel well areas to determine if there is an unused **left and right** side rear tire pressure monitor electrical connector (Figure 4).
 - Vehicles **with** unused electrical connectors, continue with Step 15.
 - Vehicles **without** unused electrical connectors, continue with Step 22.

15. Cut off plastic tie strap that holds the unused left and right rear tire pressure monitor electrical connector to the body wiring harness.
16. Pull the body wiring harness from the body studs.

17. Using diagonal pliers, cut off and discard the right and left side rear unused tire pressure monitor electrical connectors.
18. Remove approximately 2 inches (50 mm) of protective tape from the wires cut in Step 17.
