Recall Circular

Code: **26E5/R5**

Subject: **1999-2005 Passat & Passat Wagon (5th Generation)**

Install Underbody Heat Shield(s); Inspect/Replace

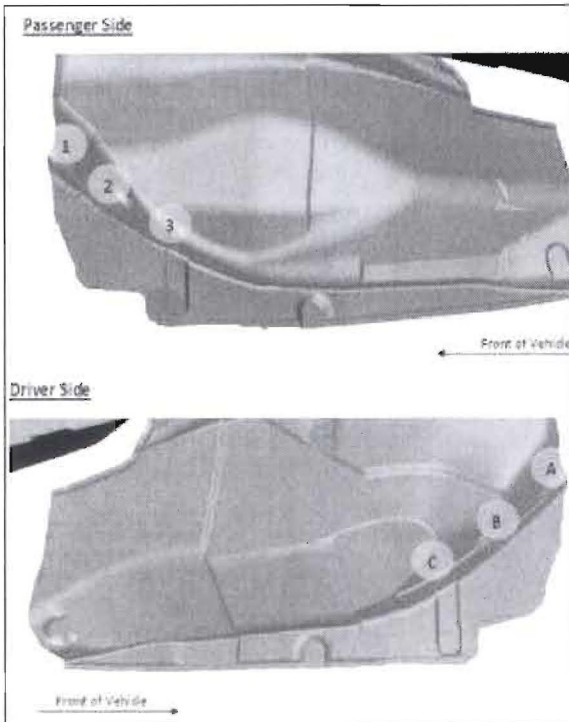
- ⇐ After the sub-frame and exhaust have been put back in place, ensure there is at least 20mm of clearance between new heat shield and exhaust pipe in locations 1,2,3 and A,B,C

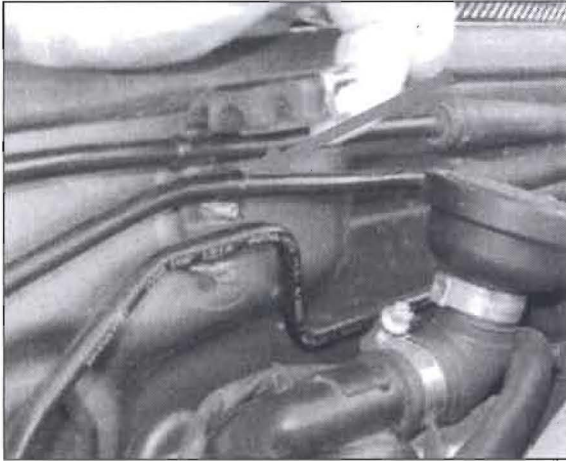
- ⇐ Check center fuel line -arrow- for signs of cracking or fuel leaks
 - If fuel line shows visible leaks or cracks, **proceed to Section D**
 - If no cracking or fuel leaks are found, close brackets and continue

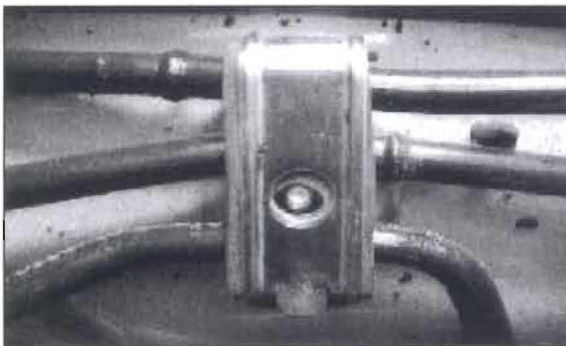
- ⇐ Inspect center fuel line to ensure flare joint is positioned to the right and outside of bracket
 - If flare joint is visible outside of bracket approximately 1mm to the right, **work is complete**
 - If flare joint is not visible outside of bracket approximately 1mm to the right, **proceed to Section C**

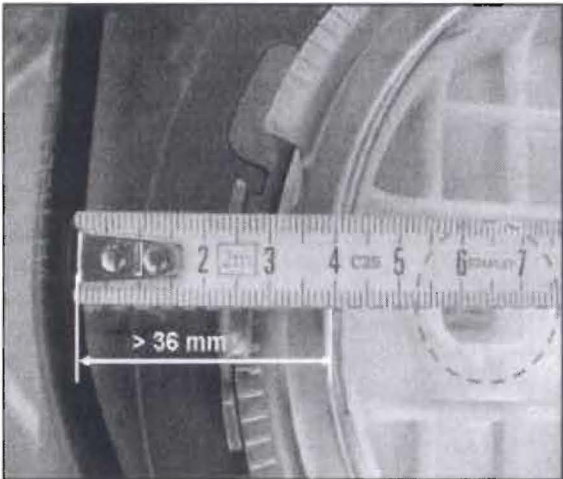
- ⇐ Using measuring tape centered over electrical connector -dotted circle-, measure distance between vent line and fuel sender retainer ring -arrow-, it should be at least 36mm

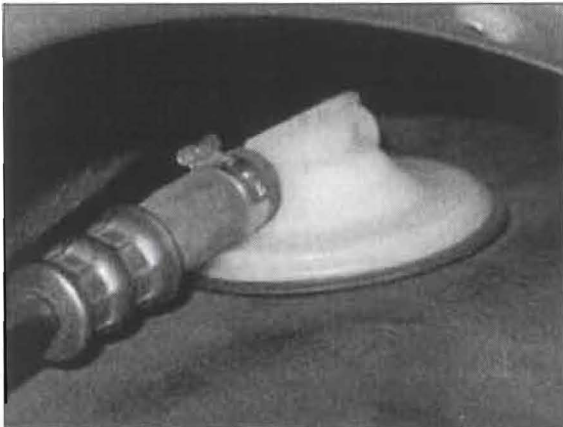
- Visually check fuel tank ventilation valve and surrounding area for fuel leak
 - If fuel leak is found go to **Section G**
 - If no fuel leak is found, continue with procedure

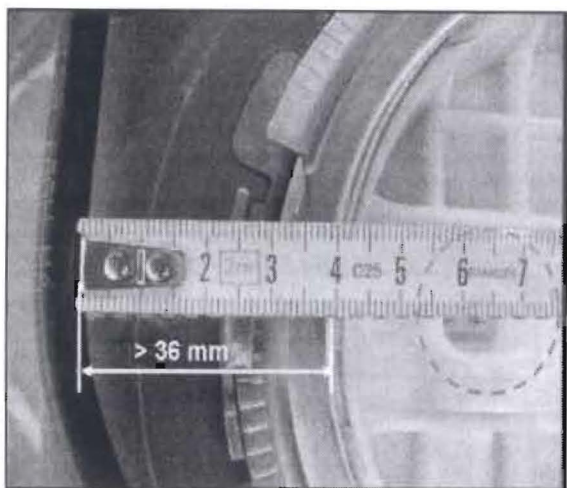
⇐ Using measuring tape centered over electrical connector -dotted circle-, measure distance between vent line and fuel sender retainer ring -arrow-, it should be at least 36mm
