Recall Circular

Code: **26E5/R5**

Subject: 1999-2005 Passat & Passat Wagon (5th Generation)

Install Underbody Heat Shield(s); Inspect/Replace

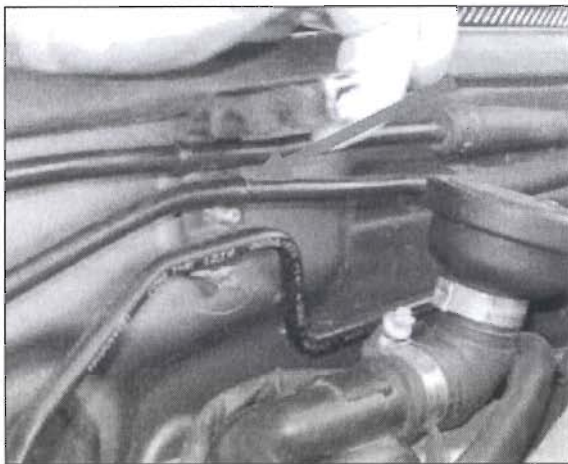
- ⇐ Check center fuel line -arrow- for signs of cracking or fuel leaks
 - If fuel line shows visible leaks or cracks, **proceed to Section D**
 - If no cracking or fuel leaks are found, close brackets and continue

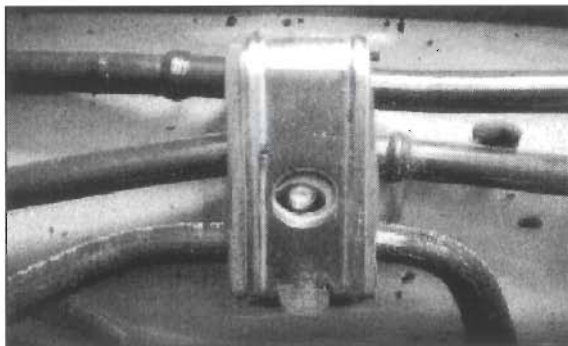
- ⇐ Inspect center fuel line to ensure flare joint is positioned to the right and outside of bracket
 - If flare joint is visible outside of bracket approximately 1mm to the right, **work is complete**
 - If flare joint is not visible outside of bracket approximately 1mm to the right, **proceed to Section C**

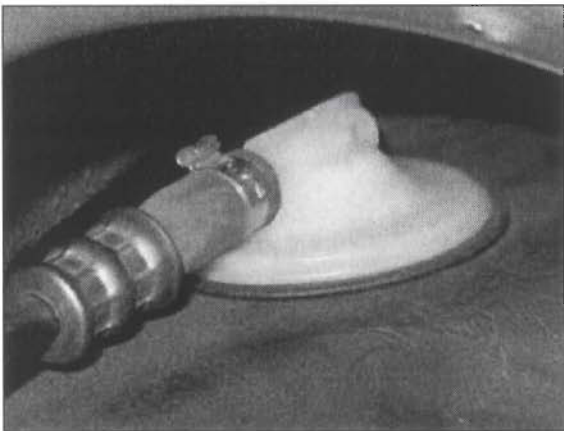
- Visually check fuel tank ventilation valve and surrounding area for fuel leak
 - If fuel leak is found go to **Section G**
 - If no fuel leak is found, continue with procedure
