Subject: Recall Campaign 26E5/R5 (08V-156)

Subject: Safety Recall 26E5/R5
Software CD for MY 2001 AUG Engine Vehicles and
SVM Patch

Code: 26E5/R5
Subject: 1999-2005 Passat & Passat Wagon (5th Generation)
Equipped With Gas Engine
Install Underbody Heat Shield(s); Inspect/Replace
Fuel Line, Fuel Tank; Update Software, if Necessary
REVISED

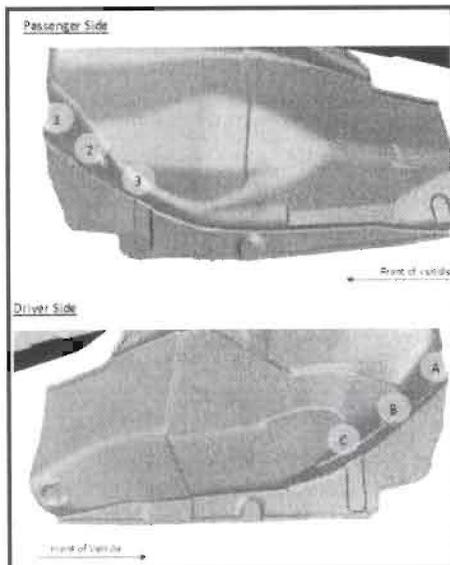
⇐ After the sub-frame and exhaust have been put back in place, ensure there is at least 20mm of clearance between new heat shield and exhaust pipe in locations 1,2,3 and A,B,C

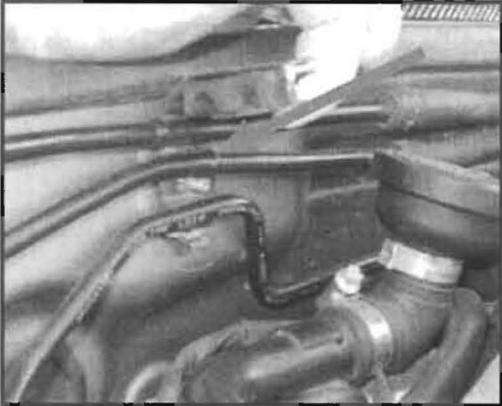
- ⇐ Check center fuel line -arrow- for signs of cracking or fuel leaks
 - If fuel line shows visible leaks or cracks, **proceed to Section D**
 - If no cracking or fuel leaks are found, close brackets and continue

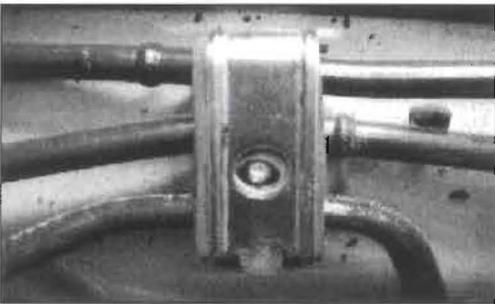
- ⇐ Inspect center fuel line to ensure flare joint is positioned to the right and outside of bracket
 - If flare joint is visible outside of bracket approximately 1mm to the right, **reinstall small plastic fuel line retainer and plastic cover for air filter housing, work is complete**
 - If flare joint is not visible outside of bracket approximately 1mm to the right, **proceed to Section C**

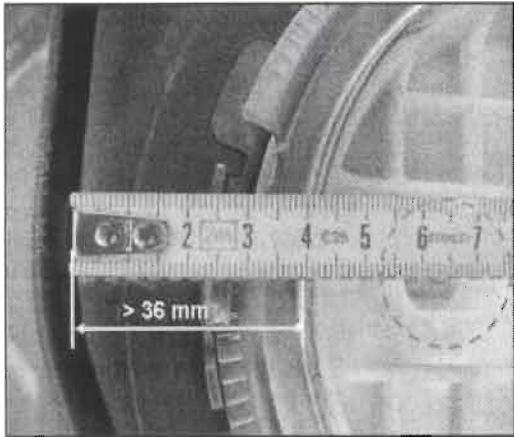
- ⇐ Using measuring tape centered over electrical connector -dotted circle-, measure distance between vent line and fuel sender retainer ring - arrow-, it should be at least 36mm
 - If the measurement is 36mm or greater, reinstall cover for fuel sending unit and rear seat bottom

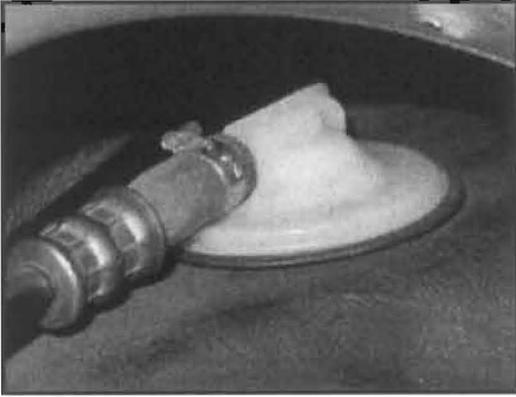
- Visually check fuel tank ventilation valve and surrounding area for fuel leak
 - If fuel leak is found go to **Section G**
 - If no fuel leak is found, continue with procedure

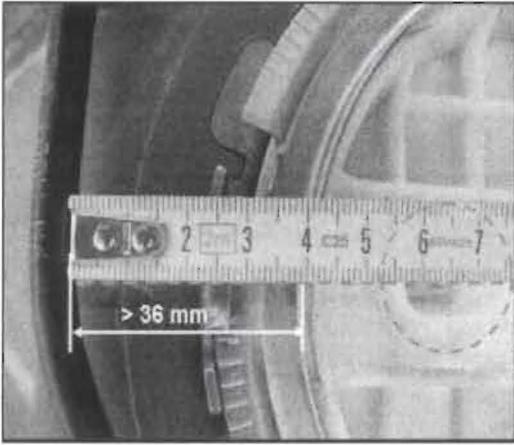
⇐ Using measuring tape centered over electrical connector -dotted circle-, measure distance between vent line and fuel sender retainer ring -arrow-, it should be at least 36mm
