**Re: Defect Information Report – Supplemental Report No. 3  
08V-159, FL-528, Bendix MV-3 Dash Valve**

## Subject: Bendix MV-3 Dash Control Valves

October 2008  
FL528A-E  
NHTSA #08V-159

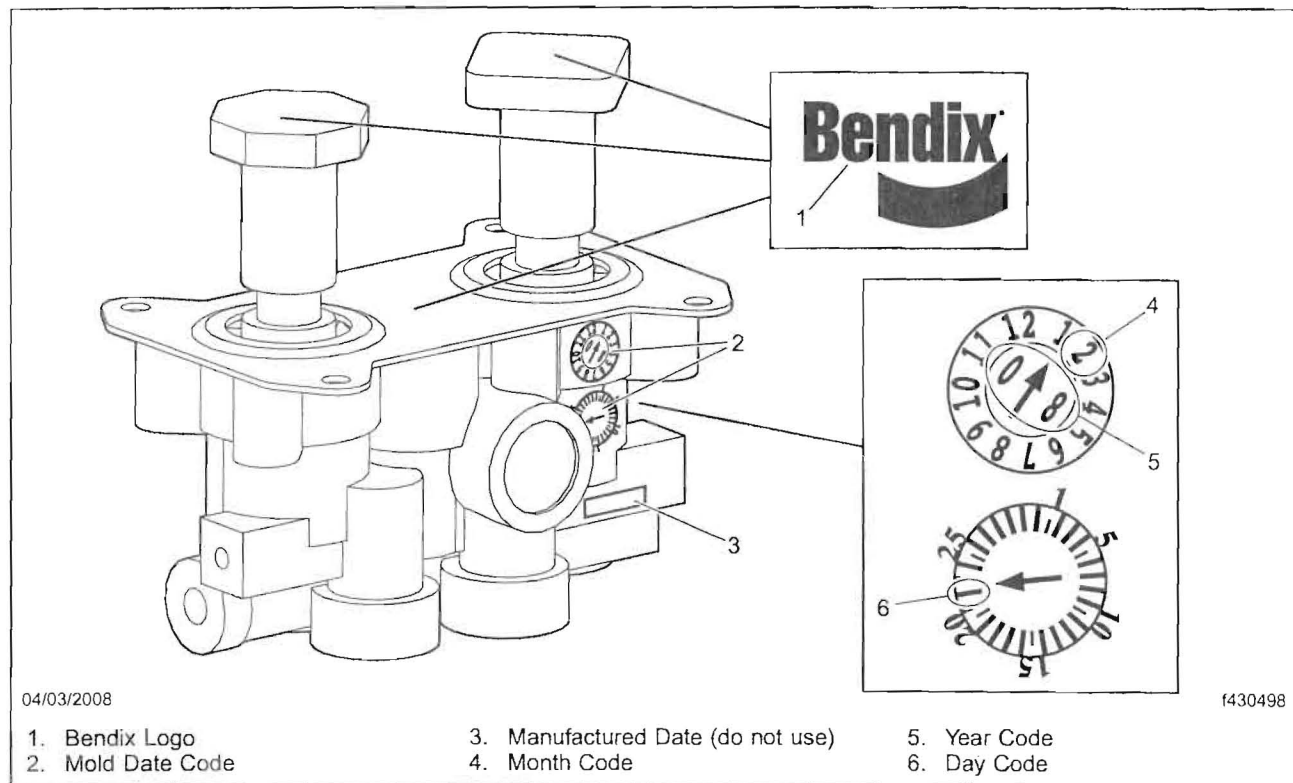
Fig. 3, Bendix MV-3 Valve Identification

7. Determine if the mold date code falls within the recall date code range, from 12/19/2007 through 1/21/2008 inclusive.
8. If the valve mold date code falls within the recall date code range, replace it (very few valves will require replacement). Go to the next step.

If the valve mold date code does **not** fall within the recall date code range, do not replace it. Go to Step 11 (do **not** perform the Leak Test).
9. With the valve and cover plate assembly pulled out slightly from the dash panel, mark the air lines, and remove the air lines from the back of the valve. Pull the valve out of the dash.
10. On the new valve, connect the air lines to the proper ports. The color of the air lines should match the colored collar at the valve fitting.
11. Install the red and yellow knobs on the threaded stems of the spools.

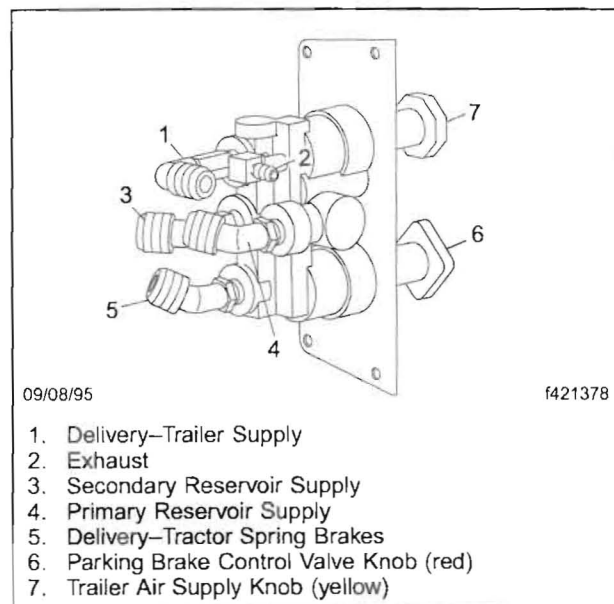
Fig. 13, MV-3 Parking Brake Valve

2. Push in the red knob. The knob must stay in. Leakage at the exhaust port (see Fig. 13) must not exceed a 1-inch (25-mm) bubble in 5 seconds.
3. Slowly reduce pressure in both service reservoirs. The red knob must pop out at 35 to 45 psi (241 to 310 kPa).
