TOYOTA CUSTOMER SERVICES

Volume: XV
Number: TC08-006
Date: 04/09/2008
 Action
 Retain
 Information

SUBJECT: SAFETY RECALL (SPECIAL SERVICE CAMPAIGN) – 80A
(CERTAIN 2003 THROUGH 2004 MODEL YEAR COROLLA AND COROLLA
MATRIX FRONT DOOR GLASS BOLTS)

Special Service Campaign 80A
2003 Through 2004 Model Year Corolla and Corolla Matrix Front Door Glass Bolts
SAFETY RECALL NOTICE

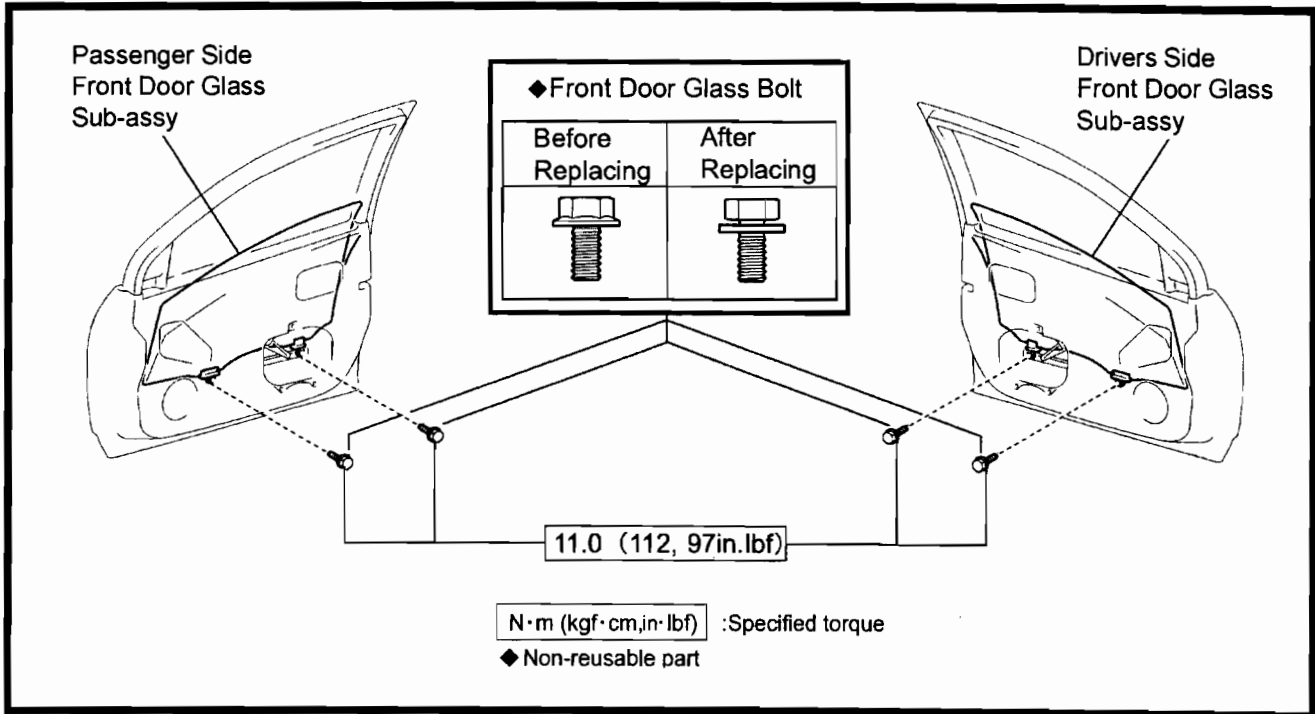
V. BACKGROUND AND COMPONENTS

On certain 2003 through 2004 model year Corolla and Corolla Matrix vehicles equipped with power windows, the driver and front passenger door glass bolts may loosen and come off, causing the door glass to separate from the window regulator. This Safety Recall involves replacement of the 2 driver and 2 front passenger door glass bolts. Total of 4 bolts.
