GM SERVICE AND PARTS OPERATIONS  
DCS2042  
URGENT - DISTRIBUTE IMMEDIATELY

Subject: 07273 - Safety Recall  
Front Door Glass Shatter – Replace Bolts

Models: 2003-2004 Pontiac Vibe Equipped with Power Windows

**SUBJECT:** Front Door Glass Shatter – Replace Bolts

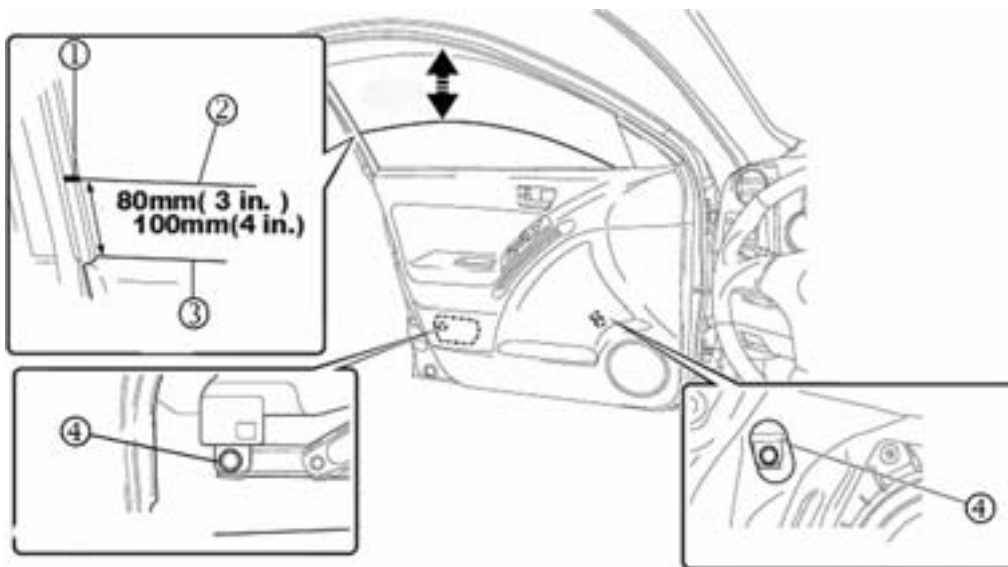
2094268

- (1) Tape Mark Location                      (3) Front Door Trim  
 (2) Front Door Glass                        (4) Service Hole Perspective View

1. Adjust the front door glass to align the position of the front door glass bolt with the service hole.
2. Approximately 100 mm (4 in) from the top of the front door trim board, mark off 80 mm (3 in) with tape.
3. Adjust the front door window glass to align with the tape marking.

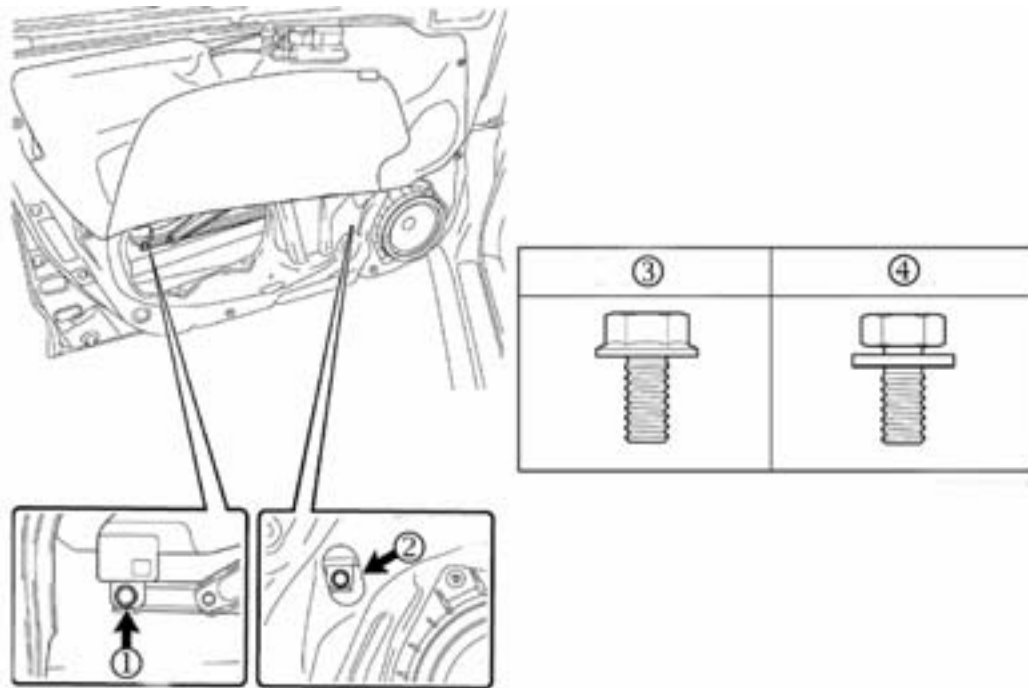
2092916

General Motors has decided that a defect, which relates to motor vehicle safety, exists in **all** 2003-2004 model year Pontiac Vibe vehicles equipped with power windows. On some of these vehicles, bolts in the front door that attach the window to the window regulator may begin to loosen, resulting in a popping or clicking sound when the window is operated. If either bolt continues to loosen and separates from the window regulator, the glass may shatter during window operation, which could cause possible injury.

(1) Bolt 1 Location  
(2) Bolt 2 Location

(3) First Design Bolt  
(4) Second Design Bolt

**Caution:** Remove and install bolts one at a time to prevent the door glass from falling. Do not shake or move the vehicle to prevent the door glass from falling.

- 13. Remove the first design bolt (1), which is securing the front door glass, and install a second design bolt (4). Finger-tighten.
- 14. Remove the first design bolt (2), which is securing the front door glass, and install a second design bolt (4). Finger-tighten.
- 15. Tighten both bolts.

Tighten to 9 N·m (80 lb in).
