**VEHICLE SAFETY DEFECT SERVICE BULLETIN**  
**Recall Campaign 08V179000 US Units**  
**Recall Campaign 08-128 CN Units**  
Monaco File R08001

**Re: Safety Recall – Missing Inverter Fuse**

### **RECALL 08V179000 CANADA # 08-128 Research # R08001 600 Watt Inverter Fuse Installation**

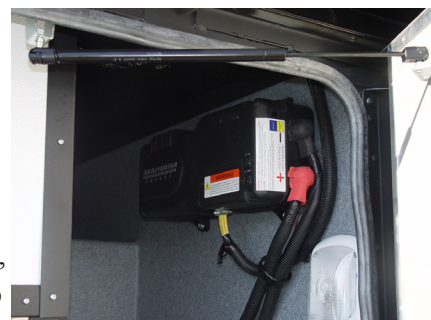
Figure 1

1. Open right rear exterior bay compartment door and verify the unit has optional inverter. (Figure 1)
2. Follow 12 Volt lead through the compartment bulkhead to the next compartment forward. The battery cable should be connected to a fuse with a jumper to the hot side of the battery disconnect. If this is correct, no further action required. Proceed to Warranty Procedure. If there is no in-line fuse, proceed below to Repair Procedure.
