Regarding: 08V-180

Technical BULLETIN

RECALL

2006~2007 CP250 (Morphous); 2005~2007 YP400 (Majesty) FACTORY MODIFICATION CAMPAIGN – Fuel Pump Harness

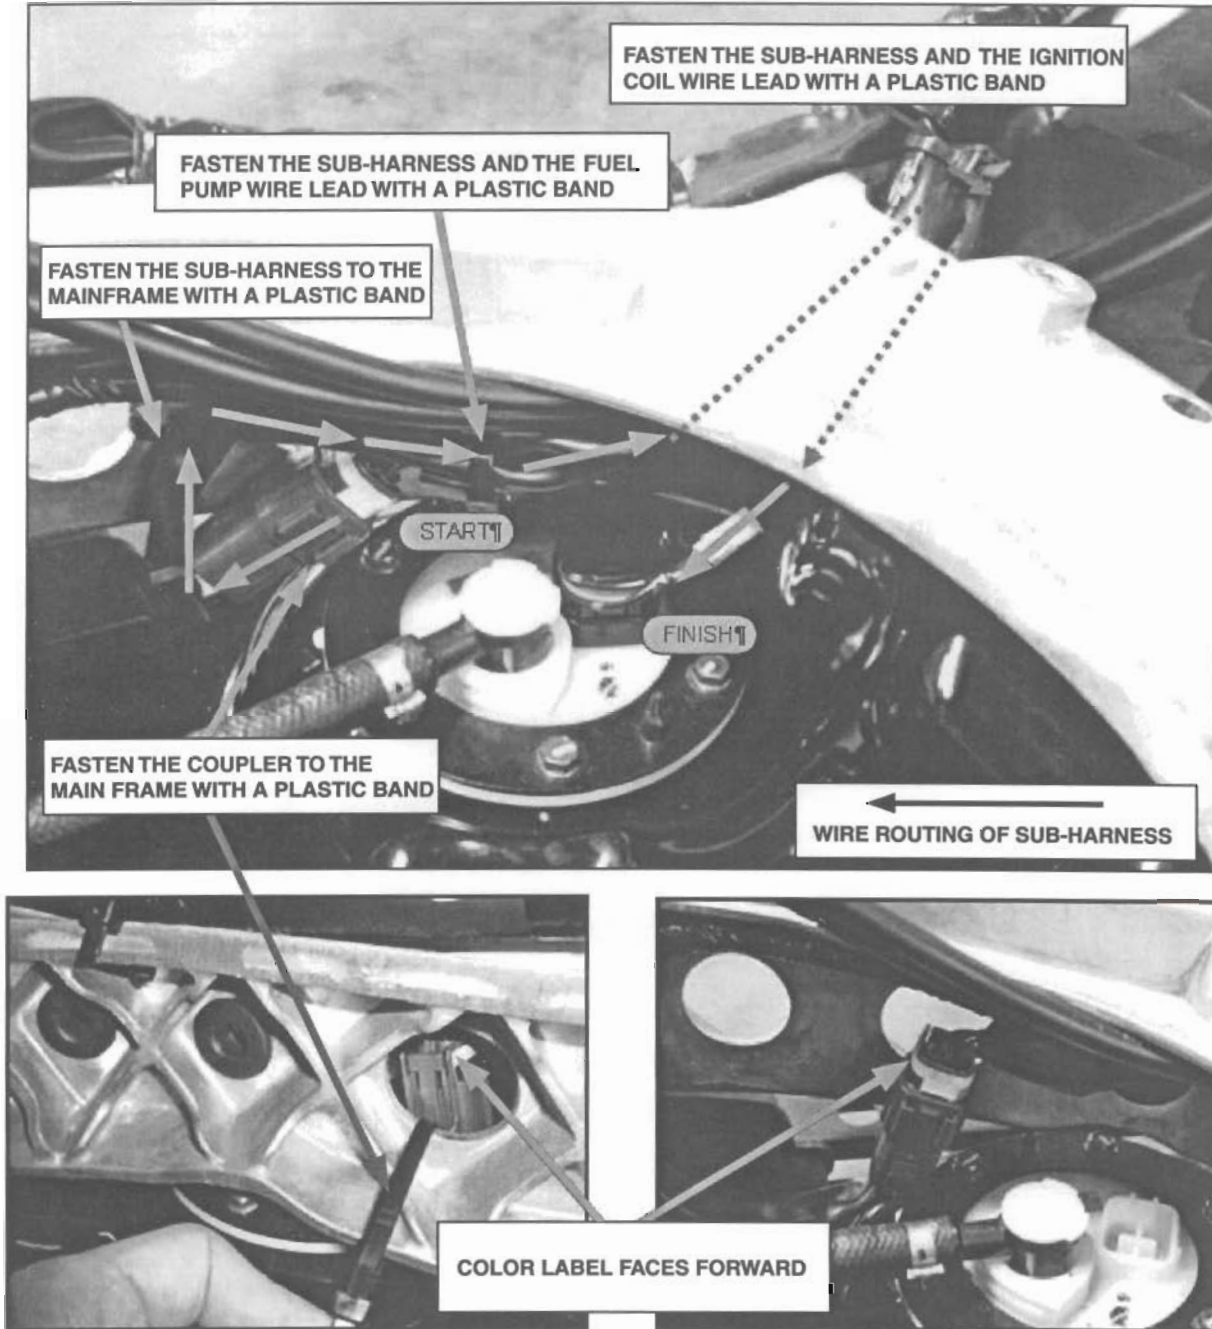
Be sure to secure the fuel pump sub-harness as shown. This positions the wire harness coupler of the main wire harness in a position that will allow any water that enters the wire harness to drain out.

6. Secure the fuel pump sub-harness with the supplied plastic bands (zip ties) as shown.

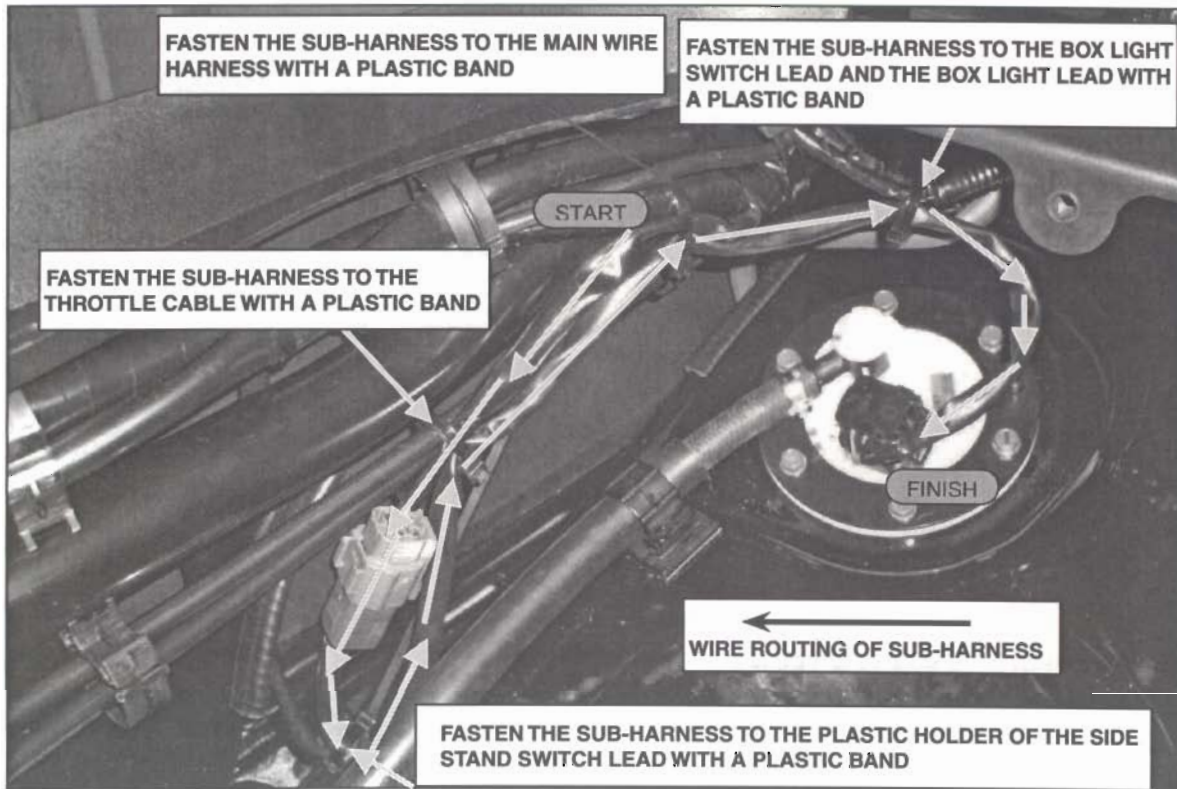
Be sure to secure the fuel pump sub-harness as shown below. This positions the wire harness coupler of the main wire harness in a position that will allow any water that enters the wire harness to drain.

10. Secure the fuel pump sub-harness with the supplied plastic bands (zip ties) as shown.
