Volume: XV
Number: TC08-018
Date: 12/10/08
 Action
 Retain
 Information

SUBJECT: **Non-Compliance Recall (Special Service Campaign) – 80D**
2008 Model Year Highlander and Highlander HV equipped with Third Row Seat

**SPECIAL SERVICE CAMPAIGN 80D (NON-COMPLIANCE RECALL)
THIRD ROW SEAT BUCKLE BRACKET REPLACEMENT**

2008 MODEL YEAR HIGHLANDER & HIGHLANDER HV

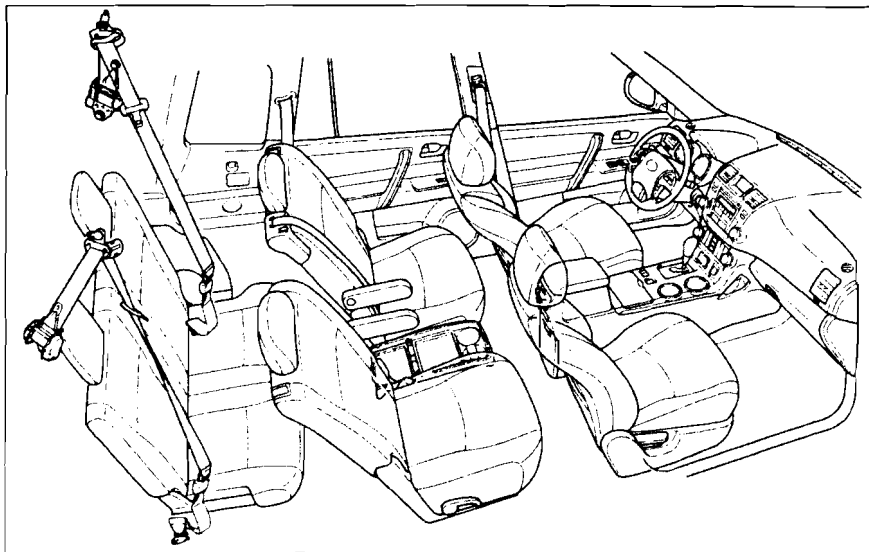
In April, 2008, Toyota filed a Non-Compliance Information Report (NCIR) with the National Highway Traffic Safety Administration (NHTSA) regarding the third row seat belt assemblies installed in these vehicles. The seat belts in the third row seat will not firmly secure certain child restraint systems (CRS') that have a short belt routing path. The seat belt assemblies at those two seating positions are equipped with an Automatic Locking Retractor (ALR) that does not lock when such CRS' are installed, and thus they do not meet specific portions of FMVSS 208. In the event a short belt path CRS is installed in the third row seat using the vehicle's seat belts, it will not be tightly secured, and may shift during normal driving maneuvers. The Emergency Locking Retractor (ELR) function in the third row seats will perform as designed and lock the belt during a sudden stop or on impact. Until this Safety Recall is completed, it is advised that customers restrain children utilizing a properly installed CRS in the second row seat or utilize a CRS which does not have a short belt path in the third row seats.

Please note that the Third Row Seat Belt Buckle Brackets will be replaced on customer vehicles.

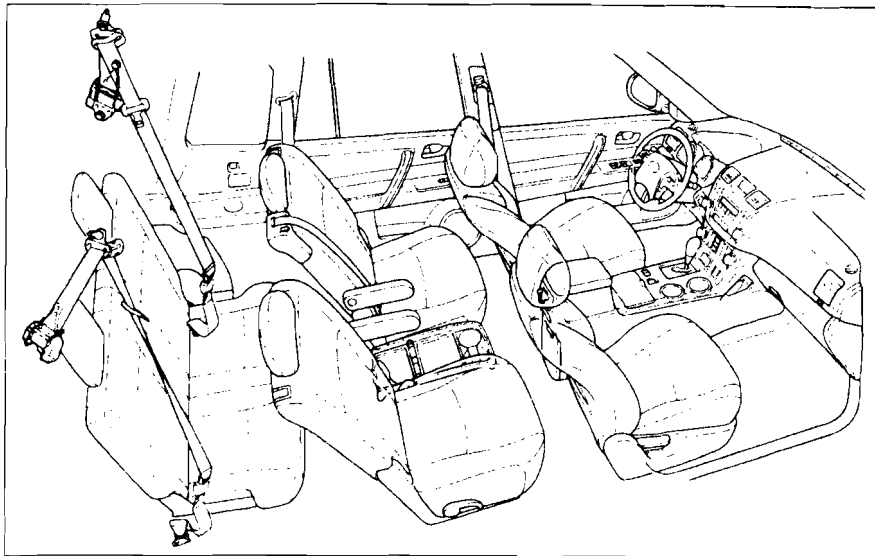
In April, 2008, Toyota filed a Non-Compliance Information Report (NCIR) with the National Highway Traffic Safety Administration (NHTSA) regarding the third row seat belt assemblies installed in these vehicles. The seat belts in the third row seat will not firmly secure certain child restraint systems (CRS') that have a short belt routing path. The seat belt assemblies at those two seating positions are equipped with an Automatic Locking Retractor (ALR) that does not lock when such CRS' are installed, and thus they do not meet specific portions of FMVSS 208. In the event a short belt path CRS is installed in the third row seat using the vehicle's seat belts, it will not be tightly secured, and may shift during normal driving maneuvers. The Emergency Locking Retractor (ELR) function in the third row seats will perform as designed and lock the belt during a sudden stop or on impact. Until this Safety Recall is completed, it is advised that customers restrain children utilizing a properly installed CRS in the second row seat or utilize a CRS which does not have a short belt path in the third row seats.

Please note that the Third Row Seat Belt Buckle Brackets will be replaced on customer vehicles.

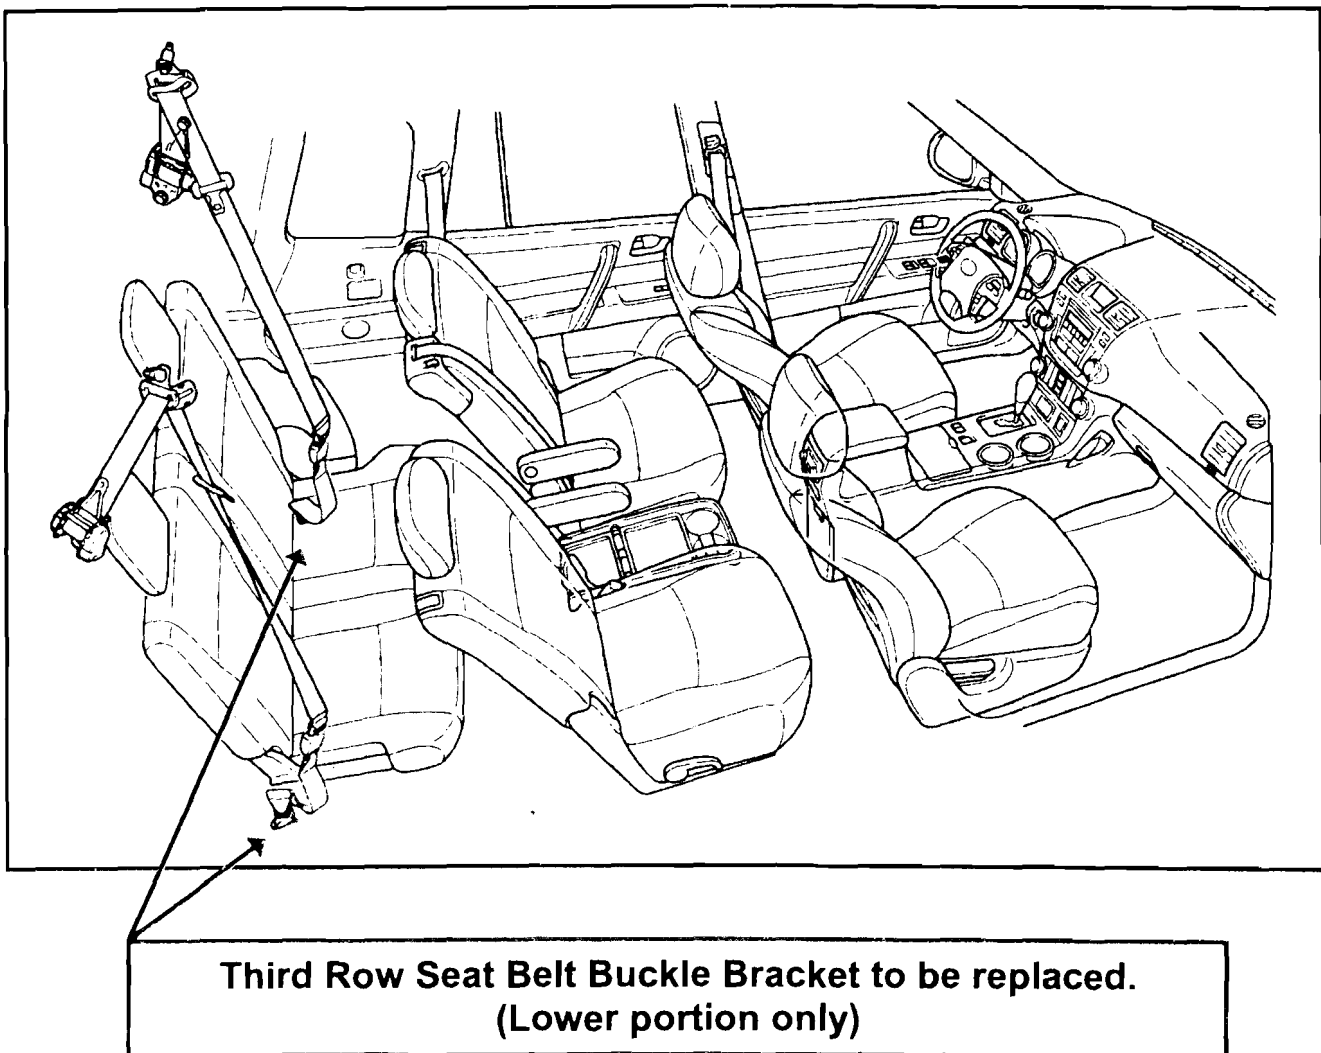
On certain 2008 model year Highlander and Highlander HVs equipped with a third row seat, the seat belts in the third row seat will not firmly secure certain child restraint systems (CRS') that have a short belt routing path. The seat belt assemblies at those two seating positions are equipped with an Automatic Locking Retractor (ALR) that does not lock when such CRS' are installed, and thus they do not meet specific portions of FMVSS 208. In the event a short belt path CRS is installed in the third row seat using the vehicle's seat belts, it will not be tightly secured, and may shift during normal driving maneuvers. The Emergency Locking Retractor (ELR) function in the third row seats will perform as designed and lock the belt during a sudden stop or on impact.
