Recall Information Bulletin

No: C1003610 **Issued:** 8/1/2008

Re: AISIN A/T Shift Linkage

Safety Recall C1003610 - AISIN Automatic Transmission Shift Linkage

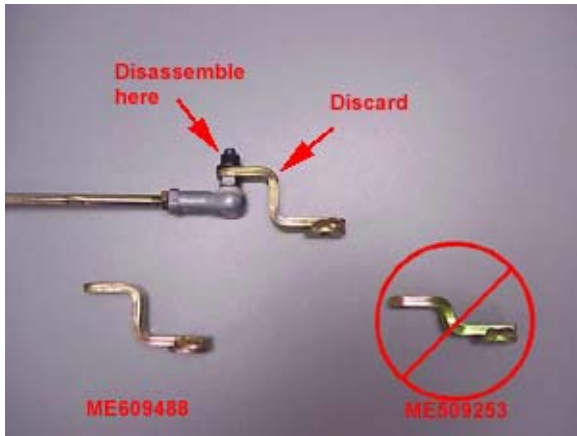
PHOTO 1

Certain affected 1999-2002 FE639, FE640, FE649 and FG639 trucks manufactured prior to October 1, 2001 already have the correct Shift Control Lever **ME609488** installed. Shift Control Lever **ME609488** is physically identical to the Shift Control Lever affixed to the new **TM070801** A/T Shift Linkage Assembly (See PHOTO 1).

Remove the Shift Control Lever from the new A/T Control Assembly **TM070801** and discard it (see PHOTO 1). Install the new A/T Shift Linkage Assembly, as instructed in Recall Information Bulletin C1003610. Affix the new A/T Shift Linkage Assembly to the existing Shift Control Lever (see PHOTO 4) and torque the attaching nut to 7.2 to 11 ft.lbs. (9.8-15 Nm).

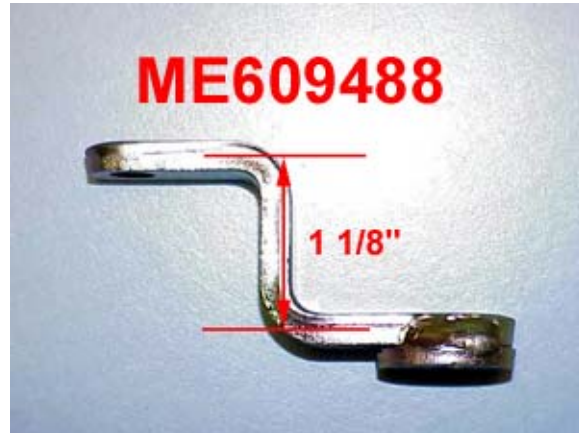
PHOTO 2

The Shift Control Levers on affected vehicles can be differentiated by their offset. The offset for the *reusable* lever **ME609488** is 1 1/8" (see PHOTO 2). The offset for lever **ME509253**, that *must be replaced*, is 5/8" (see PHOTO 3).
