Service and Parts Operations

RPB#02-107

SUBJECT: 01073A - STOP LAMPS/HAZARD LAMPS INOPERATIVE

PRODUCT SAFETY BULLETIN #01073A - JULY 29, 2002

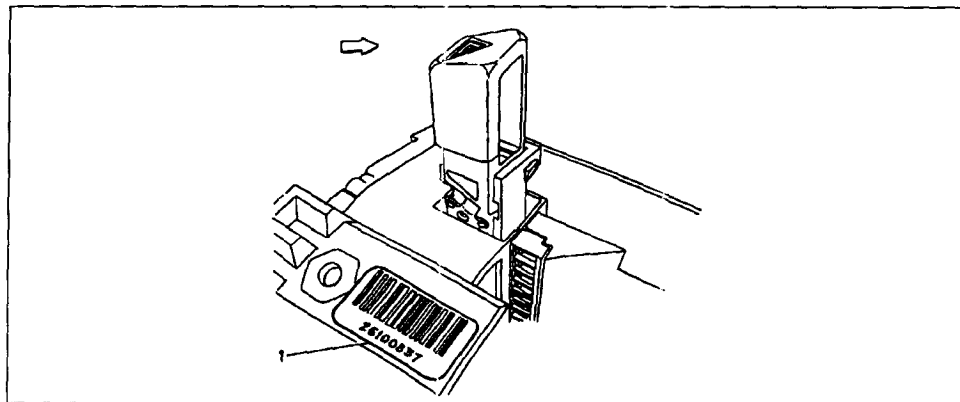
849940

12. Inspect the part number (1) on the multifunction switch at the location shown in the illustration.
- If the part number is 26100837 or 26100838, no repair is required. Proceed to the section titled "Reassemble Vehicle."
 - If there is NO part number or barcode on the switch, or if the part number is 26083635 or 26083636, proceed to the next step and replace the hazard warning flasher switch using part number 15174447.
 - If the part number or barcode on the switch is 26090641, 26090642, 26096832, or 26096833, proceed to the next step and replace the hazard warning flasher switch using part number 15177379.

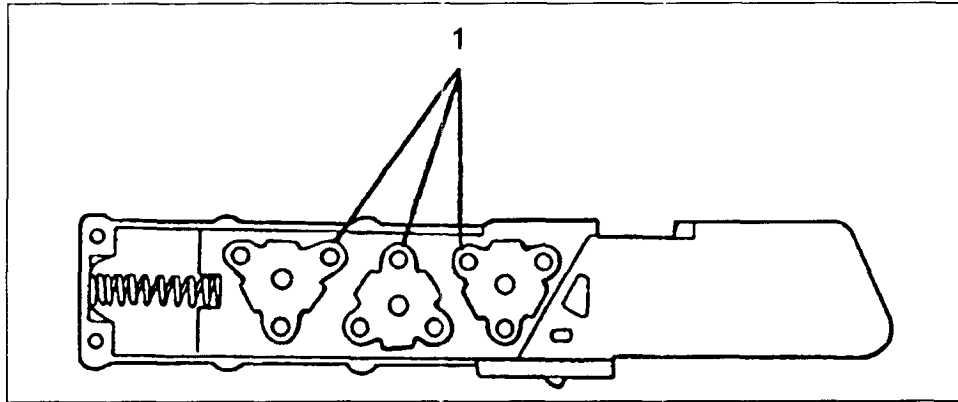
850585

Do not touch the three triangle-shaped electrical contacts (1) on the side of the switch when removing the protective packaging, handling or applying grease to the new hazard warning flasher switch in the next steps.

17. Open the container of special grease included in the kit and apply it to the surfaces of the three triangle-shaped electrical contacts (1) on the side of the new hazard warning flasher switch. When properly applied, the surfaces of the three triangle-shaped electrical contacts must be completely covered and there should be no grease left in the container. Do NOT put any grease in the opening that contains the small metal return spring.

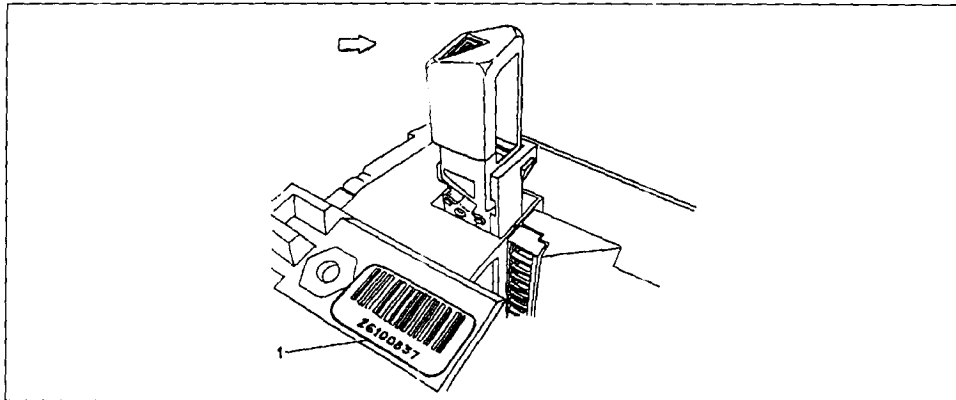
849940

12. Inspect the part number (1) on the multifunction switch at the location shown in the illustration.

- If the part number is 26100837 or 26100838, no repair is required. Proceed to the section titled "Reassemble Vehicle."
- If there is NO part number or barcode on the switch, or if the part number is 26083635 or 26083636, proceed to the next step and replace the hazard warning flasher switch.
- If the part number or barcode on the switch is 26090641, 26090642, 26096832, or 26096833, replacement of the multifunction switch is required. Proceed to the section titled "Replacing the Multifunction Switch."
