GM SERVICE AND PARTS OPERATIONS
DCS2058
URGENT DISTRIBUTE IMMEDIATELY

Subject: 01073B Product Safety Recall
Stop Lamps/Hazard Lamps Inoperative

Models: 2000-2001 Chevrolet Blazer, TrailBlazer (Classic)
2002 Chevrolet Blazer
2000-2001 GMC Jimmy, Envoy (Classic)
2002 GMC Jimmy, Envoy (Classic)
2000-2001 Oldsmobile Bravada (Classic)

SUBJECT: Stop Lamps/Hazard Lamps Inoperative

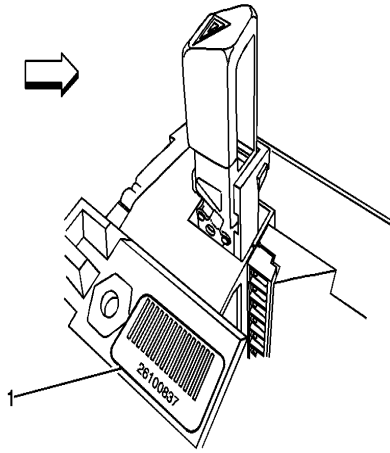
849940

12. Inspect the part number (1) on the multifunction switch at the location shown in the illustration.

- If the part number is 26100837 or 26100838, no repair is required. Proceed to the section titled, "Reassemble Vehicle".
- If there is NO part number or barcode on the switch, or if the part number is 26083635 or 26083636, proceed to the next step and replace the hazard warning flasher switch using part number 15174447.
- If the part number or barcode on the switch is 26090641, 26090642, 26096832, or 26096833, proceed to the next step and replace the hazard warning flasher switch using part number 15177379.

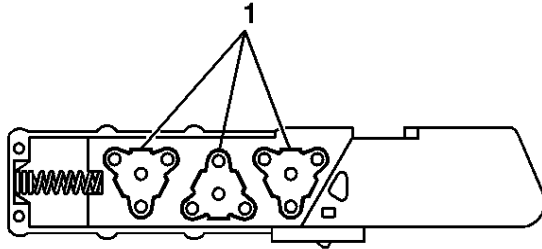
850585

Notice: Do not touch the three triangle-shaped electrical contacts (1) on the side of the switch when removing the protective packaging, handling, or applying grease to the new hazard warning flasher switch in the next steps.

16. Remove the rubber band and protective plastic wrapping from the new hazard warning flasher switch.

17. Open the container of special grease included in the kit and apply it to the surfaces of the three triangle-shaped electrical contacts (1) on the side of the new hazard warning flasher switch. When properly applied, the surfaces of the three triangle-shaped electrical contacts must be completely covered and there should be no grease left in the container. DO NOT put any grease in the opening that contains the small metal return spring.

18. Insert the hazard warning flasher switch into the opening of the multifunction switch and press down until it locks into place.
19. Remove any excess grease that may appear around the base of the hazard warning flasher switch. Proceed to the next section, "Reassemble Vehicle".
