## Service Information Bulletin

### **\*\*Notice of Recall 08V-239\*\***

**Subject:** Grubscrew not installed at the factory

**Models:** K 1200 S (K40), K1200 R (K43), K 1200 GT (K44)

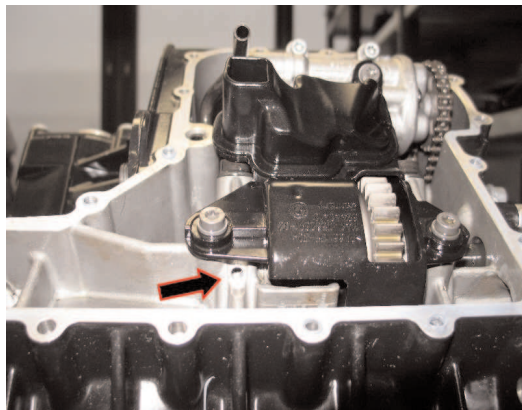
**Details:** Within the framework of continued monitoring of production in Berlin, it has been ascertained that motorcycles manufactured in the course of a limited period left the assembly line without a grubscrew installed in the oil duct of the bearing of the mass balancer.

Clean the tapped hole (arrow) for the grubscrew.

Remove the oil pan (see RSD DVD).
