**Subject: Recall Campaign 08V-178 (Volkswagen Code 69H1/R6)**

Subject: Safety Recall 69H1/R6

Inspect/Replace Air Bag Frontal Crash Sensor(s) on Vehicles with Advanced (Dual-Stage) Front Air Bag System

**Subject: 2003-2005 Model Year New Beetle Convertible and  
2004-2005 Model Year New Beetle  
Inspect/Replace Air Bag Frontal Crash Sensor(s) on Vehicles with  
Advanced (Dual-Stage) Front Air Bag System**

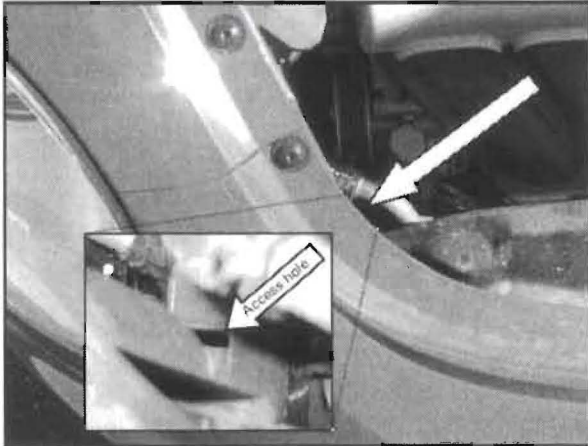
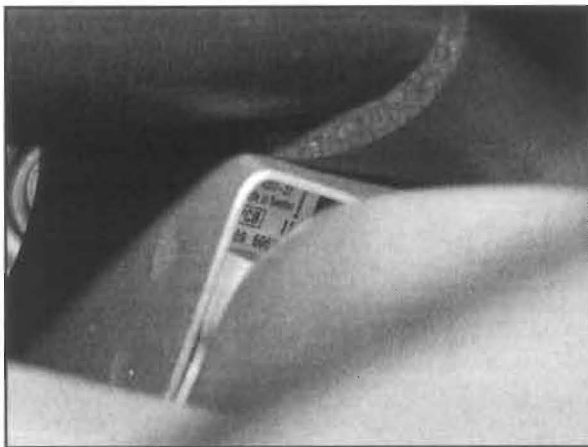
- Open hood
- ⇐ Find passenger side access hole -arrow- for inspection
- Using a flashlight, look through access hole to view front airbag crash sensor part number
- Record part number

Note: Part number may not be completely visible

- Record part number
  - If both part numbers are 6Q0 909 606H,  
**Work is Complete**
  - If one or both part numbers are  
1F0 909 606, **continue to Section C**

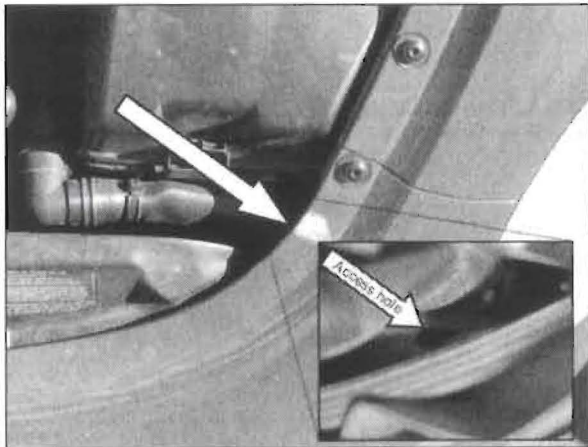
- ⇐ Find driver side access hole -arrow- for inspection
- Using a flashlight, look through access hole to view front airbag crash sensor part number

Tip: Hood release cable may need to be pushed out of the way
