TOYOTA CUSTOMER SERVICES

Volume: X
 Number: TC08-012
 Date: 07/24/2008
 Action
 Retain
 Information

SUBJECT: **Special Service Campaign (Recall) 80C – Phase 1**
 Certain 2004 - 2006 Model Year Sienna Vehicles Equipped w/Power Back Door (Power Rear Liftgate)

SPECIAL SERVICE CAMPAIGN (SAFETY RECALL) 80C

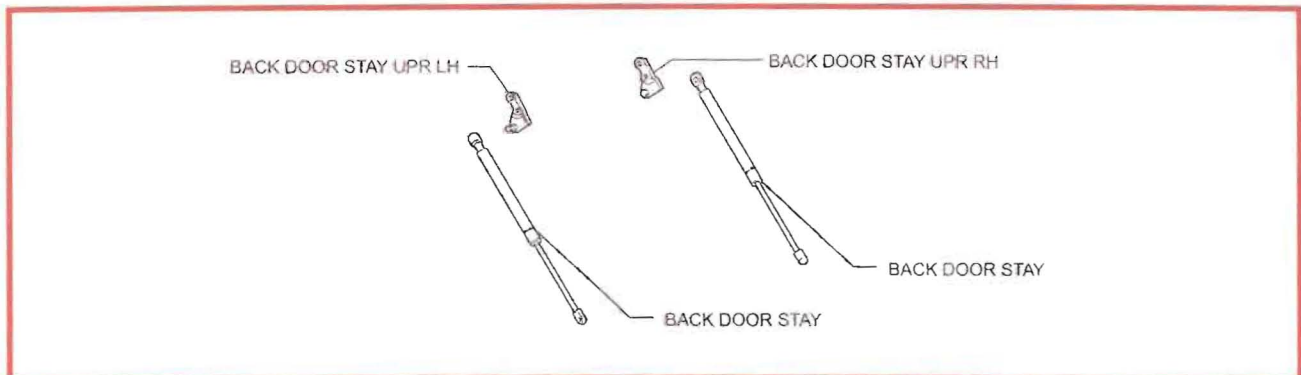
REAR LIFTGATE BRACKETS AND REAR LIFTGATE STRUTS

Toyota has determined that the gas struts used to help lift and support the Power Rear Liftgate in some Sienna vehicles are wearing out sooner than expected. As the gas struts deteriorate, the performance of the Power Rear Liftgate will begin to degrade, and the Power Rear Liftgate will operate more slowly than when the gas struts were new. If this condition is not repaired, the gas struts may not be able to support the weight of the liftgate when it is open. Eventually, the gas struts could deteriorate to the point that the liftgate will fall about ten inches after it reaches the fully open position, at which point the power motor will engage and power the liftgate to the fully closed position. This condition may cause injury to a person who is struck by the liftgate when it falls or when it is closing. Therefore, Toyota will conduct an SSC for the Power Rear Liftgate Struts.

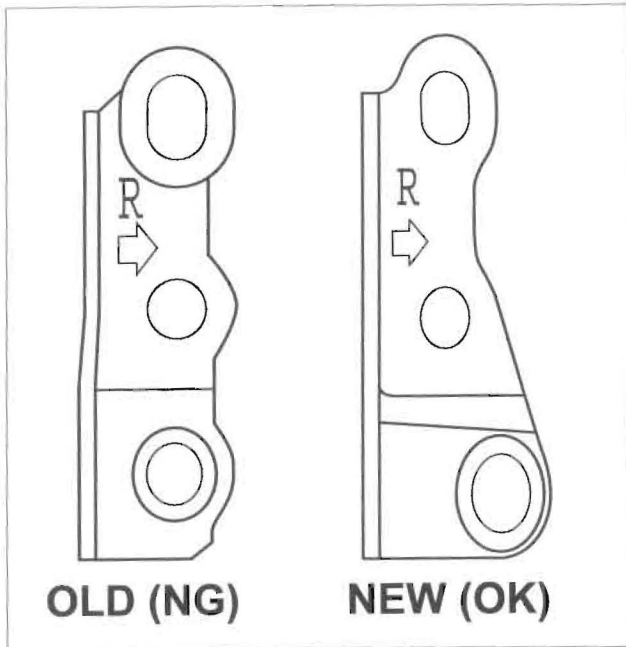
1. VERIFY THE SHAPE OF THE REAR LIFTGATE MOUNTING BRACKETS

- Inspect the shape of both the Rear Liftgate Mounting Brackets (Vehicle side).
- If the new bracket type (wider shape) is found on both sides proceed to step 2.
- If the old bracket type (narrower shape) is found on either side, replace both struts and brackets using kit number 04008-011AE as outlined in TIS/Repair Manual.

NOTE: Failure to replace the old style brackets will cause premature wear to the new liftgate struts.

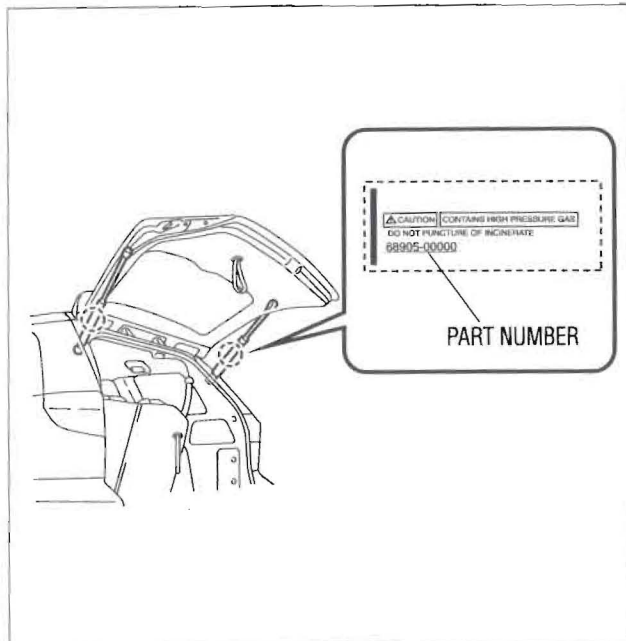
2. VERIFY THE PART NUMBER OF THE REAR LIFTGATE STRUT

- Inspect the rear liftgate strut part number on both left and right hand sides.
- If the current part number is found on both struts and both brackets are verified as being new, no further action is required, vehicle is OK.
- If old part number (as seen in the chart below) is found on either strut, replace both struts and brackets using kit number 04008-011AE as outlined in TIS/Repair Manual.

NOTE: If the part number cannot be verified due to damage, replace the back door stay.

PART NAME	OLD PART NUMBER (NG)	CURRENT PART NUMBER (OK)
BACK DOOR STAY (REAR LIFTGATE STRUT)	68905-08020	68905-AE012 or 68905-AE013 (Included in Kit P/N 04008-011AE)
	68905-AE010	
	68905-AE011
