# BMW Motorrad USA

## Service Information Bulletin

### **\*\*Notice of Recall 08V-245\*\***

**Subject:** Front brake-disc threaded fasteners

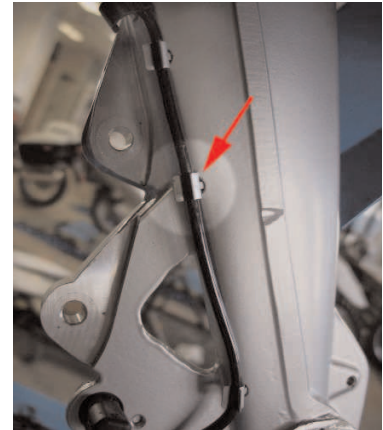
Initially motorcycles were manufactured with raised-head screws, without any change to the routing of the sensor cable. In this case there is a possibility of the cable being damaged when the motorcycle is ridden. The cable routing has to be changed (Measure 1 "Sensor cable routing").

Remove the front wheel (see RSD for details).  
Disengage the sensor cable from the three clips.  
Remove the middle clip (arrow).

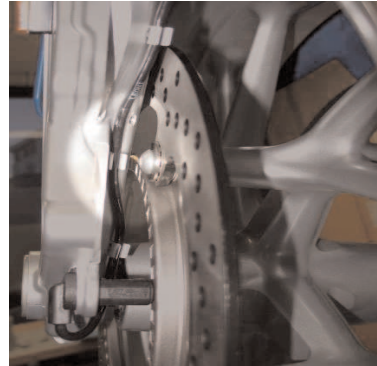
The flat-head screws (M8 x 20mm) used are not long enough to ensure that the fasteners remain secure for the duration of the service life. The threads in the tapped bores of the wheel rim could become stripped. The flat-head screws must be removed and replaced with longer raised-head screws (M8 x 25mm). The routing of the sensor cable also has to be altered (Measure 2 "Threaded fasteners and sensor-cable routing").

In addition, and this applies to all motorcycles (including those without ABS), remove the flat-head screws (M8 X 20mm) on both discs and replace them with raised-head screws (M8 X 25mm).

Remove the screws and install the replacements one at a time (do not remove the entire brake disc). After removing each flat-head screw, clean the threads in the tapped bore and install the new raised-head screw.

Tighten the raised-head screw to 24 Nm.
