## Federal Recall Information

08KW7

Kenworth Truck Company

T300/T270/T370 Fuel Line Interference

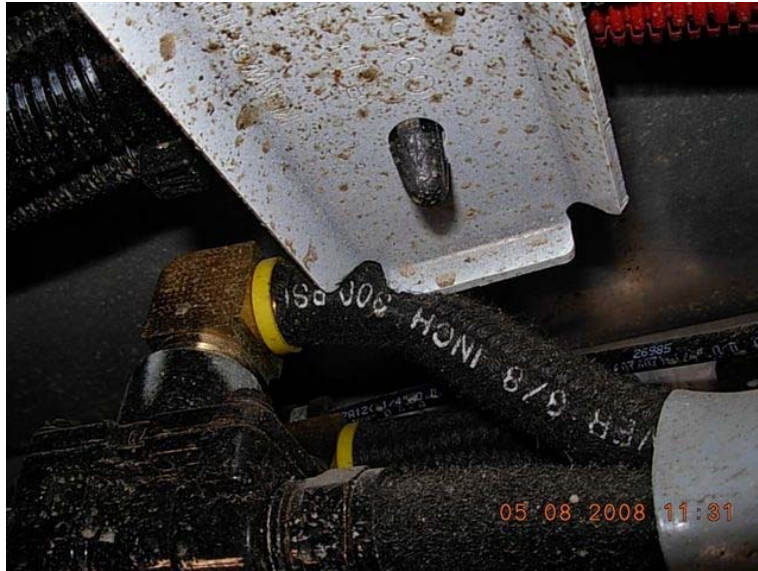
Fig. 1

Interference may exist on certain Kenworth T300, T270 and T370 vehicles with dual under-cab fuel tanks and an In-Cab Battery Box (ICBB). The ICBB harness support bracket, mounted on the under side of the cab, may come into contact with the fuel line at the top of the fuel splitter valve (ref. Figure 1). The edge of the harness support bracket may compromise the fuel line causing either a loss in fuel flow or a fuel leak, increasing the risk of a loss of vehicle performance and/or fire.

- 1) **replace** the existing K11-1044 fuel splitter valve bracket with a new K11-1058 bracket, and
- 2) **relocate** the R11-1494 harness support bracket 50mm toward the driver's side along the R11-1492 cable routing bracket.
