Reference: NHTSA Identification Number 08V-247

## **Safety Recall H21 Engine Wiring Harness Routing**

2009 (JC) Dodge Journey

The engine wiring harness on about 5,900 of the above vehicles may chafe on the left transaxle mount. This could cause a short circuit and result in an engine compartment fire.

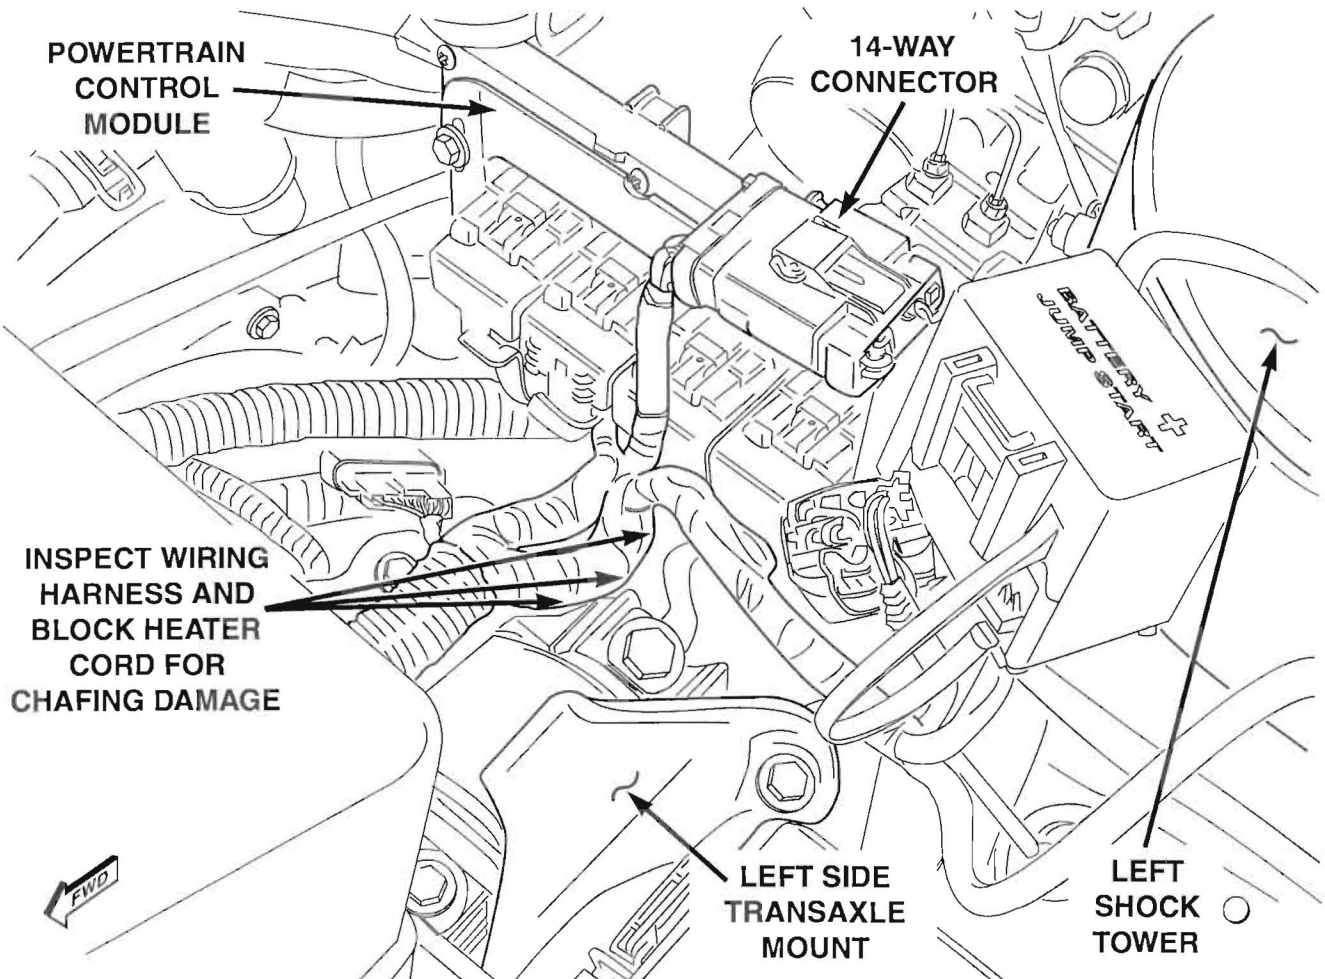
Figure 1

1. Disconnect the negative battery connection on the left shock tower.
2. Inspect the engine wiring harness and, if equipped, the 120 volt engine block heater cord at the left transaxle mount for chafed wires (Figure 1):
  - If wire chafing **is not** found, continue with Step 6 of this procedure.
  - If wire chafing **is** found, continue with Step 3 of this procedure.

3. Remove the wiring harness protective tape from around the damaged area.

4. Repair wire(s) as required.

5. Install electrical tape around repaired area of wiring harness.
