Service Bulletin

4 - STROKE
GS/GSX/GSX-R BULLETIN NO. 183
DATE: 6/6/2008

**SAFETY RECALL CAMPAIGN #2A05
CERTAIN 2008 GSX1300RK8 MOTORCYCLES
IGNITION SWITCH INSPECTION/REPLACEMENT**

AFFECTED UNITS: CERTAIN 2008 GSX1300RK8 MOTORCYCLES

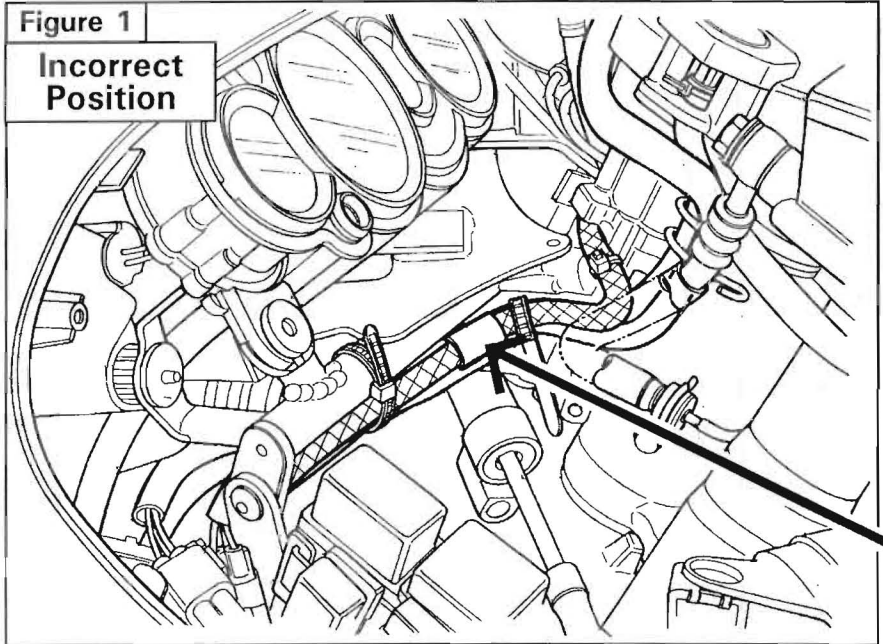
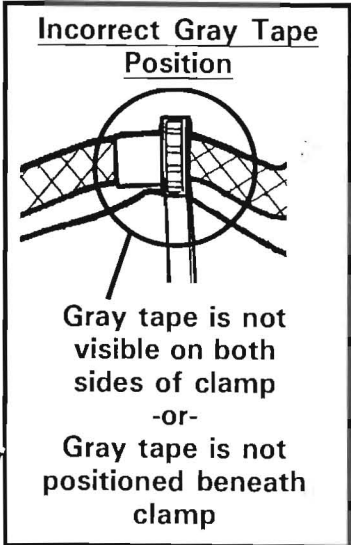
Suzuki Motor Corporation has determined that certain GSX1300RK8 motorcycles may have the ignition switch lead wire improperly routed. Handlebar movement can result in abnormal flexing and damage to the ignition switch lead wire. Damage to the ignition switch lead wire can result in intermittent or complete loss of electrical power, which can result in loss of lighting and/or stalling of the engine. This could result in a crash.

1. Remove the upper and lower meter panels (refer to Service Manual page 9D-15).
2. Check if the ignition switch lead wire is clamped and routed correctly. Incorrect positions are shown in Figures 1 and 2. Correct routing and clamping is shown in Figures 3 and 4 on page 5.

1. Reroute the ignition switch lead wire correctly (Figure 3 and Figure 4). The ignition switch lead wire should not be covered by the other wire harnesses.
2. Turn the handlebars back and forth to verify that the steering operates smoothly and the wiring harness does not become kinked or pinched.
3. Proceed to PUNCH MARK AT VIN on page 8.
