**Re: Defect Information Report – Supplemental Report No. 4
08V-269, FL-530, SAF Holland ADL Suspension Weld**

Subject: RECALL 08V-269 – SAF Holland ADL Suspension Transverse Beam Weld

TRANSVERSE BEAM WELD MISLOCATION INSPECTION & INSTALLATION PROCEDURES

Drive-Axle Air-Ride Suspension
Transverse Beam Weld Inspection
& Installation Procedures

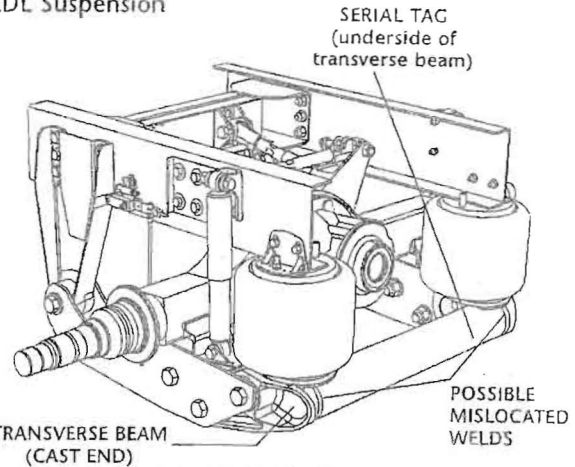
FIGURE 1
ADL Suspension

SAF-HOLLAND's ADL/ADLSD Series drive-axle suspension models may have welds that are mislocated on the transverse beam (FIGURE 1). The mislocation of these welds may diminish the strength of the transverse beam, potentially causing pre-mature failure.

Weld failures may affect vehicle stability while cornering—resulting in loss of vehicle control. Additionally, if a transverse beam drops to the ground it could create sparks which, if not avoided, could cause a fire hazard.

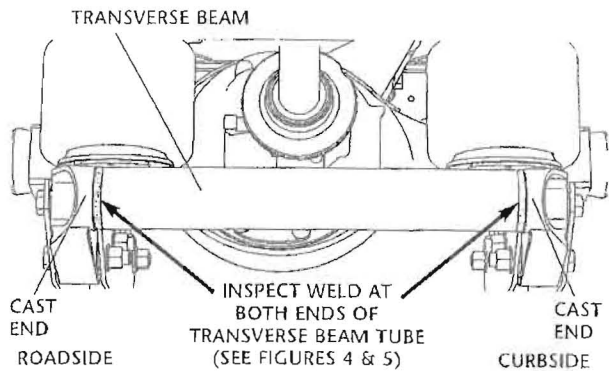
FIGURE 3
Rear View of Suspension Transverse Beam

IMPORTANT: There are two weld joints where defects may have occurred on the transverse beam. A joint at each end of the beam connects a cast end to the beam's tube structure (*FIGURE 3*). Welds at these joints are a circular band that go completely around the circumference of the tube (*FIGURE 3 DETAIL A*).

5. Visually inspect each weld joint at each end of the transverse beam (*FIGURE 3*). YOU MUST REPLACE THE BEAM IF MISLOCATED WELDS ARE PRESENT. DO NOT ATTEMPT TO REPAIR MISLOCATED WELDS. *FIGURES 4* and *5* are close up views of the correct and mislocated weld profiles.
