**Re: Defect Information Report – Supplemental Report No. 6
08V-269, FL-530, SAF Holland ADL Suspension Beam Weld**

Subject: SAF Holland ADL Suspension Transverse Beam Welds

September 2008
FL530AB
NHTSA #08V-269

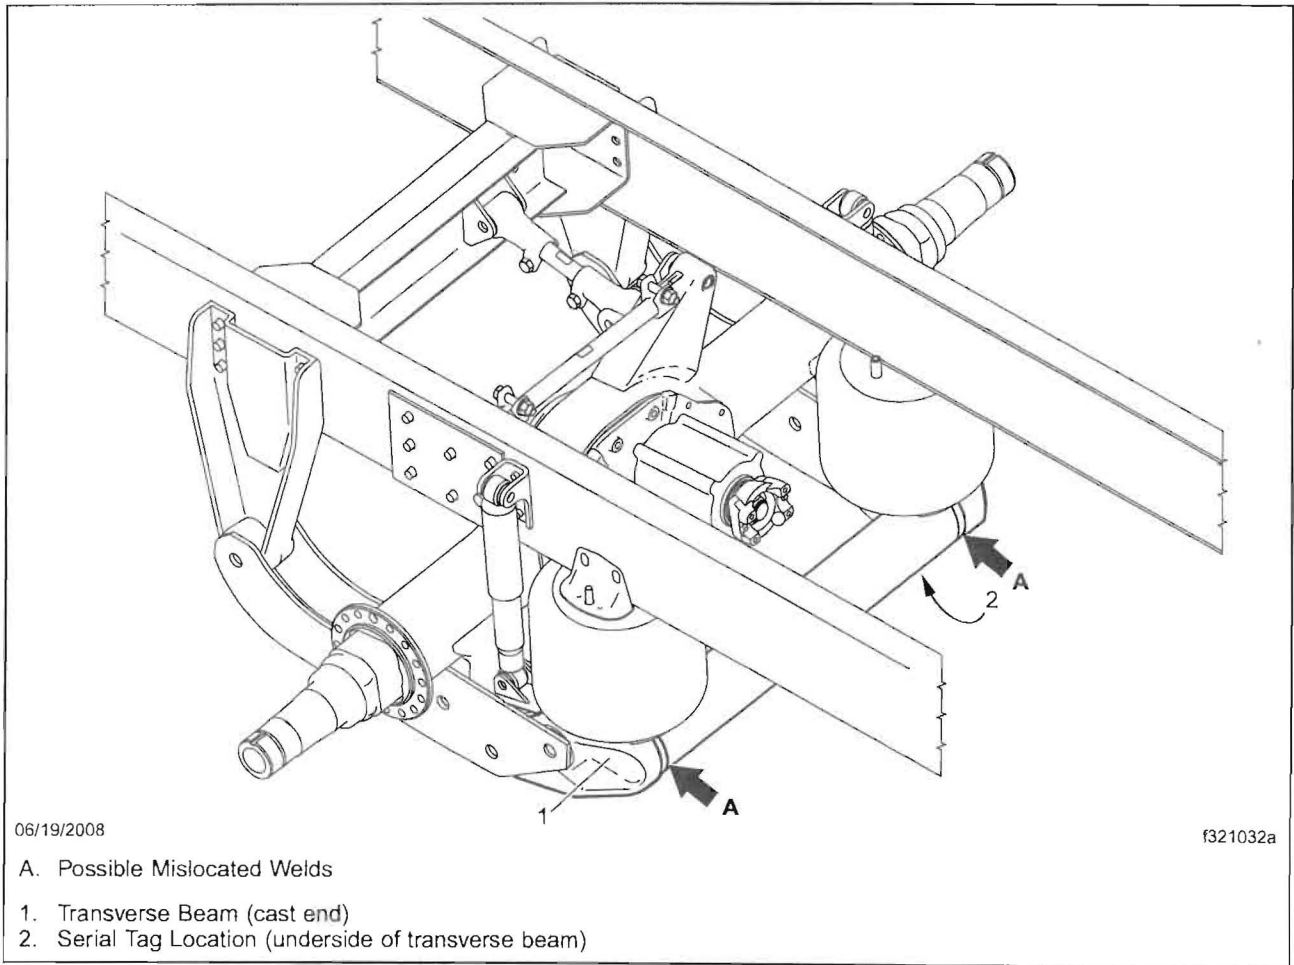
Fig. 1, Transverse Beam Area

4. At the rear of the drive suspension, look for the serial tag located under the transverse beam to identify the part number and 2-letter date code that describes the manufactured month as follows.
 - July 2007 - suspension date code GM
 - August 2007 - suspension date code HM
 - September 2007 - suspension date code JM
 - October 2007 - suspension date code KM

See Fig. 1, Item 2, and Fig. 2.

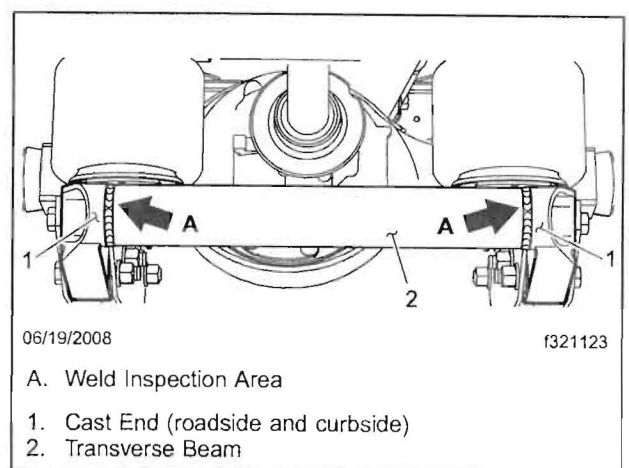
Fig. 3, Rear View of Transverse Beam

NOTE: There are two weld joints where defects may have occurred on the transverse beam. A joint at each end of the beam connects a cast end to the beam's tube structure. See Fig. 3. Welds at these joints are a circular band that wrap completely around the tube.

5. Visually inspect each weld joint at each end of the transverse beam. If damaged, the transverse beam must be replaced.

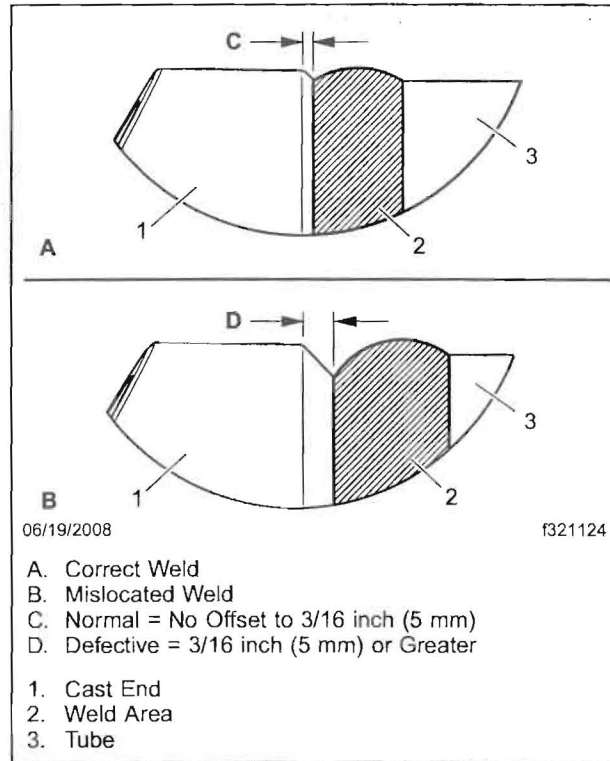
Fig. 4, Mislocated Weld Inspecting

Certain vehicles may have been built with SAF Holland ADL suspensions that have improperly located transverse beam welds, which may cause the transverse beam to separate from the suspension casting. If the transverse beam separates from the casting, vehicle stability while cornering could be affected, resulting in a loss of vehicle control and possible crash without prior warning.

IMPORTANT: Do not attempt to repair mislocated welds. See Fig. 4, for an example of correctly located and mislocated welds.
