DATE: August 25, 2008
TO: Mitsubishi Motors Service Managers
RE: SR-08-004 – Galant Shift Interlock Safety Recall
ATIN NO. ATIN-08-SR-004

AFFECTED VEHICLES: 2004-05 Galant

SUBJECT:		No: SR-08-004	
GALANT SHIFT INTERLOCK SAFETY RECALL CAMPAIGN		DATE: August, 2008	
		MODEL: 2004-05 Galant	
CIRCULATE TO:	<input type="checkbox"/> GENERAL MANAGER	<input checked="" type="checkbox"/> PARTS MANAGER	<input checked="" type="checkbox"/> TECHNICIAN
<input checked="" type="checkbox"/> SERVICE ADVISOR	<input checked="" type="checkbox"/> SERVICE MANAGER	<input checked="" type="checkbox"/> WARRANTY PROCESSOR	<input checked="" type="checkbox"/> SALES MANAGER

On some affected vehicles, it may be possible for the key to be removed from the ignition switch when the transmission gear selector is in a position other than P (Park). The gearshift to ignition switch interlock system may allow the ignition key to be removed from the ignition switch without placing the gearshift in the "P" position. If the driver does not shift to "P" before removing the key from the ignition, and does not engage the parking brake, the vehicle could roll away and a crash could occur.

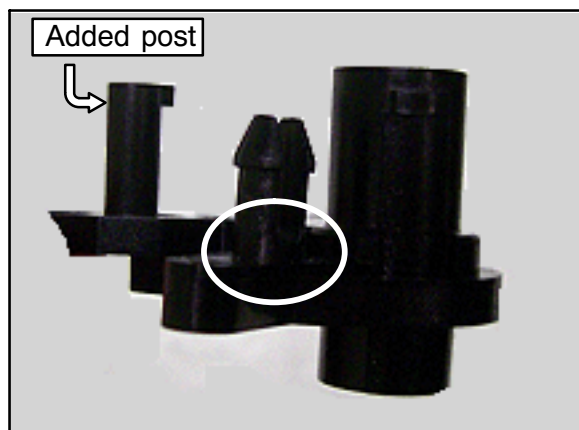
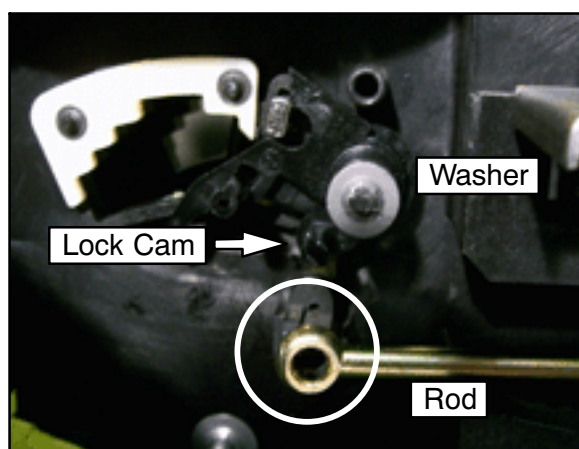
A new lock cam is included in the parts kit. **It is not used unless the vehicle's lock cam is broken.** Inspect the "split" post on the lock cam in the area indicated for breakage or weakened material (tang is overly flexible).

The new lock cam has an additional post.

Either of the tangs for the split post could be broken. Broken tangs can occur during lock cam rod installation. Take care when installing the lock cam rod onto this post and inspect it after installation.

If the lock cam is not broken as described, **DO NOT REPLACE** it. Continue with the Cable Return Spring Installation Procedure on the next page.
