GM SERVICE AND PARTS OPERATIONS  
DCS2082  
URGENT DISTRIBUTE IMMEDIATELY

Subject: 08205 Product Safety Recall  
Fuel Tank Housing May contact Frame Side Rail

Models: 2008 Chevrolet Express  
2008 GMC Savana  
139" Wheel Base Cutaway

# Recall Bulletin

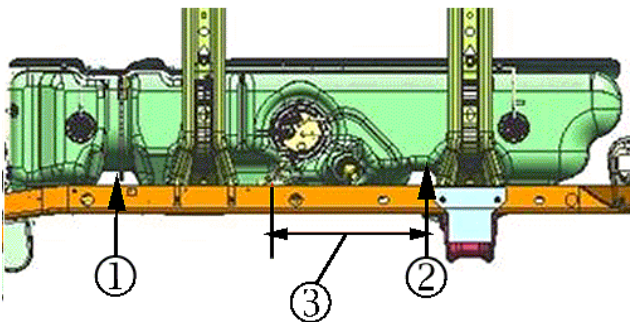
2166613

There are two fuel tank flange access areas located on the driver's side of the vehicle. Perform the frame side rail inspection at the rear fuel tank flange area (2) only. Do NOT inspect the frame side rail at the front fuel tank flange access area (1). Refer to the illustration to view the tank inspection area (3). The spring perch is near the rear fuel tank flange area.

**Important:** If the vehicle does not have a body (frame rail only), the frame rail inspection can be performed without removing the fuel tank. Inspect the frame rail from the top of the vehicle in the area outlined in the illustration. Refer to Steps 3-4 in *Vehicles with a Body* for inspection instructions. Follow Steps 5-15 in *Vehicles with a Body* if the frame side rail must be reworked.

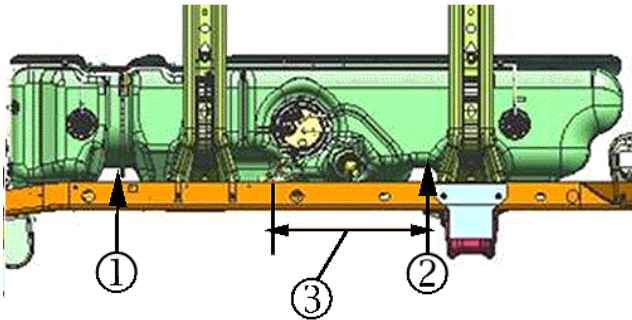
2166613

**Important:** There are two fuel tank flange access areas located on the driver's side of the vehicle. Perform the frame side rail inspection at the rear tank flange area (2) only. Do **NOT** inspect the frame side rail at the front fuel tank flange access area (1). Refer to the illustration to view the tank inspection area (3). The spring perch is near the rear fuel tank flange area.

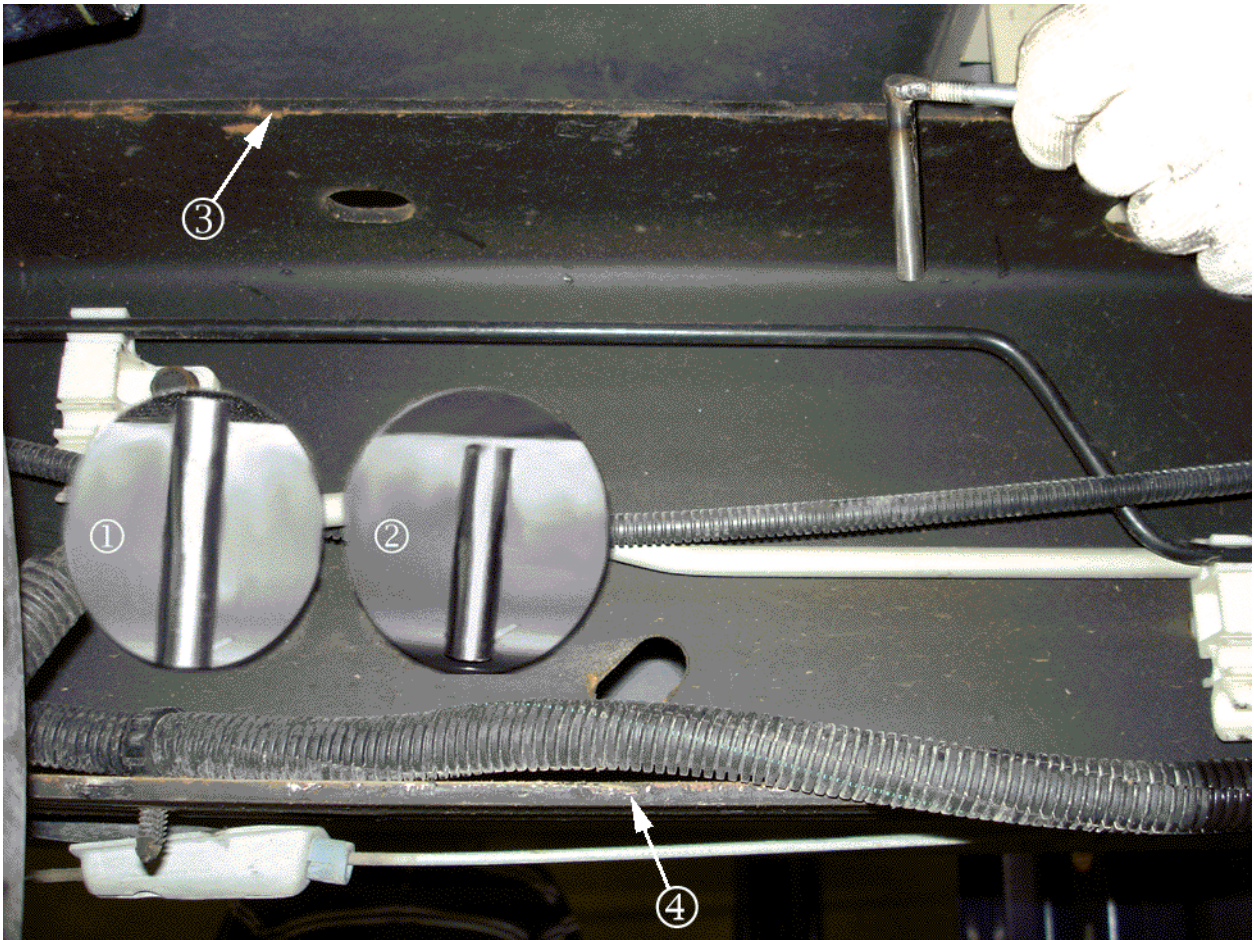
2166607

**Important:** Make sure the inspection pin is flat against the frame side rail web and **NOT** in the radius of the bend. An extra piece of steel stock was welded to the inspection pin to create a handle. This inspection pin handle is not required to perform the inspection.

4. Inspect the width of the frame side rail on the driver's side of the vehicle, near the rear fuel tank flange access area of the frame side rail. Insert the inspection pin along the width of the frame side rail as shown in the illustration. Inspect the top of the frame side rail (3) only. Do **NOT** inspect the bottom of the frame side rail (4).
  - If the inspection pin is equal to or longer than the width of the frame side rail (1), then the frame side rail is within the desired specification. Proceed to Step 14.
  - If the inspection pin is shorter than the width of the frame side rail (2), then the frame side rail is too wide and must be reworked to the proper width. Proceed to Step 5.
5. Make sure the fuel filler neck, lines, and harnesses, etc., in the rework area are protected before you perform the rework (i.e., use a welding blanket, metal guard, etc.).

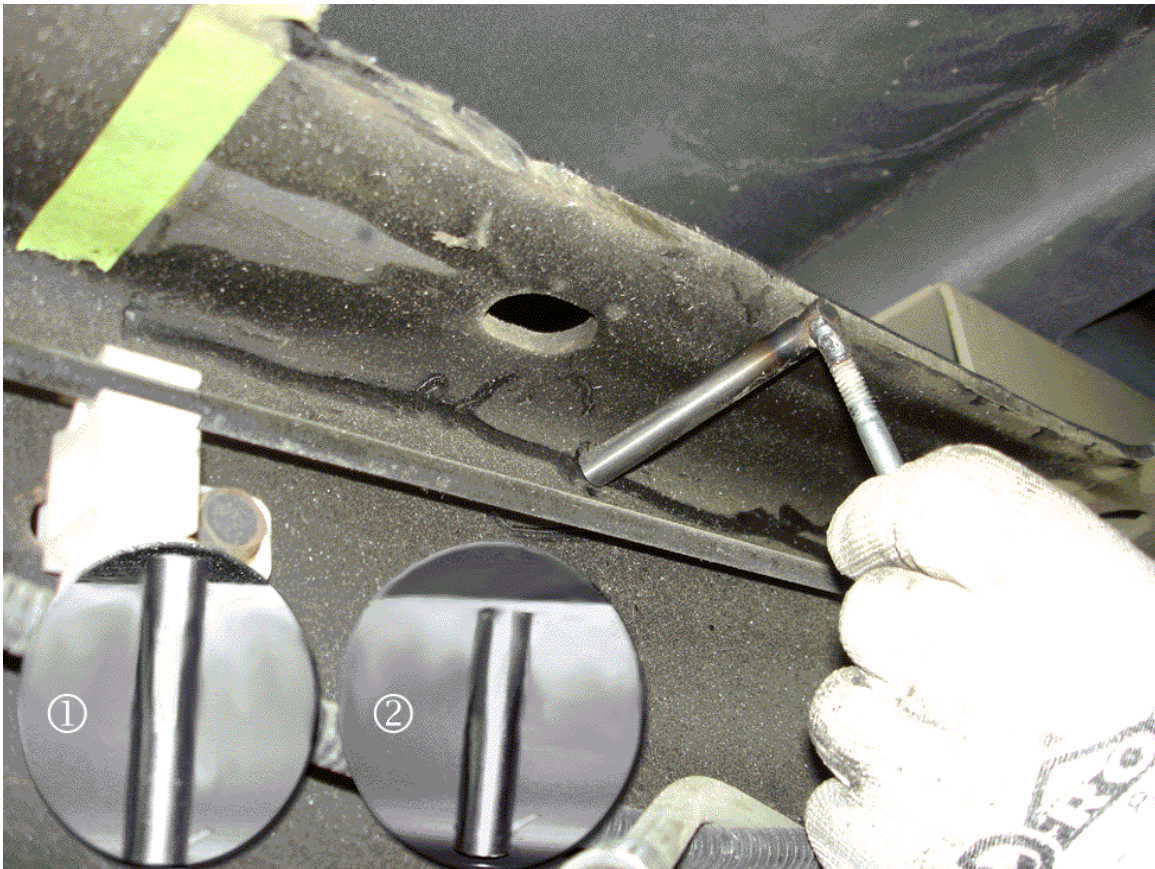
2166615

10. Using the inspection pin, ensure the frame side rail width is within the desired specification. If the inspection pin is equal to or longer than the side rail (1), then the side

rail is within the desired specification. Make sure that all upper flanges have at least 5 mm (0.2 in) radii (for/aft direction). The minimum upper flange width is 80.1 mm (3.15 in) outside of the frame side rail.

11. Apply anti-corrosion treatment, GM P/N 12378399, (or equivalent), to the bare metal edges of the frame rail rework area.
12. Remove all protection devices, and reinstall the filler neck, lines, harnesses, and surrounding components.
13. Inspect the fuel tank for damage. If the fuel tank is damaged, replace the fuel tank. Wholesale authorization will be required for fuel tank replacement.
14. Install the fuel tank. Refer to *Fuel Tank Replacement (Cutaway Van Side Tank)* in SI.
15. Lower the vehicle. Refer to *Lifting and Jacking the Vehicle* in SI.
