# *AIRSTREAM Inc.*

**Bulletin Number: 144**  
**Product Line: 2008 & 2009 Interstate Motorhome**  
**Subject: Seat Swivel Recall**  
**Attn.: Dealer General & Service Managers**

Date: July 25, 2008

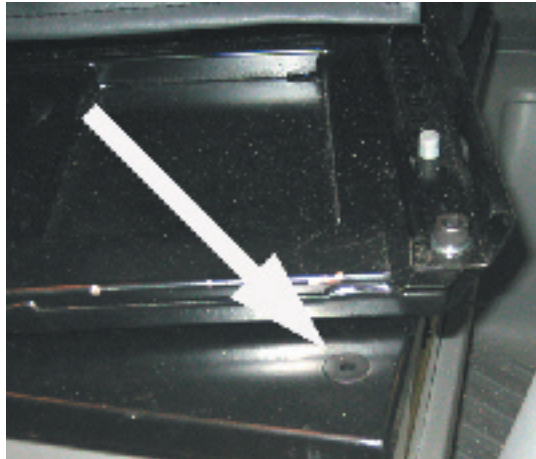
1. Slide drivers seat forward and rotate the seat to expose and remove the 4 allen headed mounting bolts on each corner.

2. Remove the four allen headed bolts and lay the driver seat against the passenger's seat.
3. Disconnect the seat belt warning two wire connection and remove seat/swivel assembly from coach.
4. Repeat procedure for passenger seat. There is no wiring to disconnect on the passenger side.
5. Remove the four bolts holding the swivel to each seat and remove the swivels.
6. Install new swivels onto seat base using same bolts. Torque all 8 bolts to 30 newton-meters or 22 ft/lbs. Remember there is a driver and passenger side.
7. Reinstall seat/swivel assemblies to seat bases. Don't forget to plug in the wires on the driver's seat.
