Applies To: **2008 Element 2WD** – From VIN 5J6YH1...8L013895 thru 5J6YH1...8L013924
2008 Element 4WD – From VIN 5J6YH2...8L014984 thru 5J6YH2...8L015673

July 25, 2008

Safety Recall: Left Rear Trailing Arm May Come Loose

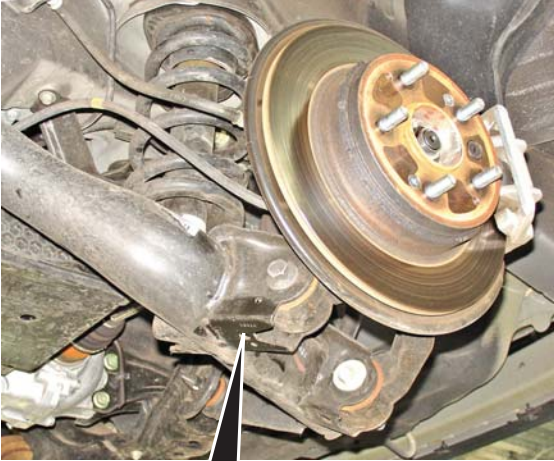
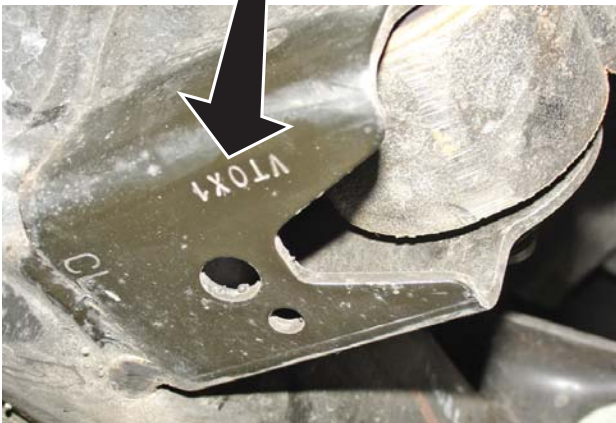
1. Raise the vehicle on a lift, and remove the left rear wheel.
2. Check the date code stamped on or near the bottom of the front lower mount of the left trailing arm:
 - If the date code is NROX 1, go to REPAIR PROCEDURE.
 - If the date code is not NROX 1, go to step 3.

- If the code is NROX 1, replace the left trailing arm and its attaching bolts and nuts.
- If the code is not NROX 1, a new left trailing arm is not needed. Center-punch a campaign completion mark above the 1st character of the engine compartment VIN.
