Applies To: **2008 Element 2WD** – From VIN 5J6YH1...8L013895 thru 5J6YH1...8L013924  
**2008 Element 4WD** – From VIN 5J6YH2...8L014984 thru 5J6YH2...8L015673

**August 13, 2008**

### Safety Recall: Left Rear Trailing Arm May Come Loose

(Supersedes 08-053, dated July 25, 2008, to update the information marked by the black bars)

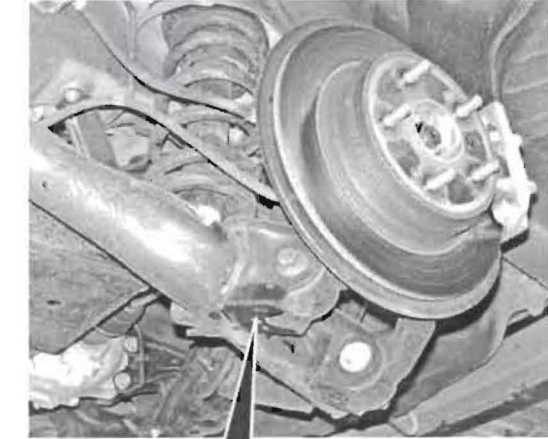
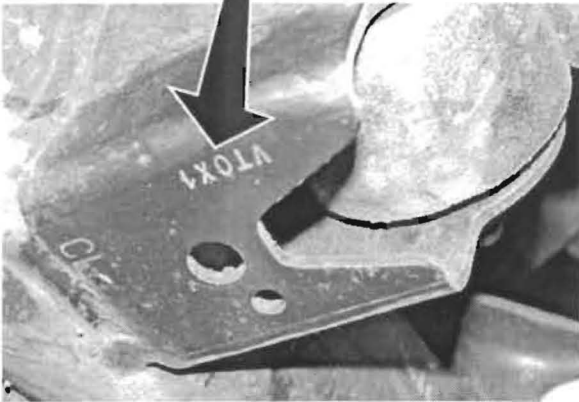
1. Raise the vehicle on a lift, and remove the left rear wheel.
2. Check the date code stamped on or near the bottom of the front lower mount of the left trailing arm:
  - If the date code is NROX 1, go to REPAIR PROCEDURE.
  - If the date code is not NROX 1, go to step 3.

- If the code is NROX 1, replace the left trailing arm and its attaching bolts and nuts.
- If the code is not NROX 1, a new left trailing arm is not needed. Center-punch a campaign completion mark above the 1st character of the engine compartment VIN.
