Reference: NHTSA Identification Number 08V-352

Safety Recall H27 Left Axle Shaft

2008 (VB) Dodge Sprinter 3500 Series

2008 (VB) Freightliner Sprinter 3500 Series

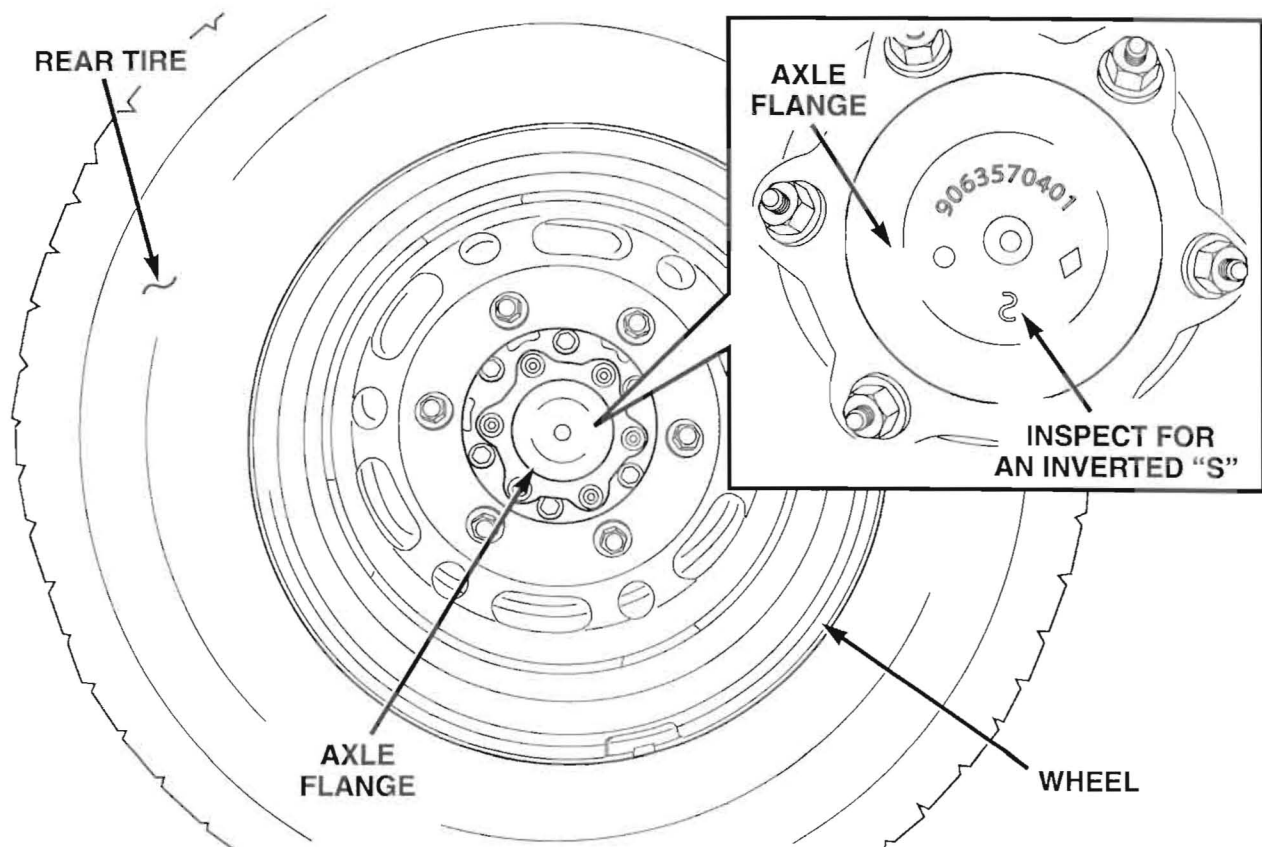
Figure 1

1. Apply the park brake.
2. If equipped, remove the left rear wheel cover.
3. Inspect the axle shaft flange for an inverted “S” cast into the axle shaft flange (Figure 1).
 - If an inverted “S” **was not found** on the face of the axle flange, the axle shaft does not require replacement. Install the wheel cover (if equipped) and return the vehicle to the owner.
 - If an inverted “S” **was found** on the face of the axle flange, replace the axle shaft. **Continue with Section B. Axle Shaft Replacement.**

The left axle shaft must be inspected. Axle shafts with an inverted "S" on the axle shaft flange must be replaced.
