Service Bulletin No. 290B

MODEL D4005 / D4505 Series Coaches	TYPE Field Change Program	SECTION/GROUP 3-Body	DATE Aug. 22, 2008
SUBJECT DURA AUTOMOTIVE SYSTEMS WINDOW DE-BONDING			
CONDITIONS

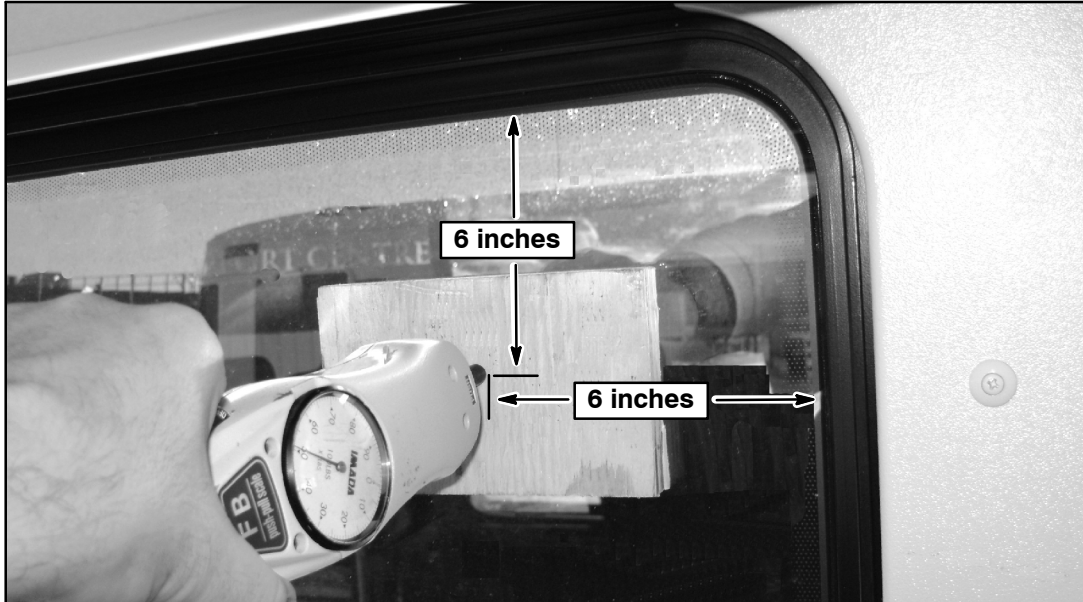
Figure 1.

2. Ensure window is in locked position.
3. From inside the coach, carefully position a 4.0 x 4.0 x 0.5 inch flat wood block flat against glass surface six inches from both edges (Figure 1). Position a push / pull gauge at center of wood block and apply 50 lbs. push force against glass perpendicular to the glass surface, to accentuate any partial de-bonding.
4. Observe any evidence of glass separation / de-bonding against the frame, as force is applied.
