Subject: Revision to Recall Campaign 08V-397 (37D5/J2)

**Subject: Revision to Safety Recall Circular 37D5/J2
1996-2003 Audi A8 with 5-speed Automatic Transmission
Automatic Transmission Locking Cable Modification**

Code: 37D5/J2

Subject: 1996-2003 Audi A8 with 5-speed Automatic Transmission
Automatic Transmission Locking Cable Modification

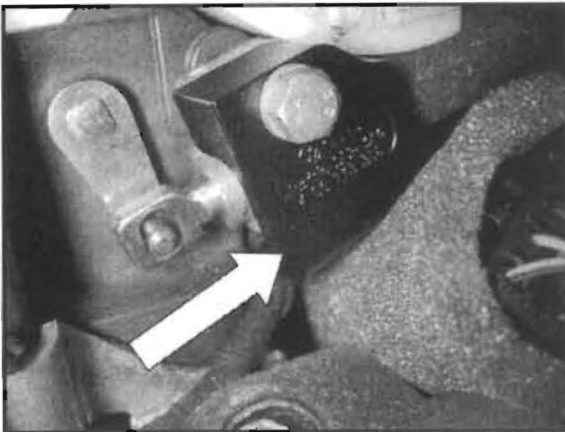
⇐ Inspect locking cable for presence of adjusting piece -arrow- (part number 4D0713299 B, C, D, or E)

- If adjusting piece (part number 4D0713299 B, C, D, or E) is present, install parts in reverse order; **WORK IS COMPLETE**
- If adjusting piece (part number 4D0713299 B, C, D, or E) is not present, **proceed to Section B**

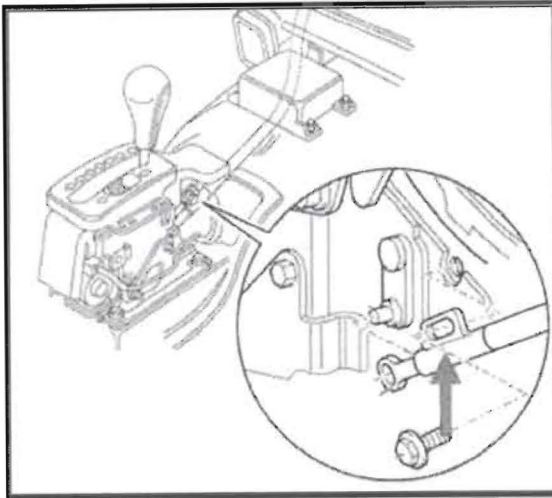
Tip: Elongated hole –arrow- will no longer be used for locking cable adjustment

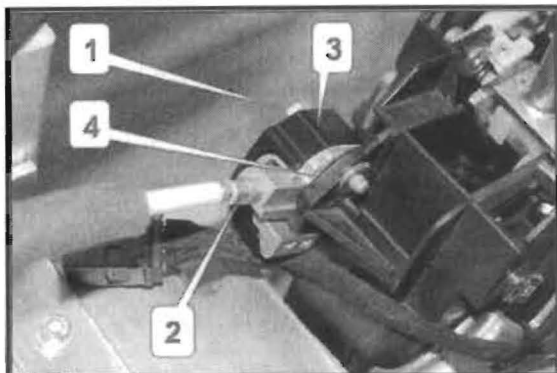
Tip: Photo shows selector lever unit removed and serves to illustrate fitting locations:

- 1- Bolt M6
- 2- Locking cable
- 3- Clamping piece
- 4- Adjusting piece
