**Subject: Recall Campaign 08V-397 (37D5/J2)**

# Safety Recall Circular

Code: **37D5/J2**

**Subject: 1996-2003 Audi A8 with 5-speed Automatic Transmission  
Automatic Transmission Locking Cable Modification**

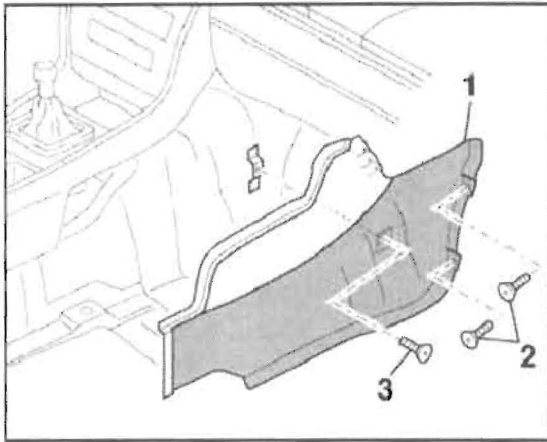
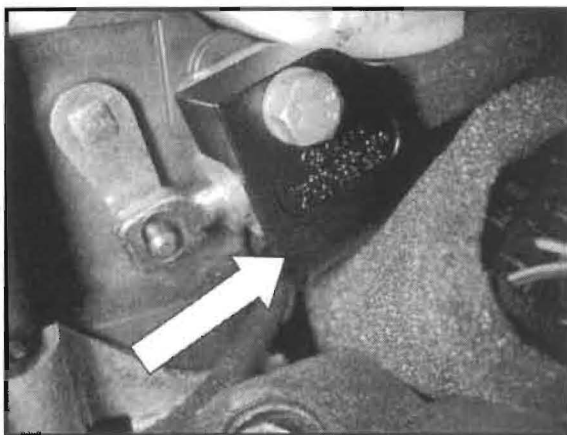
**Section A – Locking Cable Inspection**

- ⇐ Remove carpet (front right) and right side trim of center console -1-
- ⇐ Remove bolts -2- (below floor covering) and -3-
- Slide trim forward and unhook at rear
- Take hold of front end of air duct for rear cabin ventilation (located behind side trim for center console) and push it aside slightly
- ⇐ Inspect locking cable for presence of adjusting piece -arrow- (part number 4D0713299 B, C, D, or E)
- If adjusting piece (part number 4D0713299 B, C, D, or E) is present, install parts in reverse order; **WORK IS COMPLETE**
- If adjusting piece (part number 4D0713299 B, C, D, or E) is not present, **proceed to Section B**

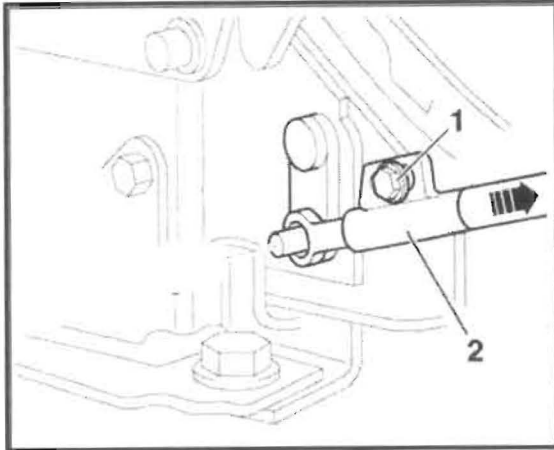
Tip: Locking cable is attached to shift unit (bottom part of selector lever unit) and can be accessed through opening in center console

← Remove bolt -1-

← Disengage locking cable -2-

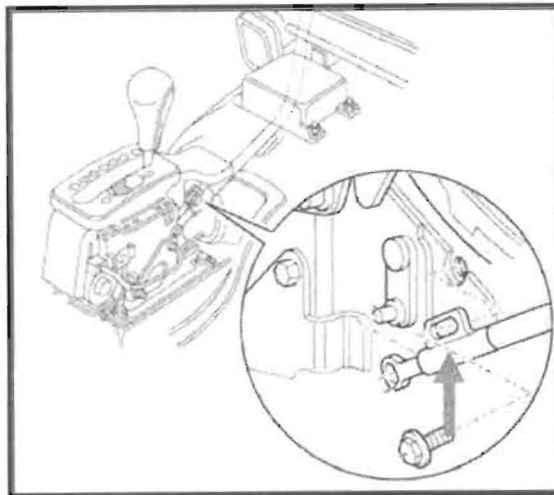
Tip: Elongated hole –arrow- will no longer be used for locking cable adjustment

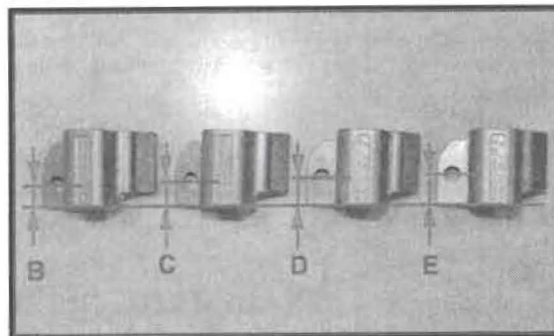
Tip: One of four adjusting pieces (part number 4D0713299 B, C, D, or E) with different hole alignments will now be used instead of elongated hole.

To determine the correct adjusting piece, try each one until the best fitting piece is matched

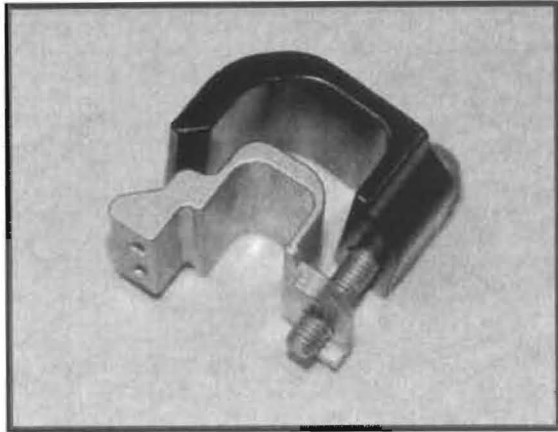
Tip: The ignition key must be removed

Tip: To find the proper adjusting piece, start with index B from previous picture

⇐ Insert new bolt (N 090 364 5) through black clamping piece (4D0 713 358) and adjusting piece (4D0713299 B, C, D, or E) as shown

⇐ Attach locking cable -2- and secure clamping piece -3- by tightening bolt -1-

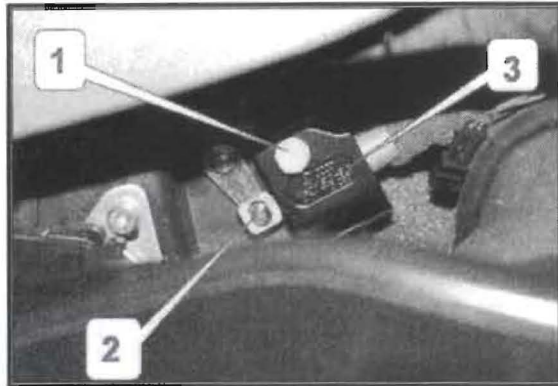
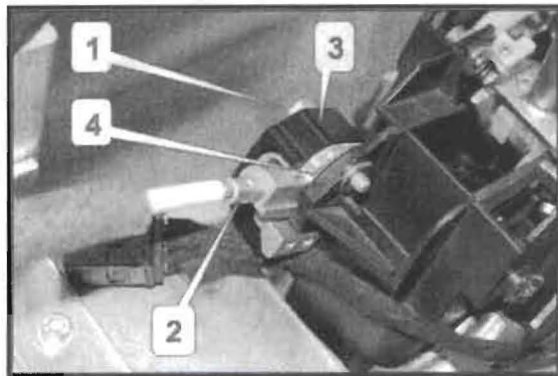
Tip: Photo shows selector lever unit removed and serves to illustrate fitting locations:

- 1- Bolt M6
- 2- Locking cable
- 3- Clamping piece
- 4- Adjusting piece

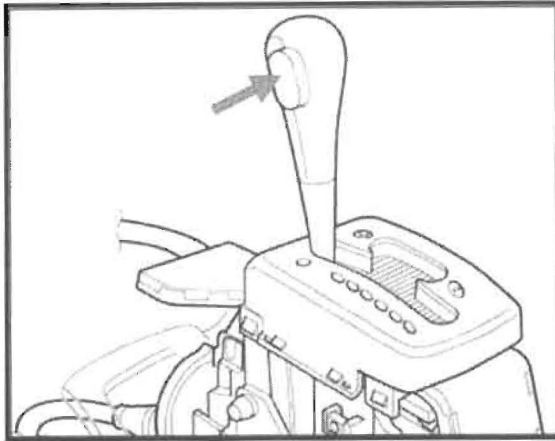
Tip: If ignition key cannot be removed freely, repeat adjustment procedure with next adjusting piece

- With selector lever in Park "P", switch ignition on
- Press brake pedal and move selector lever to "D" and back to "P"
- Switch off ignition and remove key

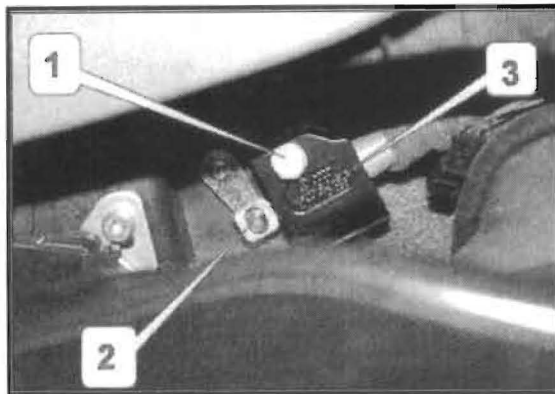
Tip: Locking effect decreases with each adjusting piece in alphabetical order (example: 4D0713299 B => C=> D=> E)

- Switch off ignition and remove ignition key
- ⇐ It should not be possible to press interlock button –arrow- so far in that selector lever can be moved out of position “P”.
- ⇐ If selector lever can be moved out of “P”, repeat procedure with next adjusting piece

- Once proper adjusting piece is identified, remove bolt -1- again, coat with locking fluid Part No. D 000 600 A2 (shop supply) and torque to 10Nm
- Install parts in reverse order
- Properly dispose of remaining parts from parts kit
