Re: Newmar Corporation – Motor Vehicle Recall Notification

Subject: Recall Campaign No.: 08V-443

TSB 355

Subject: Missing heat shielding for engine exhaust.

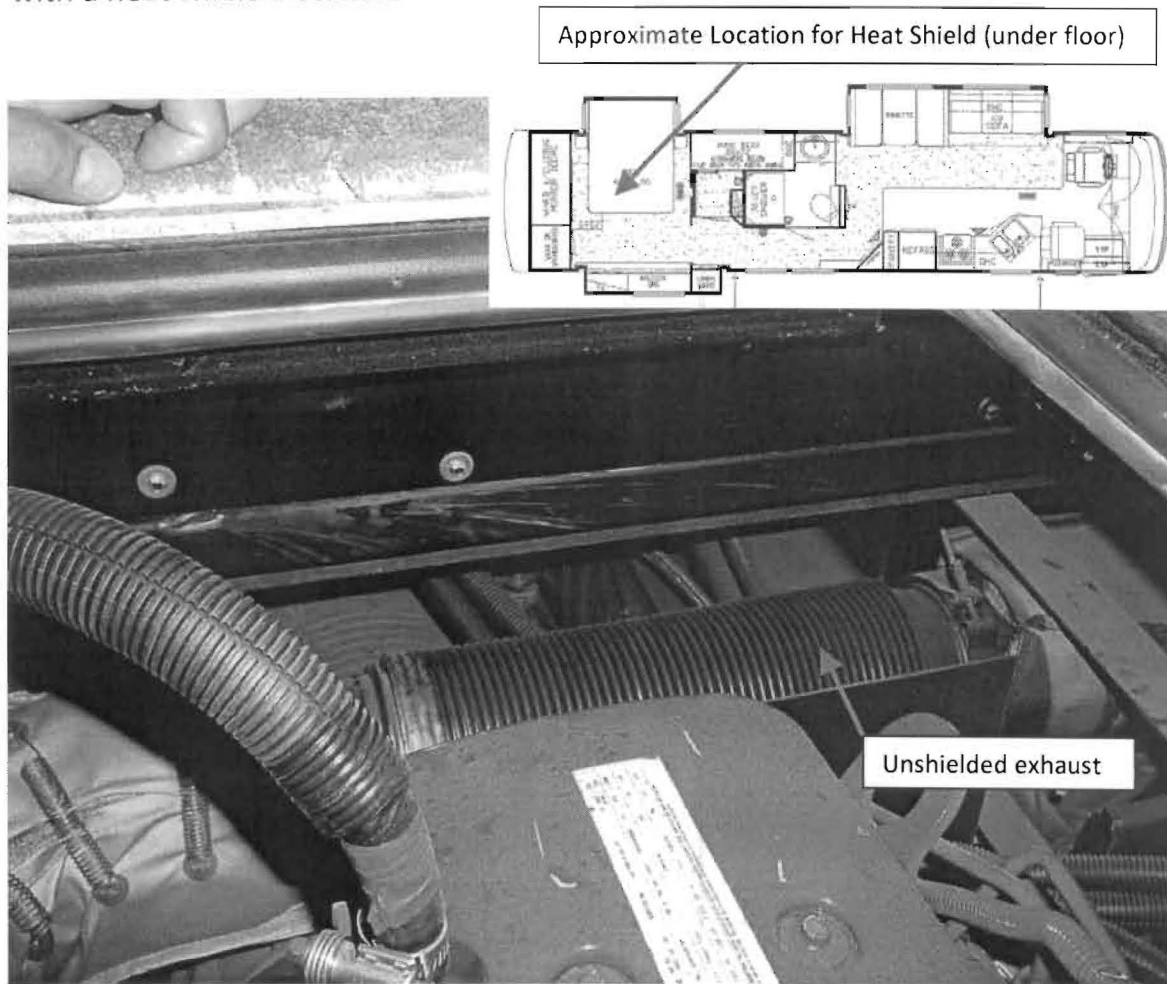
Diagnosis Procedure: Move any obstructions, and open the engine access located in the floor. Look forward toward the front end of the engine compartment. Look for the heat shield on the cross member that is located just below the engine access opening. This heat shield will be installed on the cross member. Figure 1 shows the unit without a heat shield, figure 2 shows the unit with a heat shield installed.

Figure 1: No heat shield installed

If a heat shield is not present you will need to install one to redirect the heat. Use **ONLY** the specified Heat Shield (Newmar part #112234) for this recall.

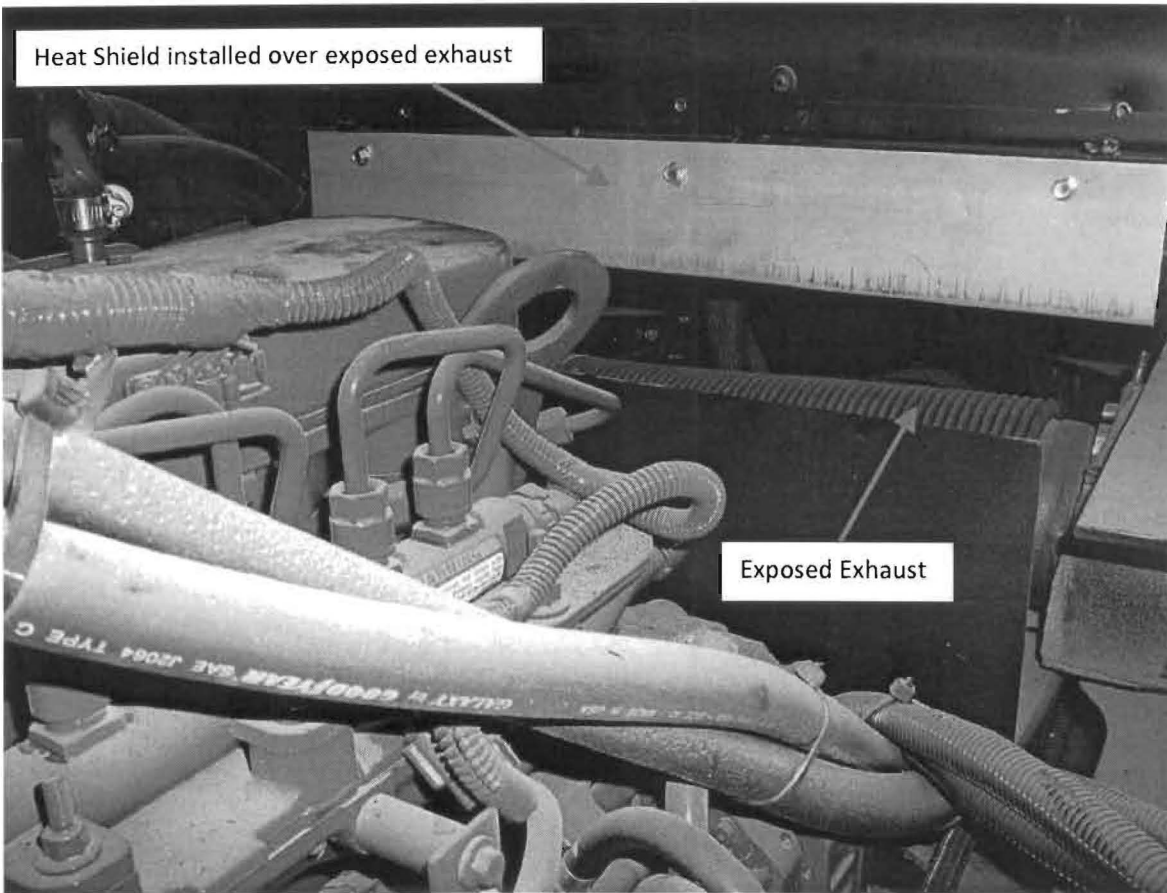
Figure 2: Heat Shield installed

If a heat shield is already installed, no further action is required.

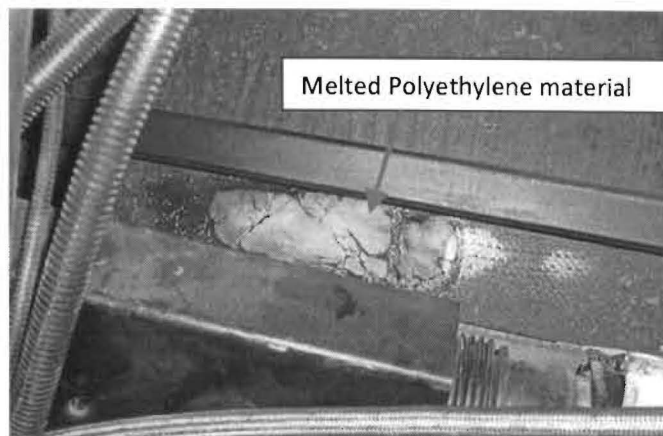
Figure 2A

Before installing the heat shield, inspect the polyethylene vapor barrier above the exhaust for signs of heat damage. If the vapor barrier has been heat damaged, it will need to be repaired prior to installing the heat shield (see figure 2A).

If a repair is required, Newmar recommends installing a piece of .030 aluminum or galvanized steel, cut to fit, and secured into place with screws and silicone as necessary. This patch may need to be 17-33 in. by 3-4 in. and must be fastened directly to the stringers between the structural cross-members forward of the engine compartment. Clean any dust, dirt, or road debris from the area to be repaired, then install the cover into place over the damaged section. Inspect the repair to be sure it is thoroughly covering the damaged area, and is properly secured to insure it will not fall off.

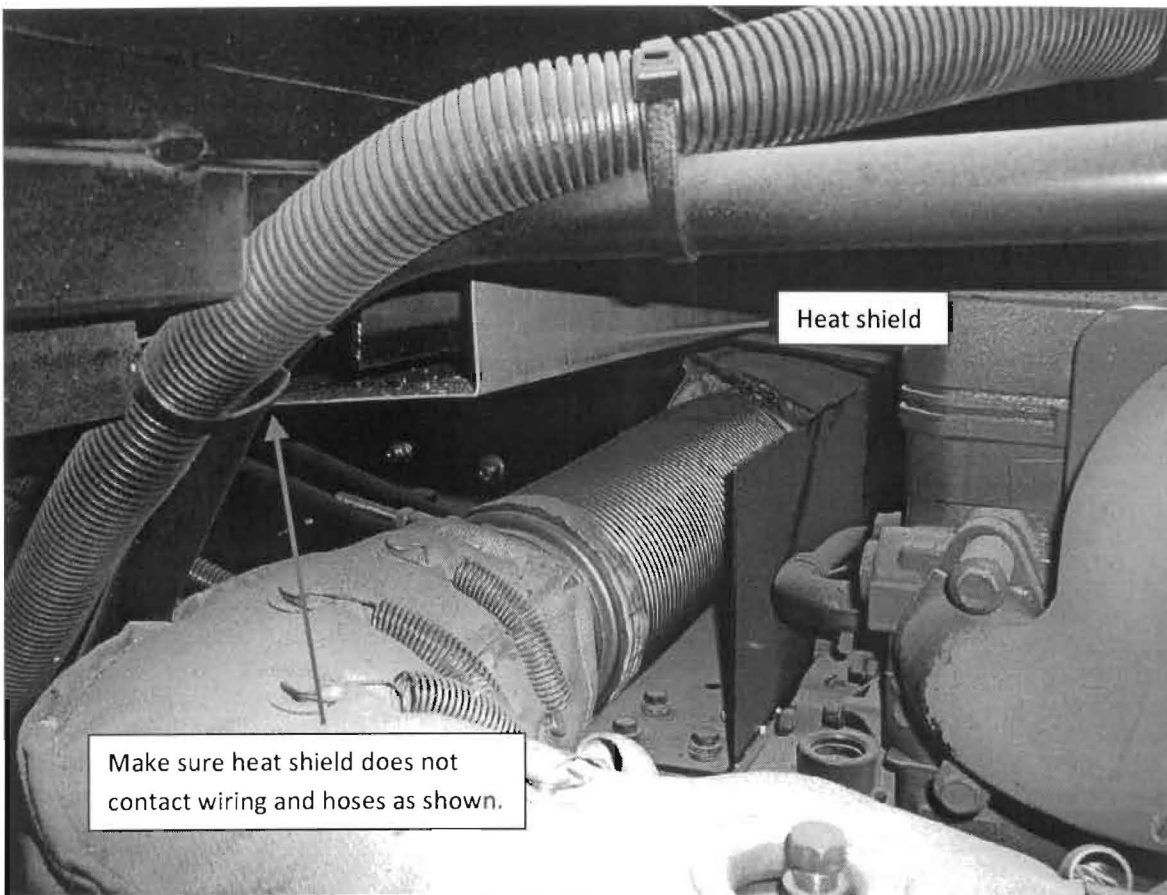
Figure 4: Check for contact / chaffing

IMPORTANT: Once installed, be certain the heat shield is not rubbing against or chaffing any surrounding wiring, hoses, or other items in the engine compartment (Figure 4). Contact with wiring, hoses, and other items will cause excessive wear and potential failures in those components. If the heat shield is properly positioned (over the exposed exhaust between the two existing heat blankets) and there is physical contact between the shield and any wiring or hoses in the engine compartment, reposition the wires or hoses and tie them back to prevent chaffing. Positioning the heat shield properly between the heat blankets and over the exposed exhaust is critical to this repair.
