GM SERVICE AND PARTS OPERATIONS
DCS 2196
URGENT - DISTRIBUTE IMMEDIATELY

SUBJECT: 08157 – Noncompliance Recall
Instrument Panel Storage Bin Door Compliance - Add Reinforcement Bracket

MODELS: 2006-2008 Chevrolet HHR

F/CMVSS NONCOMPLIANCE RECALL

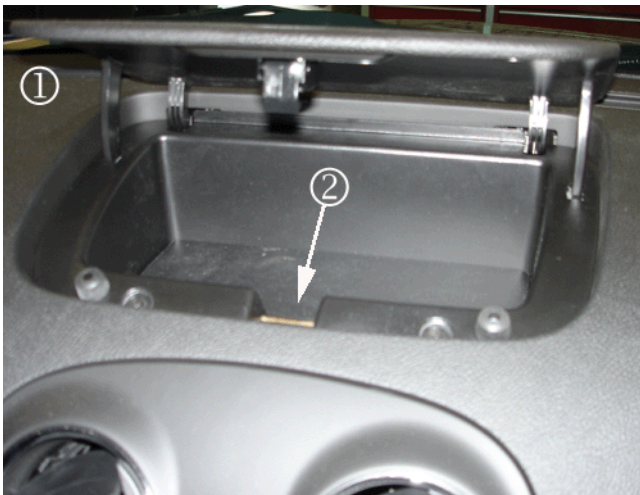
1. Locate and open the instrument panel storage bin (1).
2. Locate the instrument panel storage bin latch (2).

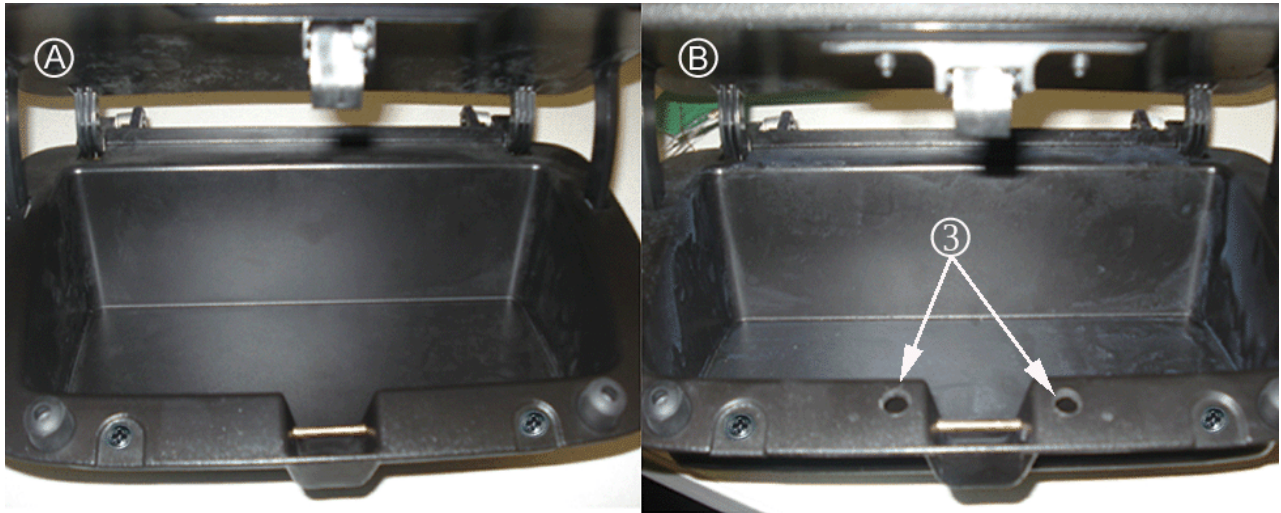
22002517

3. Determine if the storage bin is a first (A) or second (B) design storage bin. The second design storage bin (B) includes latch pin holes (3) on the left and right side of the latch.
 - If the vehicle is equipped with a first design storage bin (A), installing a reinforcement latch plate bracket *IS* required. Proceed to Step 4.
 - If the vehicle is equipped with a second design storage bin (B), installing a reinforcement latch plate bracket is *NOT* required. No further action is required.
