# TECHNICAL SERVICE BULLETIN

## Victory Motorcycle

Bulletin Number: **V-08-03**

**SUBJECT:** Loose Circuit Breaker Terminal Nuts and ECM Reprogramming

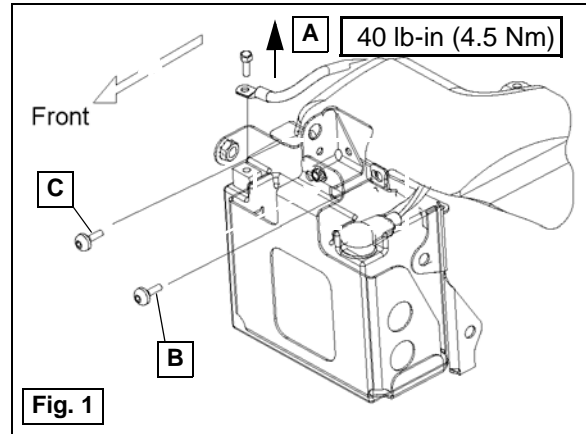
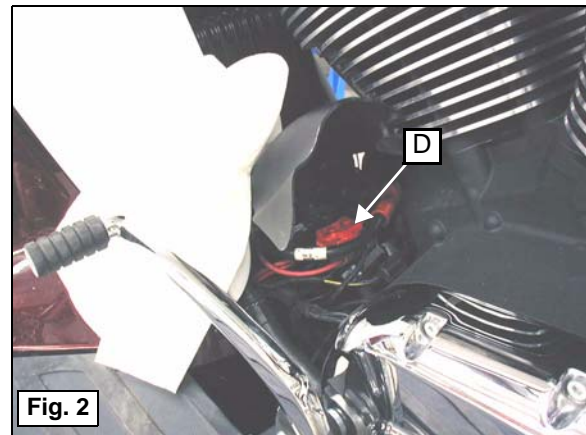
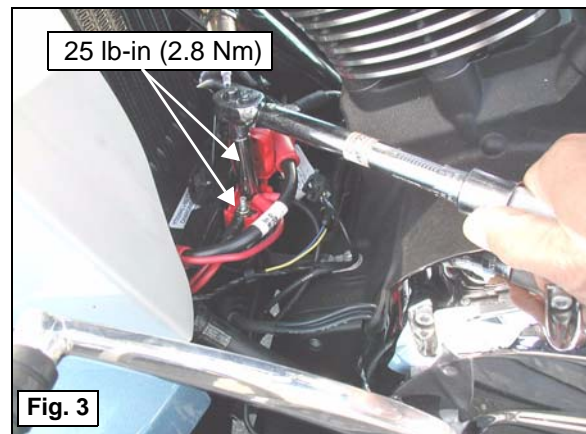
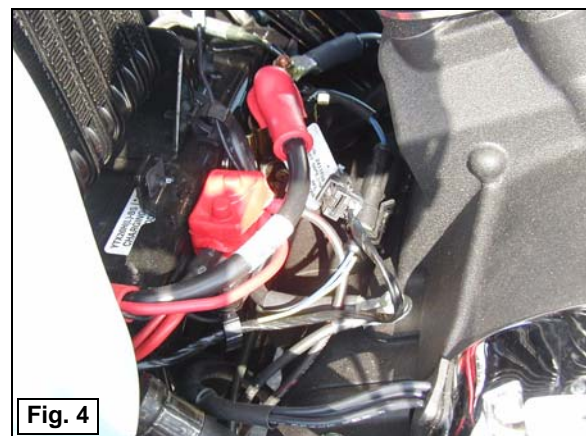
- 1) The terminal nuts that secure the main power supply wires could be loose at the circuit breaker, which can cause an unexpected loss of electrical power to the vehicle.
- 2) The current fuel / ignition map (pre-programmed into the Electronic Control Module or "ECM") can cause engine stalling under unusual and specific rider inputs.

Overview: Tighten *both* circuit breaker terminal nuts to specified torque on all affected vehicles. Use a thin wall socket to ensure full engagement with the nut. Keep the socket at a 90 degree angle to the terminal stud when torquing the nuts.

1. Remove battery negative (-) cable (A). (Fig. 1)
2. Remove screw (B) from electrical cover (4mm internal hex). (Fig. 1)
3. Loosen screw (C).
4. Place a protective cloth between cover and lower leg fairing. Prop cover for access to circuit breaker (D). (Fig. 2)
5. Lift protective cover off circuit breaker.
6. Using a thin wall 3/8 inch deep socket, torque *BOTH* nuts to 25 lb-in (2.8 Nm). (Fig. 3)
7. Re-install protective cover securely over circuit breaker, pushing it firmly onto the studs. (Fig. 4)
8. Set electrical cover back in place and remove protective cloth.
9. Install cover screw and torque both screws to 18 lb-in. (2.0 Nm).
10. Install battery negative cable. Torque terminal bolt to 40 lb-in (4.5 Nm).
11. Perform reflash procedure following basic procedure outlined on Page 5, and instructions within Digital Wrench™.
