**SUBJECT: 08V-448 SAFETY RECALL NOTIFICATION**

## Sr08-12

| SUBJECT : REPLACING WEAKENED BOLTS ON THE ROOF<br>ESCAPE HATCH | |

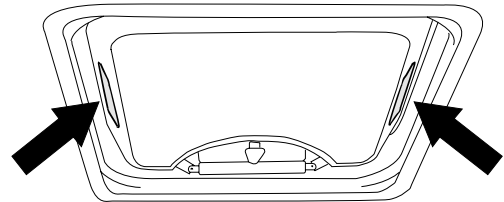
On the vehicles mentioned above, it is **absolutely necessary** to replace weakened bolts on the roof escape hatch. The roof escape hatch manufacturer encountered a quality issue related to the bolt's installed strength. Bolts exposed to higher than normal torques were used in the manufacturing of the escape hatches. Weakened bolts can fracture during opening of the hatch for ventilation. The hatch can detach completely, causing injuries, damages to nearby vehicles and even cause a crash.

1. Open the hatch. To do so, push the escape hatch outwards, pressing with both hands where indicated.
2. Four bolts must be replaced on each hatch.
3. Remove the first bolt and put aside. You will need a screwdriver bit Torx T40 or Phillips #4 depending on the existing bolt type.

If necessary, remove old Loctite™ residues in the threaded hole. To do so, use a 5/16X18 tap.
