# MEDIC UPDATE

## SAFETY RECALL BULLETIN

<b>SUBJECT:</b> <b>FUEL TANK BRACKET SAFETY RECALL</b>		No: <b>SR-08-005</b>	
		DATE: <b>September, 2008</b>	
		MODEL: <b>See Below</b>	
<b>CIRCULATE TO:</b>	<input type="checkbox"/> GENERAL MANAGER	<input checked="" type="checkbox"/> PARTS MANAGER	<input checked="" type="checkbox"/> TECHNICIAN
<input checked="" type="checkbox"/> SERVICE ADVISOR	<input checked="" type="checkbox"/> SERVICE MANAGER	<input checked="" type="checkbox"/> WARRANTY PROCESSOR	<input checked="" type="checkbox"/> SALES MANAGER

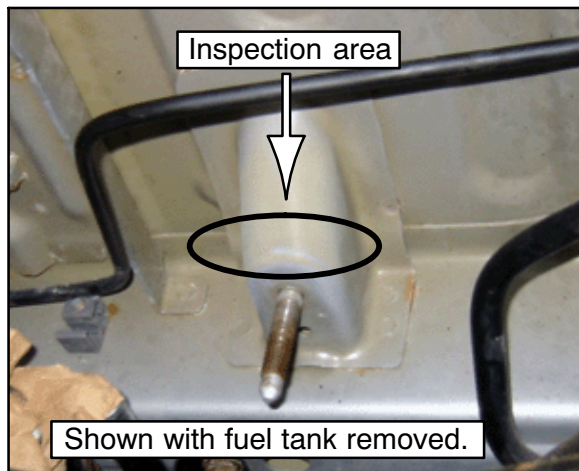
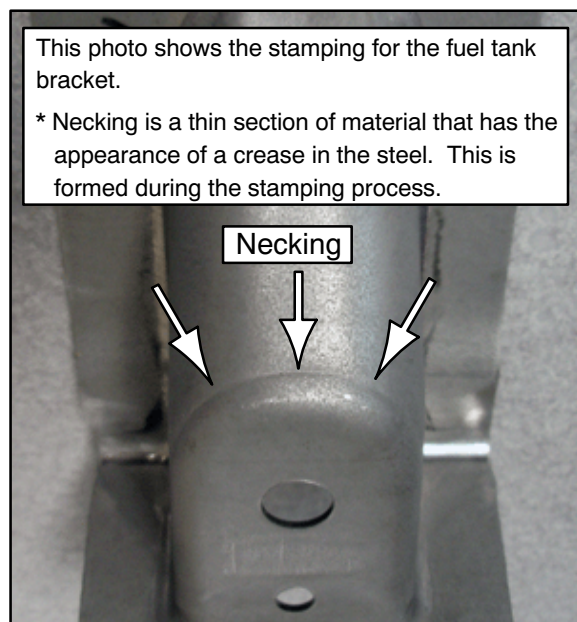
7. Carefully inspect the bracket using a mirror and flashlight. Pay close attention to the indicated area of the rear bracket for necking\* or any sign of a crack.

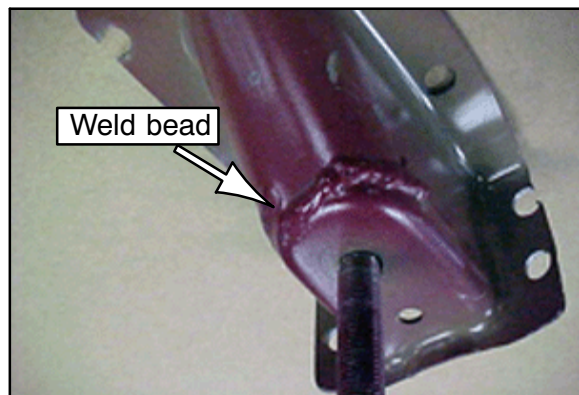
### EVIDENCE OF WELDING OR NO NECKING VISIBLE

- a. If there is no sign of necking in the inspection area, or if a bead of welding is seen across the surface of the bracket, no repairs are required. Reattach the tank strap and retorque the nuts to 26 - 31 Nm (19 - 22 ft-lbs). Reassemble the tank strap, lower the vehicle, and return the vehicle to the customer.

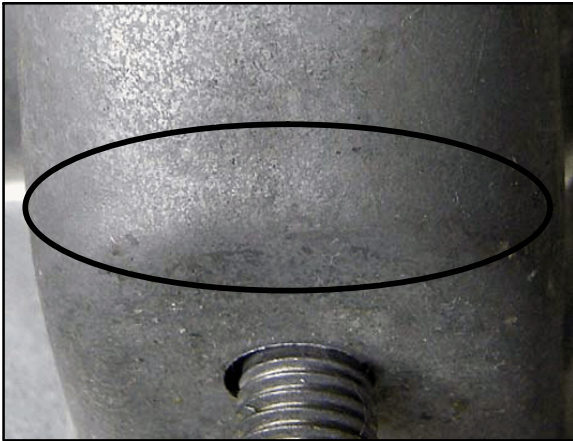
#### LIGHT NECKING

- b. If necking is light (almost no crease visible or not continuous along the radius of the part.), **no repairs are required.** Reassemble the tank strap and retorque the nuts to 26 - 31Nm (19 - 22 ft-lbs). Lower the vehicle and return it to the customer.

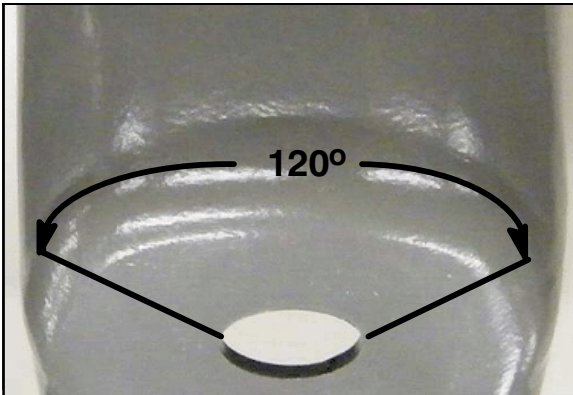
#### MEDIUM NECKING

- c. If necking is medium, determine if it exceeds 120° as shown in the photo.
  - (1) If medium necking is less than 120°, **no repairs are required.** Reassemble the tank strap and retorque the nuts to 26 - 31Nm (19 - 22 ft-lbs). Lower the vehicle and return it to the customer.
  - (2) If medium necking is 120° or greater, lower the vehicle and proceed to the repair procedure.

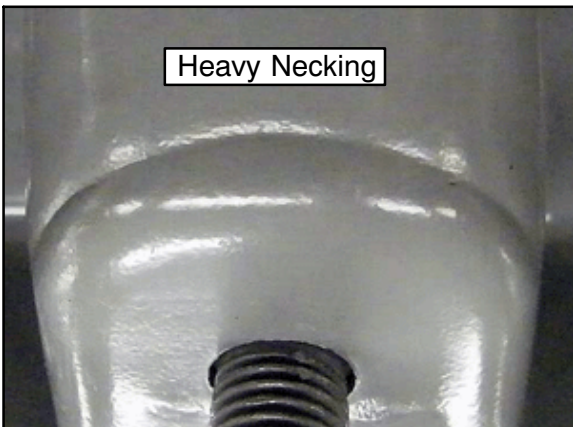
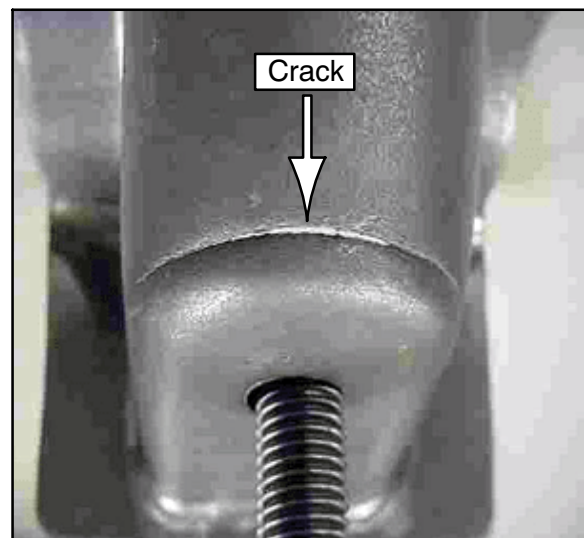
#### HEAVY NECKING OR VISIBLE CRACK

- d. If necking is heavy or if there is a crack with a visible gap, lower the vehicle and proceed to the Repair Procedure.
