GM SERVICE AND PARTS OPERATIONS  
DCS2174  
URGENT - DISTRIBUTE IMMEDIATELY

Subject: 08243 - Product Safety Recall  
Front Windshield Wiper Operation - Replace Module Cover

Models: 2003 HUMMER H2

**SUBJECT:** Front Windshield Wiper Operation – Replace Module Cover

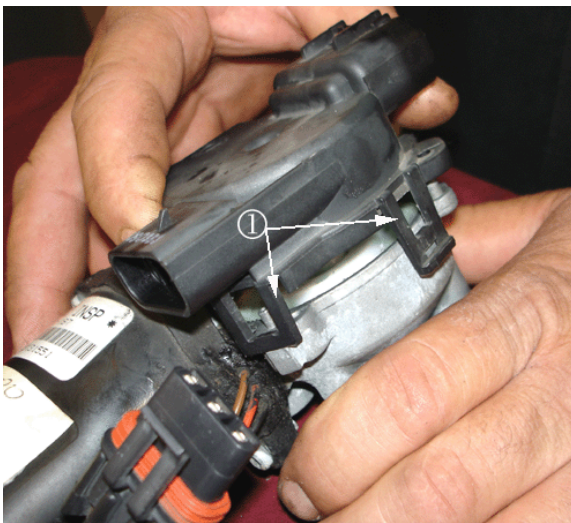
2182695

Wiper motor shown out of vehicle for illustration purposes only.

1. Remove the wiper arms. Lift the arm and raise it approximately 50 mm (2 in) from the glass. Release the locking tab at the base of the arm by sliding the tab outward with a flat bladed tool. With a flat bladed tool, lift the wiper arms off of the post.
2. Remove the air inlet grille panel caps by applying upward pressure to the caps.
3. Remove the air inlet grille panel. The panel has two screws, one on each end of the panel and two push pins in the front of the panel. Use a flat bladed tool to release the four retainers under the panel.
4. Move the panel forward to gain access to the wiper motor.
5. Disconnect the electrical connector from the module.

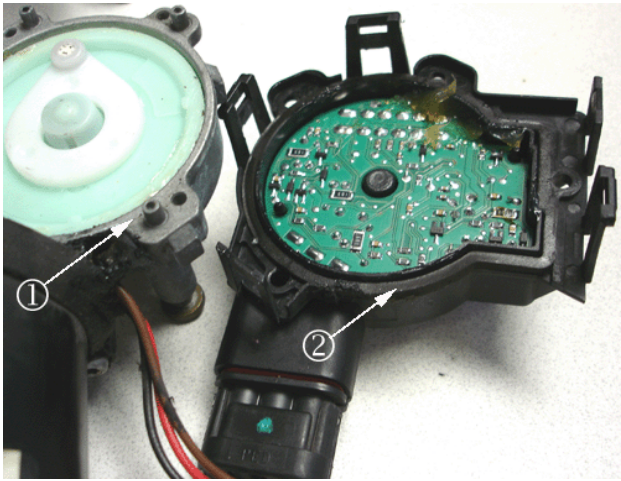
2182696

Wiper motor/module shown out of vehicle for illustration purposes only

6. Release the five retainers (1) that retain the cover/module to the motor.
