Subject: Update - Subaru Recall WVF-16 Turbo Charger Oil Supply Pipe

PRODUCT CAMPAIGN BULLETIN

APPLICABILITY: 2007 & 2008 Legacy/Outback,
 2008 Impreza and 2009 Forester
SUBJECT: Turbo Oil Supply Pipe

NUMBER: WVF-16
DATE: Oct. 2008

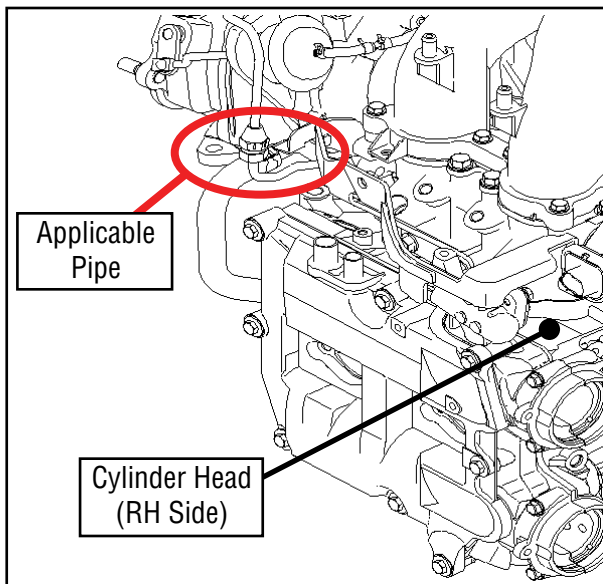
Figure 1

- 1) Identify the location of the applicable turbo charger oil supply pipe as illustrated in Figure 1, below.
- 2) Visually check the pipe for signs of cracking and/or oil leakage in the area of the pipe identified in Figure 2, below.
 - If the pipe shows signs of cracking and/or oil leakage, replace the pipe and related parts using part number 15192AA512KAI – Pipe Kit - Oil. Skip Step 3, and proceed to the “*Turbo Charger Oil Supply Pipe Replacement Procedure*” found on page 8 of this bulletin.
 - If there are no signs of cracking and/or leakage, proceed to Step 3.

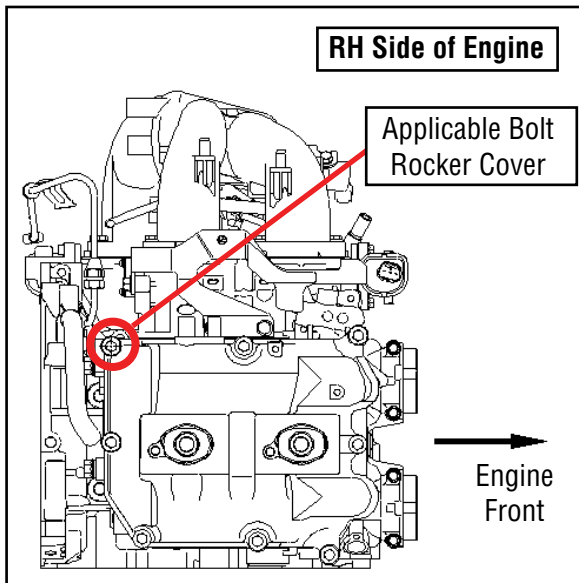
Figure 3

- (a) Remove the original rocker cover bolt which is located at the upper rear of the RH side of engine. (See Figure 3)
- (b) With the plastic clip attached to the pipe stay bracket, insert the plastic clip firmly onto the pipe beneath the pipe flare nut as illustrated in Figure 4.

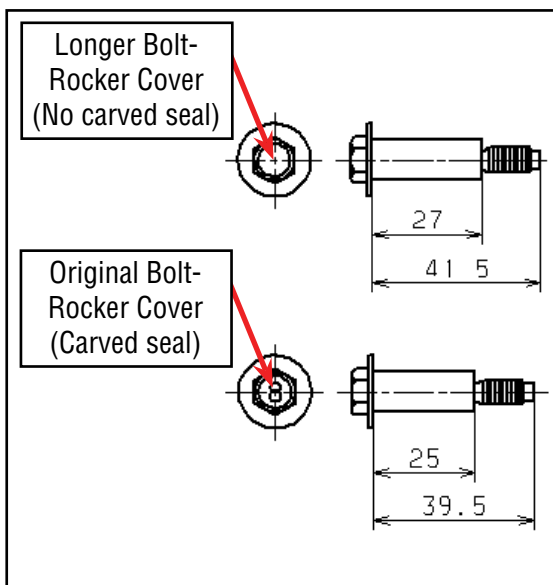
Figure 5

- (c) Be sure to use the new rocker cover bolt contained in the “stay set” kit when installing the stay bracket. The new style bolt is longer than the original and has no carved seal on the head of the bolt. **Caution:** Do Not Reuse The Original Bolt. However, do not discard the bolt at this time. (See Figure 5)
- (d) Attach the pipe stay bracket to the engine using the new rocker cover bolt as illustrated in Figure 6. Tightening torque: 6.4 +/- 0.5N-m (0.65kgf-m, 4.7ft-lb)

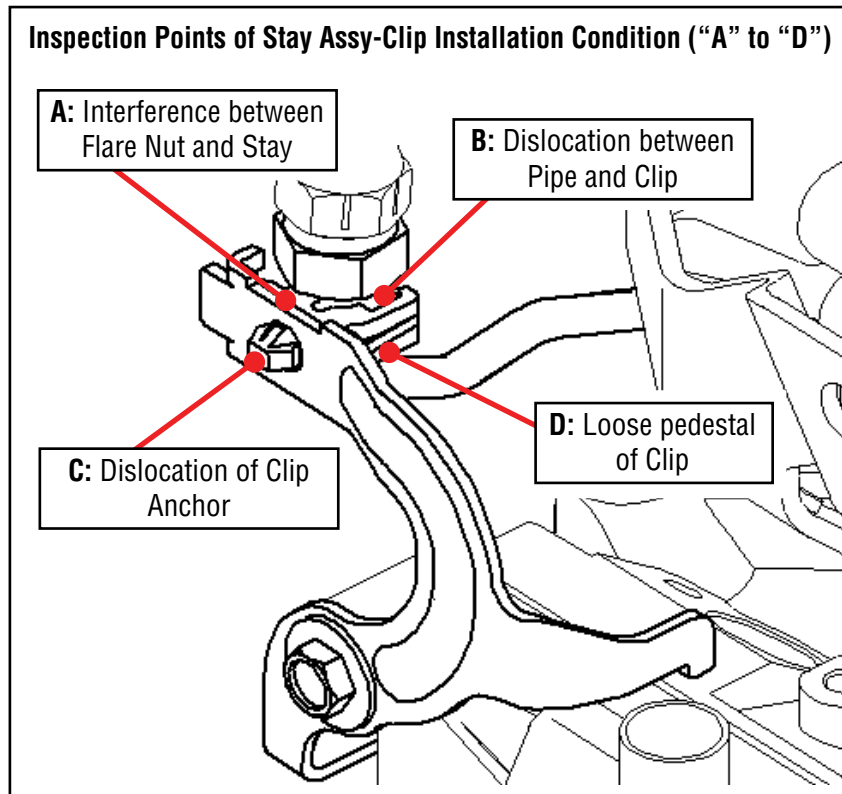
- (e) Referring to the measurements defined in Figure 7 below, make a visual inspection to determine if the pipe is properly seated in the pipe stay bracket clip. Check the 4 reference points “A” through “D”. Refer to the corresponding photographs that follow Figure 7 for visual confirmation. During this process, a “GO” or “NG” (No Go) condition will be determined for each of the 4 reference points (“A” through “D”).
- If all 4 reference points are within the “GO” range, the inspection is complete and no further action is required.
 - If any of the reference points are found to be in the “NG” range, replace the pipe. Refer to the *Turbo Charger Oil Supply Pipe Replacement Procedure*, found on page 8 of this bulletin.

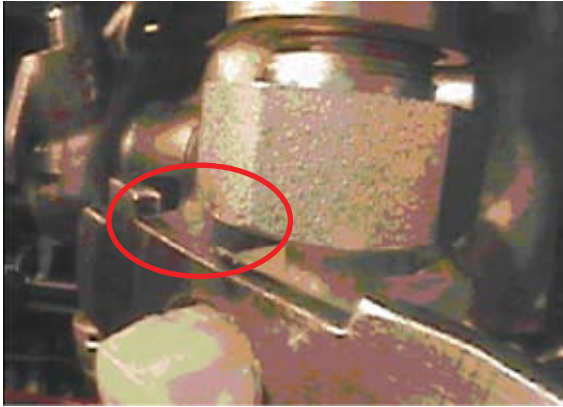
<GO>

“A” Interference between Flare Nut and Stay.

A gap exists between the pipe flare nut and the stay with no interference.

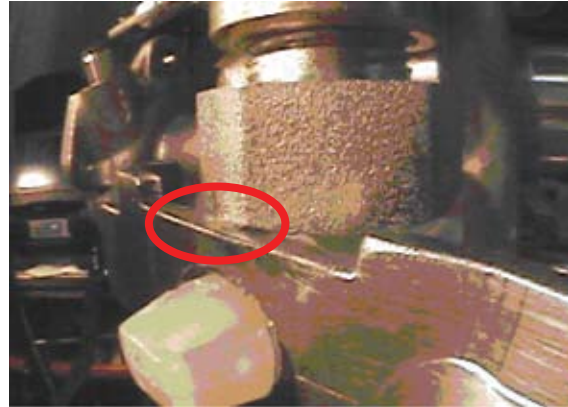
<NG>

The pip flare nut interferes with the stay body.

Turbo Charger Oil Supply Pipe Replacement Procedure

If it has been determined that the turbo charger oil supply pipe requires replacement, replace the pipe and related parts using part number 15192AA512KAI – Pipe Kit - Oil. This part is a kit and contains all necessary gaskets and seals to perform the repair. Although no specific instructions for replacement of the turbo charger oil supply pipe are listed in the Service Manuals, follow the procedure for removal and reinstallation of the intake manifold found in the applicable Service Manual. After removal of the intake manifold, replace the oil supply pipe. Note: For vehicles that have been in service, prior to installing the oil pipe banjo bolt, inspect the mesh screen for debris. Clean or replace as necessary. Use the following torque specifications for proper pipe installation.

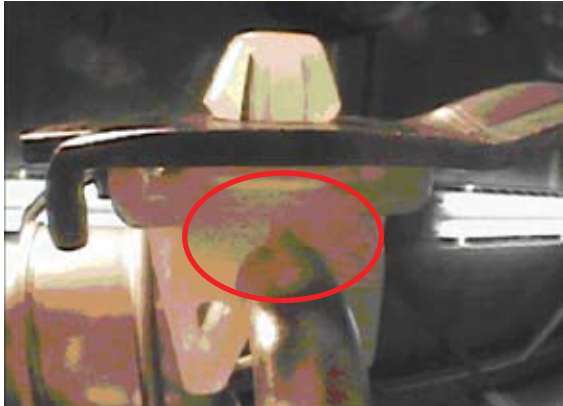
<GO>

“B” Dislocation between Pipe and Clip (Mirror might be used to check beneath the clip).

The pipe is inserted into the clip firmly.

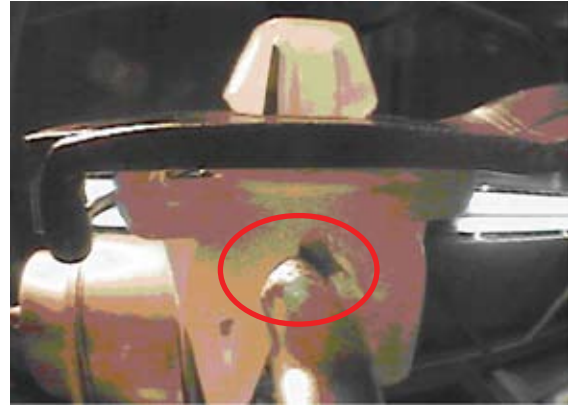
<NG>

A gap exists between the pipe and the clip.

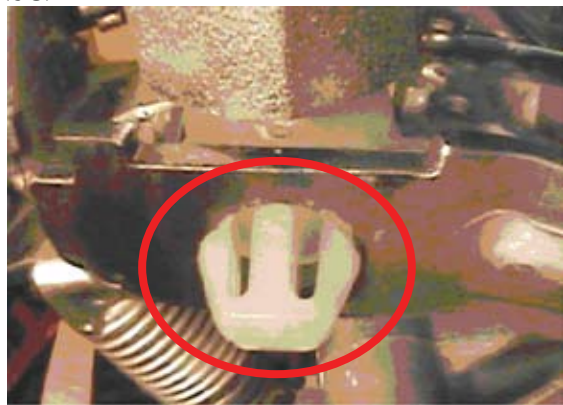
<GO>

“C” Dislocation of Clip Anchor

The clip anchor is completely inserted into the stay hole.

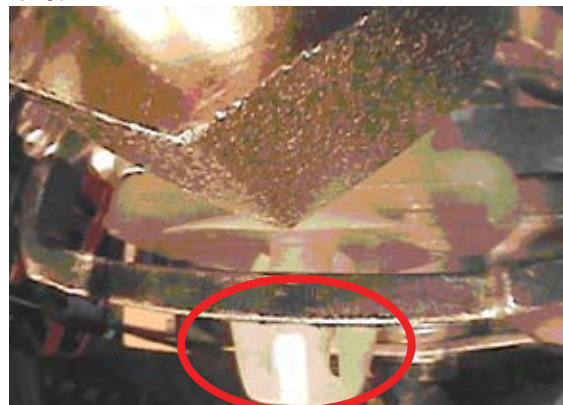
<NG>

The clip anchor is dislocated from the stay hole.

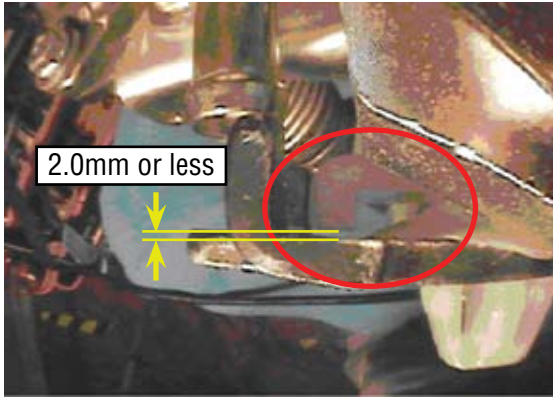
<GO>

“D” Loose Clip Pedestal

A gap is 2.0mm **or less** between the plastic clip pedestal and the stay surface.

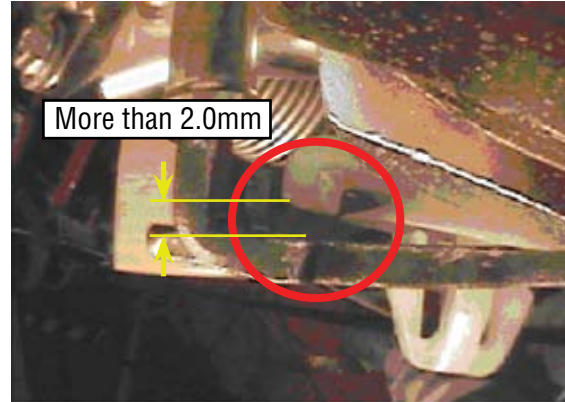
<NG>

A gap is **more than** 2.0mm between the plastic clip pedestal and the stay surface.

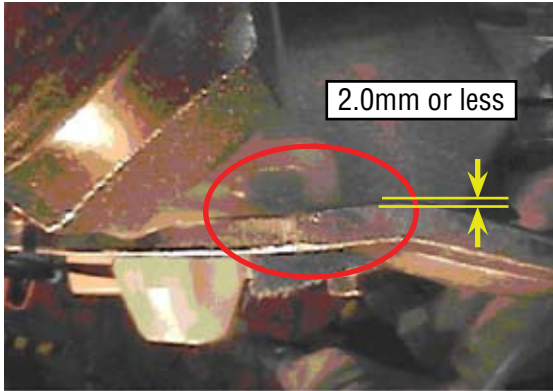
<GO>

“D” Loose Clip Pedestal

A gap is 2.0mm **or less** between the plastic clip pedestal and the stay surface.

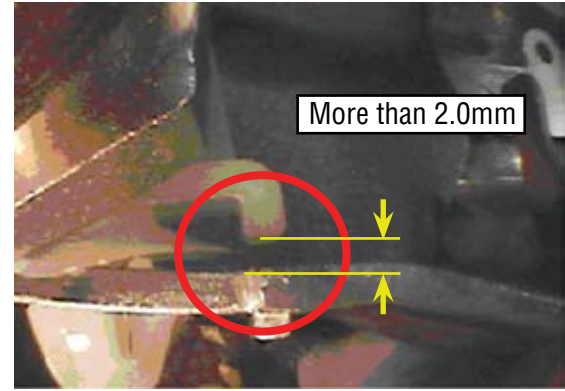
<NG>

A gap is **more than** 2.0mm between the plastic clip pedestal and the stay surface.
