Recall Bulletin

PRODUCT SAFETY RECALL

SUBJECT: Power Steering Fluid Leak – Inspect and Tighten Nut

MODELS: 2008-2009 Chevrolet Captiva
2008-2009 Saturn VUE

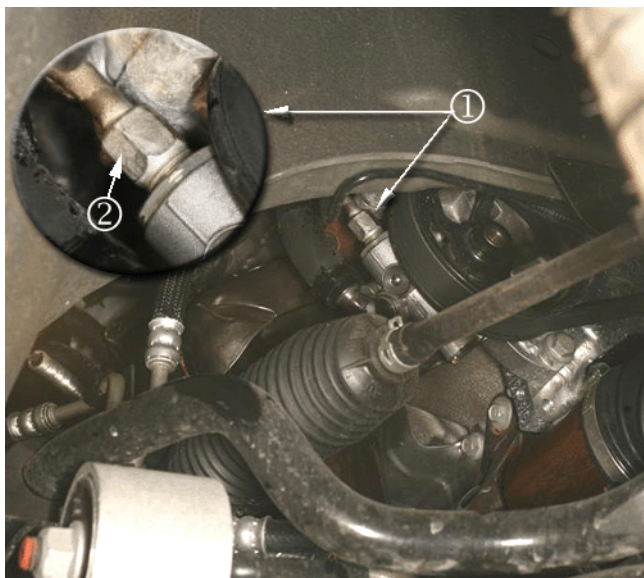
2185804

Important: Inspect the bottom side of the power steering reservoir and high pressure output line for evidence of a fluid leak. Clean the affected area, if required.

4. Using a 16mm open-end wrench, loosen the high pressure line tube nut (1). **Do not remove the tube nut from the power steering pump.**

5. Fully tighten the tube nut (1) by hand.
6. Note the position of the tube nut flats (2).
7. Using a 16mm open-end wrench, tighten the tube nut (1) 60-90 degrees (about 1 to 1½ hex flats). Do not tighten the tube nut more than 90 degrees (1½ hex flats).
8. Install the right front wheel. Refer to *Tire and Wheel Removal and Installation* in SI.
9. Lower the vehicle. Refer to *Lifting and Jacking the Vehicle* in SI.
10. If a power steering leak was found in Step 2 or 4, check the power steering fluid and add fluid if required. Refer to *Checking and Adding Power Steering Fluid* in SI.
