Subject: 08178A– Product Safety Bulletin
Automatic Transmission Shift Lever Shifts Out Of Park

Models: 2004 Cadillac SRX With Automatic Transmission

SUBJECT: Automatic Transmission Shift Lever Shifts Out of Park

MODELS: 2004 Cadillac SRX
With Automatic Transmission

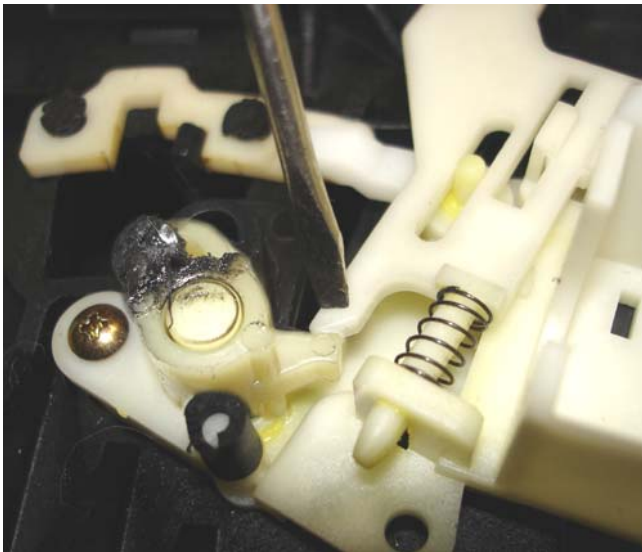
2184264

Caution: The BTISI solenoid cradle tabs are fragile. Do NOT attempt to aggressively pry the retention tabs away from the BTISI solenoid.

3. Remove the BTISI solenoid by gently separating the retention tabs and lifting the solenoid out of the cradle.

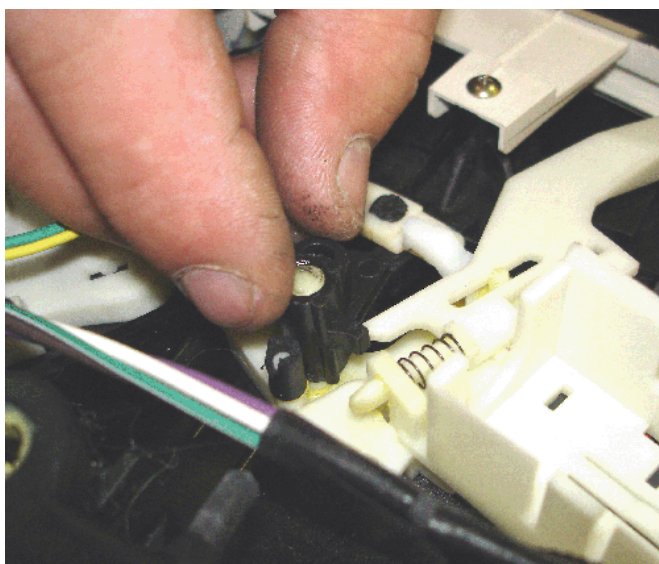
2184240

Caution: Do NOT attempt to pry the park override arm up to remove the pawl stopper. Do NOT attempt to lift the pawl stopper off of the pivot pin until the pawl stopper clears the park override arm.

4. Push down on the tip of the park override and rotate the pawl stopper counterclockwise until it clears the park override.
5. Lift the pawl stopper off of the pivot pin. Do not wipe the grease from the pivot pin.
6. Replace the pawl stopper with the new black pawl stopper from the kit.

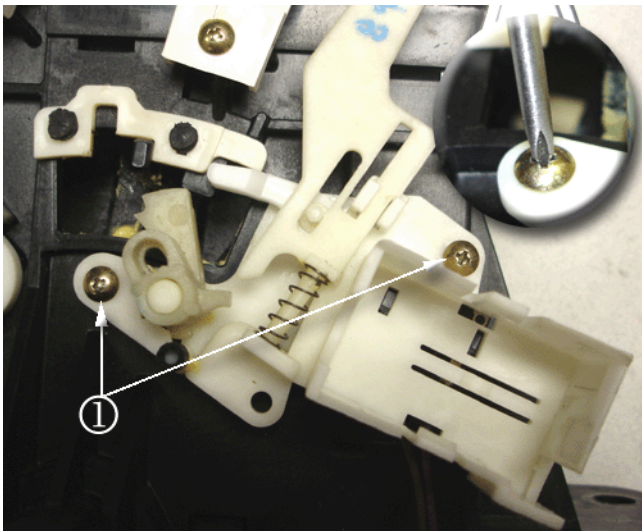
2184249

Caution: The BTSI solenoid cradle tabs are fragile. Do NOT attempt to aggressively pry the retention tabs away from the BTSI solenoid.

3. Remove the BTSI solenoid by gently separating the retention tabs and lifting the solenoid out of the cradle.

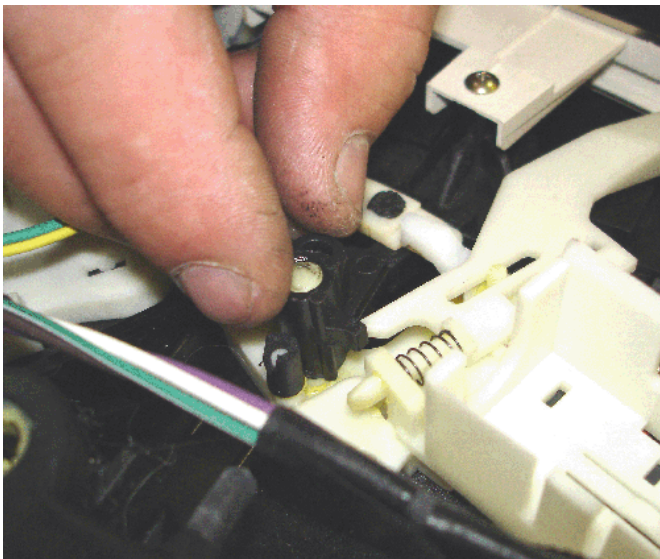
2184240

Caution: Do NOT attempt to pry the park override arm up to remove the pawl stopper. Do NOT attempt to lift the pawl stopper off of the pivot pin until the pawl stopper clears the park override arm.

5. Push down on the tip of the park override and rotate the pawl stopper counterclockwise while lifting the stopper to clear the rib that is part of the shifter base, until it clears the park override.
6. Lift the pawl stopper off of the pivot pin. Do not wipe the grease from the pivot pin.
7. Replace the pawl stopper with the new black pawl stopper from the kit.
